CS001016

Site SIT0311 CURRIE HIGH SCHOOL
Address 31

Building Summary BLD00567 CURRIE HIGH SCHOOL - MAIN BUILDING

Survey Date: 12/08/2016

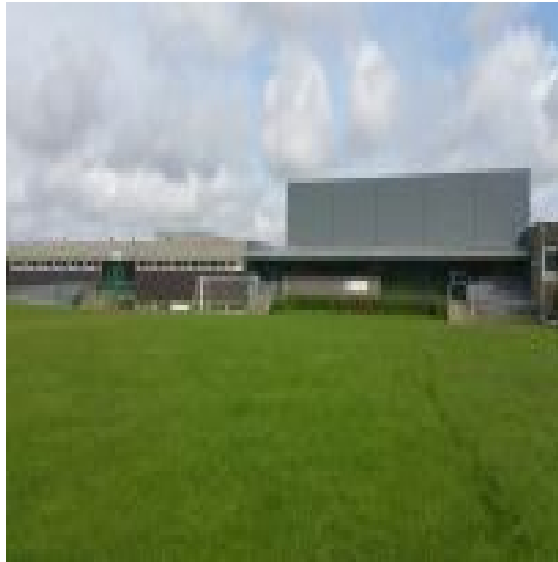
Code: IW00000909
Element: 11 External Areas
Subelement: 11.01 Paths & Paved Pedestrian Areas
Item: 11.01.01
Condition: C Poor
Priority: 02 Essential - Within 2 years

Comments: This is a large area of ground to lay unused.

Site: SIT0311 CURRIE HIGH SCHOOL
Building:
Room:
Cost: £3317.12
Remedy: Consider additional planting to soak up
Defect: excess water found near disused former playing fields
to NW.

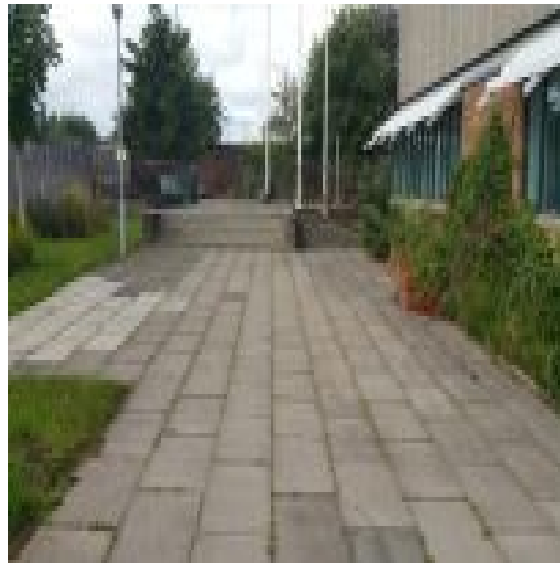
Code: IW00000900
Element: 11 External Areas
Subelement: 11.01 Paths & Paved Pedestrian Areas
Item: 11.01.04
Condition: C Poor
Priority: 01 Urgent
Comments:
Photo:

Site: SIT0311 CURRIE HIGH SCHOOL
Building:
Room:
Cost: £1500.00
Remedy: Repairs to and resetting of concrete slabs.
Defect: concrete slabs in poor condition.

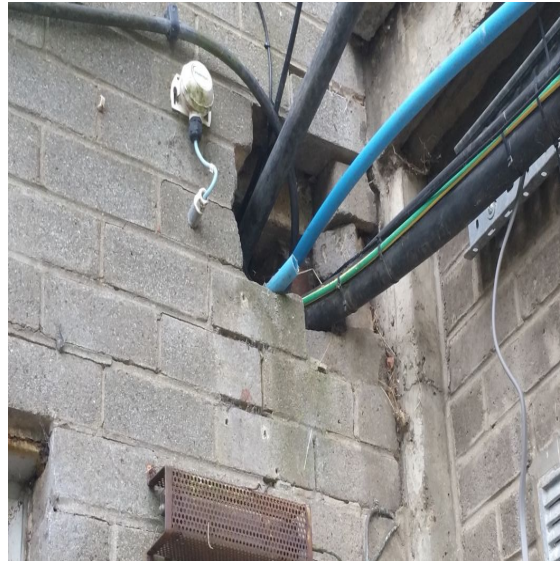
Code: IW00000905
Element: 11 External Areas
Subelement: 11.02 External works/infrastructure
Item: 11.02.01
Condition: C Poor

Defect: Snagging issues remain incomplete

Remedy: Snagging issues regarding the new extension have not been resolved satisfactorily. Although outwith defects period someone needs to take a look at this along with original project manager.

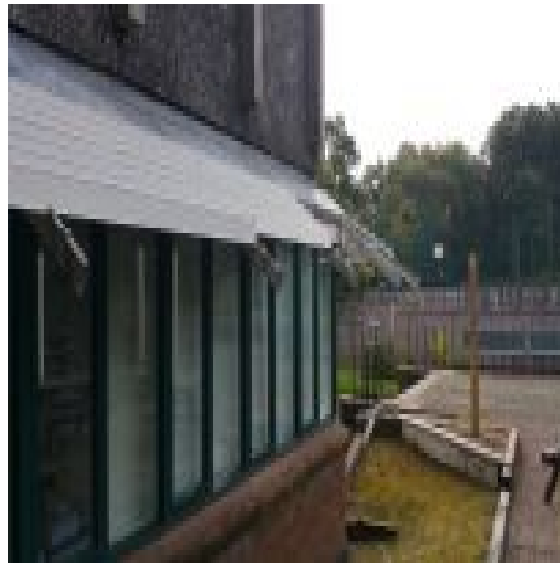
Code: IW00000907
Element: 11 External Areas
Subelement: 11.02 External works/infrastructure
Item: 11.02.01
Condition: C Poor

Site: SIT0311 CURRIE HIGH SCHOOL
Building:
Room:
Cost: £2817.12
Remedy: Repairs to Brise soleil solar shading. Change of specification may be required if these vanes are unable to resist wind loadings.
Defect: Brise soleil solar shading requires repair.

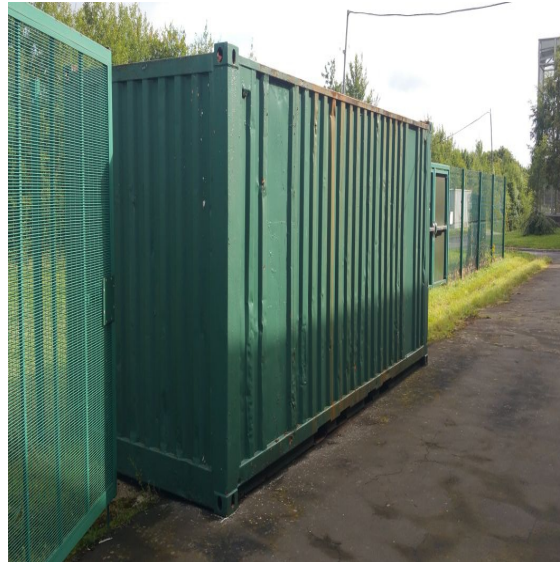
Code: IW00000915
Element: 11 External Areas
Subelement: 11.02 External works/infrastructure
Item: 11.02.01
Condition: C Poor

Site: SIT0311 CURRIE HIGH SCHOOL
Building:
Room:
Cost: £200.00
Remedy: Containers need rationalised and any not required should be removed.
Defect: Containers need rationalised

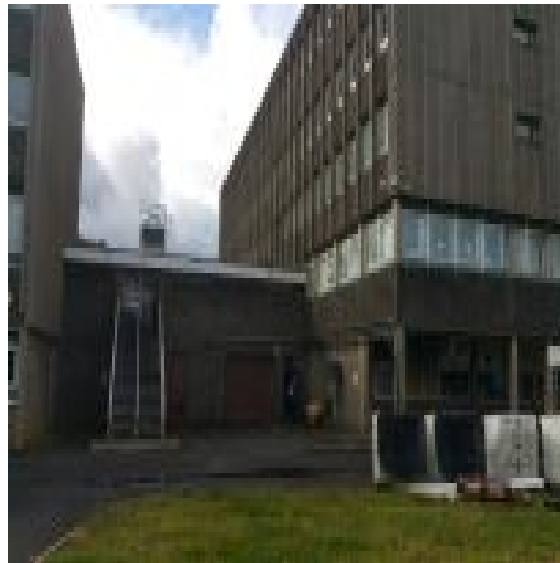
Code: IW00000913
Element: 11 External Areas
Subelement: 11.02 External works/infrastructure
Item: 11.02.01
Condition: D Bad

Site: SIT0311 CURRIE HIGH SCHOOL
Building:
Room:
Cost: £3000.00
Remedy: Separate locked cage away from building is needed for bin store to prevent arson attacks. This is really a suitability issue and was one of the Cullen recommendations
Defect: Bin Store required.

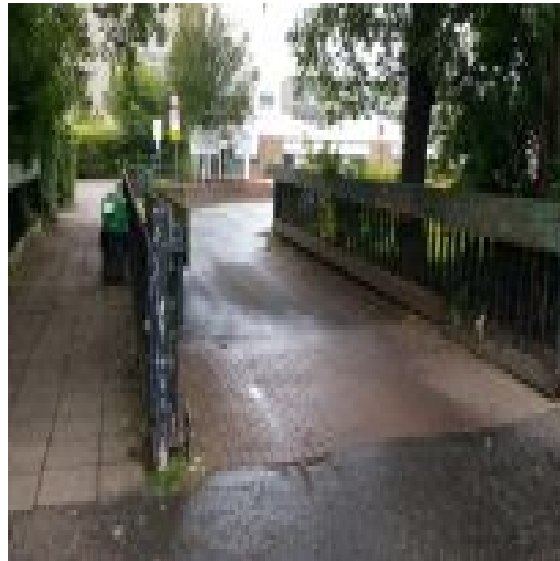
Code: IW00018195
Element: 11 External Areas
Subelement: 11.03 Walls, Fencing & Gates
Item: 11.03.03
Condition: C Poor

Comments: Entire perimeter of the school is poor in terms of security against intruders/vandalism. This would cost a considerable sum to address thoroughly.

Site: SIT0311 CURRIE HIGH SCHOOL
Building:
Room:
Cost: £6585.60
Remedy: Main gates and fencing should be removed and replaced with black, colour coated, roll top mesh type.
Defect: Vehicular and pedestrian entrance fencing and gates are in very poor condition and create a poor first impression.
Defect Location: Main entrance

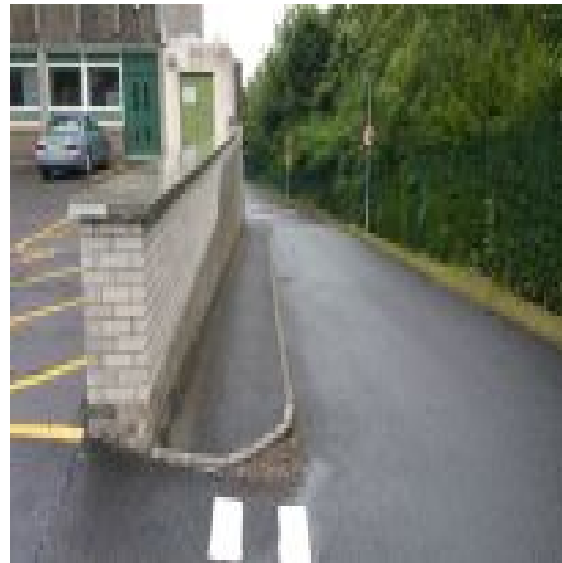
Code: IW00000906
Element: 11 External Areas
Subelement: 11.04 Roads & Car Parks
Item: 11.04.05
Condition: C Poor

Site: SIT0311 CURRIE HIGH SCHOOL
Building:
Room:
Cost: £10000.02
Remedy: Pedestrian/vehicular traffic needs to be very well defined or completely separate. Localised repairs are needed to macadam and drainage improvements.
Defect: Pedestrian/vehicular traffic undefined.

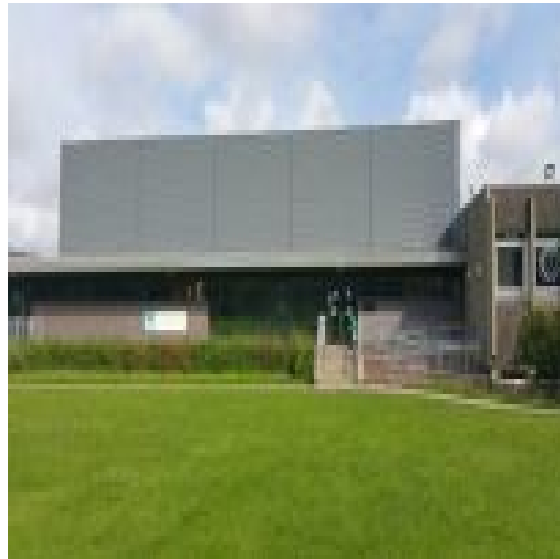
Code:	IW00018196	Site:	SIT0311 CURRIE HIGH SCHOOL
Element:	12 Outdoor sports facilities and fixed furniture	Building:	
Subelement:	12.02 Pitch	Room:	
Item:	12.02.02	Cost:	£1448.83
Condition:	B Satisfactory	Remedy:	Automatic mowing system should be considered. Level change needs a handrail
Priority:	02 Essential - Within 2 years	Defect:	Grassed area used for field sports is in good condition. Requires regular cutting and line marking, and removal of dog dirt.
Comments:	Entire perimeter of the school is poor in terms of security against intruders/vandalism. Percieved right of way through school grounds was supposed to be closed post Cullen.

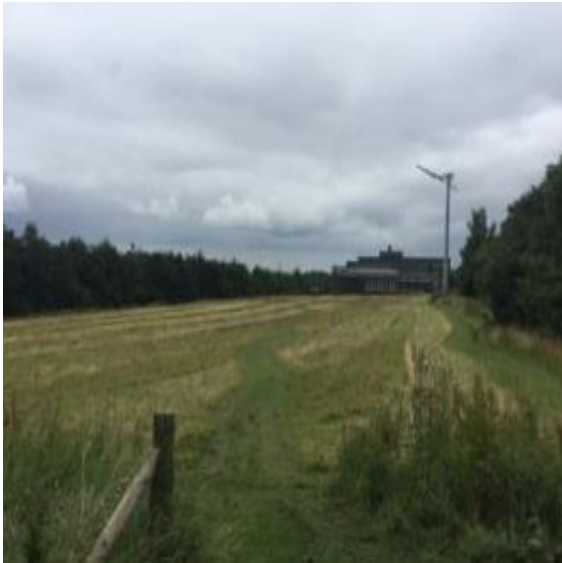
Code:	IW00018197	Site:	SIT0311 CURRIE HIGH SCHOOL
Element:	12 Outdoor sports facilities and fixed furniture	Building:	
Subelement:	12.02 Pitch	Room:	
Item:	12.02.02	Cost:	£7968.57
Condition:	C Poor	Remedy:	Automatic mowing system should be considered and fence to enable controlled access and night security.
Priority:	02 Essential - Within 2 years	Defect:	Grassed area used for field sports is in poor condition. Requires drainage improvement, regular cutting and line marking, and removal of dog dirt.
Comments:	Entire perimeter of the school is poor in terms of security against intruders/vandalism. Percieved right of way through school grounds was supposed to be closed post Cullen.		
Photo:

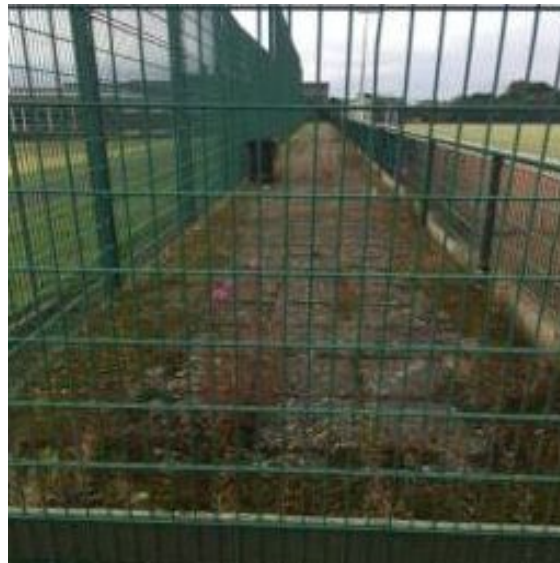
Code: IW00018198
Element: 12 Outdoor sports facilities and fixed furniture
Subelement: 12.02 Pitch
Item: 12.02.03
Condition: B Satisfactory
Priority: 03 Desirable - Within 3 to 5 years

Site: SIT0311 CURRIE HIGH SCHOOL
Building:
Room:
Cost: £289.76
Remedy: Replace toe boards and add weed killer to perimeter.
Defect: All weather pitches in very good condition but some toe boarding needs replaced and weed suppressent is needed.
Defect Location: South of school

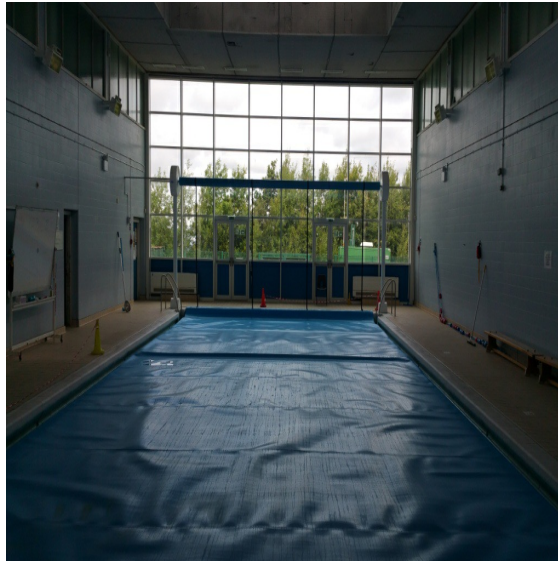
Code: IW00018190
Element: 02 Floors and stairs
Subelement: 02.01 Floor Finishes
Item: 02.01.11
Condition: B Satisfactory
Priority: 03 Desirable - Within 3 to 5 years

Room:
Cost: £52684.80
Remedy: Kitchen, dining, pool areas need works.
Defect: Floor finishes are generally sound but some need replaced and within the 5 year period 10% of the entire area will need replaced.

Comments: Some specialist finishes are needed in some areas to aid hygiene cleansing, slip resistance etc.

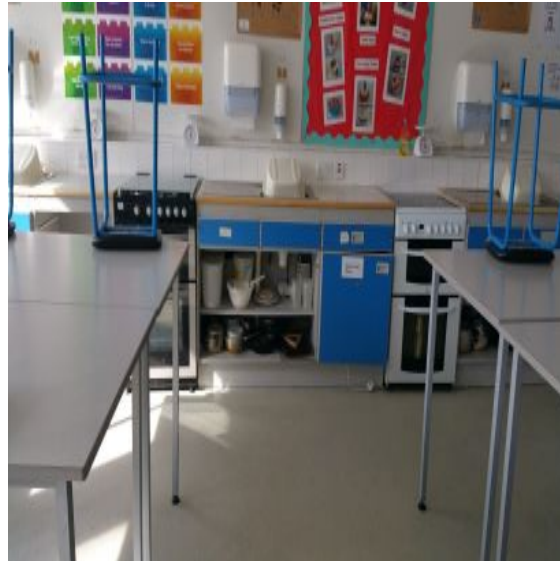
Code: IW00018079
Element: 02 Floors and stairs
Subelement: 02.02 Floor structure
Item: 02.02.01
Condition: D Bad

Comments: This fault has been evident since the school was opened. Any attempt to introduce lightweight leveling screed etc will merely impose more load on the structure.

Site: SIT0311 CURRIE HIGH SCHOOL
Building: BLD00567
Room:
Cost: £2635.47
Remedy: Pending results of separate structural Survey. Monitor any movement or deflection change.
Defect: Tower block beams and floors are not level
Defect Location: Main tower block and apticularly at Home economics

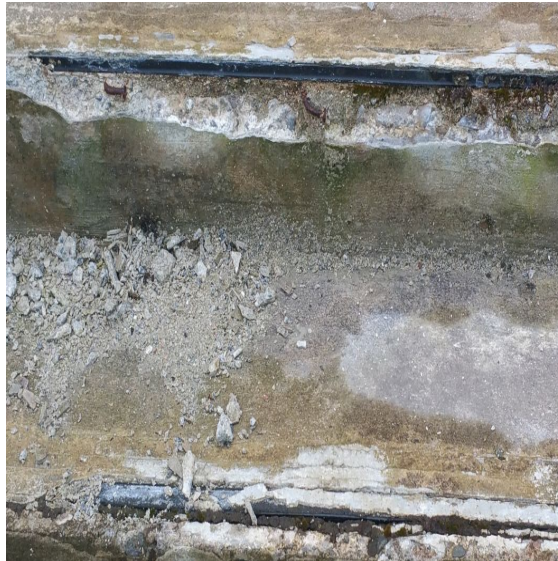
Code: IW00000899
Element: 02 Floors and stairs
Subelement: 02.04 Staircases
Item: 02.04.01
Condition: C Poor

Site: SIT0311 CURRIE HIGH SCHOOL
Building: BLD00567
Room:
Cost: £197568.00
Remedy: External steps at various locations need design review/renewal.
Defect: External steps of outdated design. Some have erroneously had handrails removed and not replaced, some poor design.

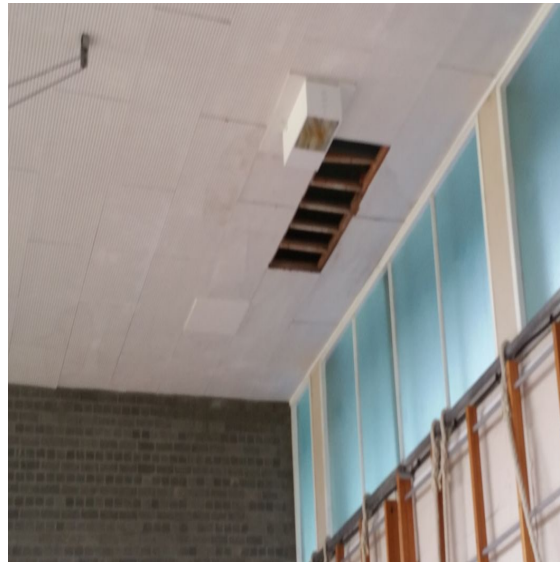
Code: IW00005436
Element: 03 Ceilings
Subelement: 03.01 Ceiling Finish
Item: 03.01.05
Condition: C Poor
Priority: 03 Desirable - Within 3 to 5 years

Site: SIT0311 CURRIE HIGH SCHOOL
Building: BLD00567
Room:
Cost: £3147.91
Remedy: Replace ceiling tiles
Defect: Several ceiling tiles are dislodged or stained.
Defect Location: Differing locations including classrooms

Comments: Suspended ceilings in poor condition give a poor impression though light weight materials unlikely to cause injury as a result of failure.

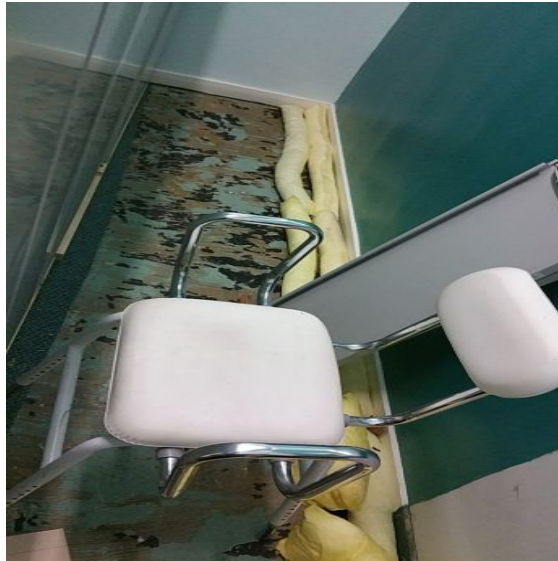
Code: IW00000917
Element: 04 External walls windows and doors
Subelement: 04.04 Ext Walls Structure & Foundations
Item: 04.04.04
Condition: C Poor

Comments: Courtyard excavation and temporary storage of material will be labour intensive. Wall should also be checked structurally as this acts as a retaining wall and may have been weakened by freeze/thaw cycles.

Site: SIT0311 CURRIE HIGH SCHOOL
Building: BLD00567
Room:
Cost: £20000.00
Remedy: External tanking to walls at stores medical rooms etc. DPC needs to be tied into new tanking as worst water penetration seems to be at floor level.
Defect: External tanking to walls at stores medical rooms requires upgrade.
Defect Location: at courtyard adjacent to dining hall and in front of medical room

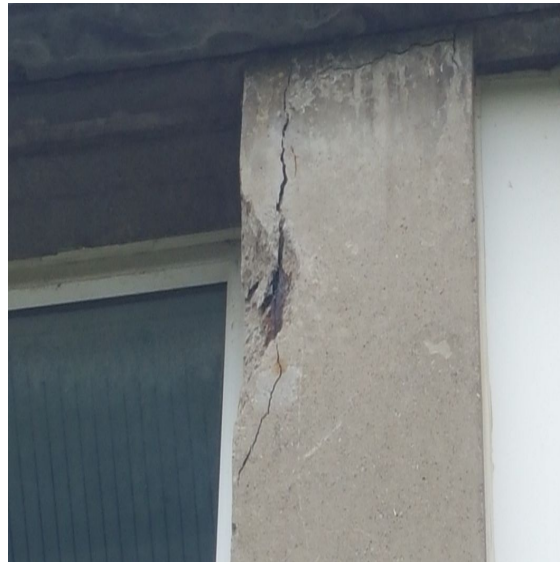
Code: IW00000922
Element: 04 External walls windows and doors
Subelement: 04.04 Ext Walls Structure & Foundations
Item: 04.04.08
Condition: D Bad

Defect: Extensive concrete repairs/internal insulation and over-cladding or similar major refurbishment is required.

Remedy: Extensive concrete repairs/replacement cladding will need to be considered to usefully extend the buildings lifespan. Costs will vary widely dependant on specification.

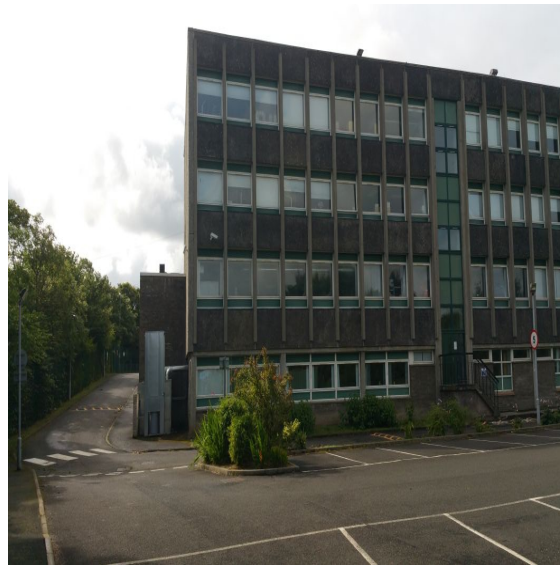
Code: IW00018192
Element: 04 External walls windows and doors
Subelement: 04.07 Window Framing & Glazing
Item: 04.07.03
Condition: D Bad
Priority: 03 Desirable - Within 3 to 5 years

Site: SIT0311 CURRIE HIGH SCHOOL
Building: BLD00567
Room:
Cost: £65856.00
Remedy: Renew defective or dated windows.
Defect: Window replacement phases have been completed over the years but further works are needed.
Defect Location: Main tower block

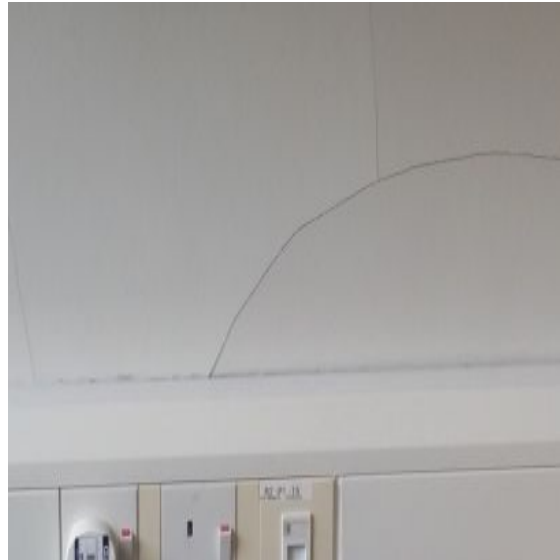
Code:	IW00005435	Site:	SIT0311 CURRIE HIGH SCHOOL
Element:	05 Internal walls and doors	Building:	BLD00567
Subelement:	05.03 Internal Wall Finish	Room:	
Item:	05.03.02	Cost:	£31610.88
Condition:	B Satisfactory	Remedy:	Simple remedy is to temporary remove all MK trunking, skirtings and other wall mounted services. Remove defective inner wall lining and inspect to determine cause of fault. If all proves to be sound then dry line the wall and introduce plasterboard with a scrim coat of plaster. Following decoration and services should be reinstated. Additional insulation could also be introduced when undertaking the works.
Priority:	03 Desirable - Within 3 to 5 years	Defect:	Minor cracking and crazing has manifested in 4 walls of Computer Studies classrooms.
Comments:	Costs are dependant of level of remedial works that might be uncovered.		
Photo:

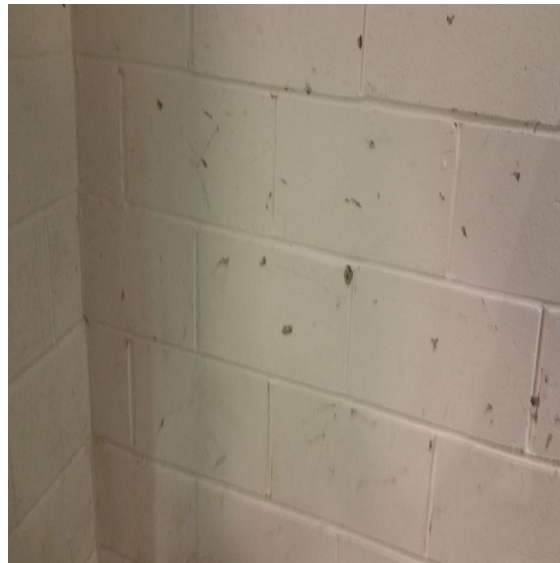
Code: IW00005437
Element: 05 Internal walls and doors
Subelement: 05.03 Internal Wall Finish
Item: 05.03.02
Condition: B Satisfactory

Defect: Walls are currently in reasonable condition although heavy circulation areas are beginning to become marked and worn.

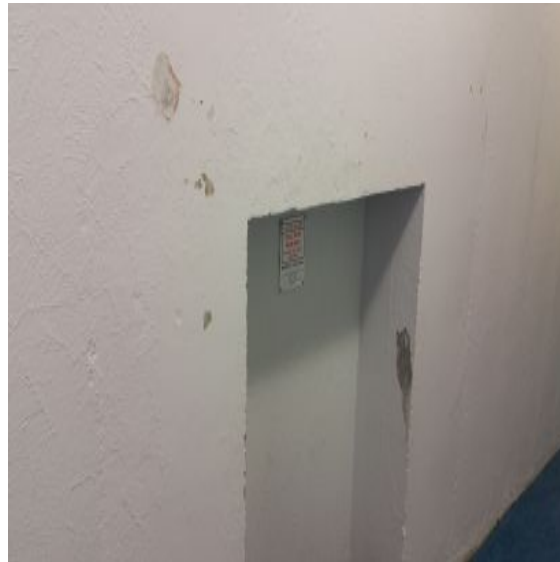
Code: IW00018193
Element: 05 Internal walls and doors
Subelement: 05.03 Internal Wall Finish
Item: 05.03.02
Condition: B Satisfactory
Priority: 03 Desirable - Within 3 to 5 years

Site: SIT0311 CURRIE HIGH SCHOOL
Building: BLD00567
Room:
Cost: £15963.49
Remedy: Dry-line, repaint and perhaps introduce a wall guard system for worst areas.
Defect: Internal walls are severely affected by water ingress as a result of faulty tanking where external ground level is higher than floor level.
Defect Location: Medical room, store room, and dining areas.

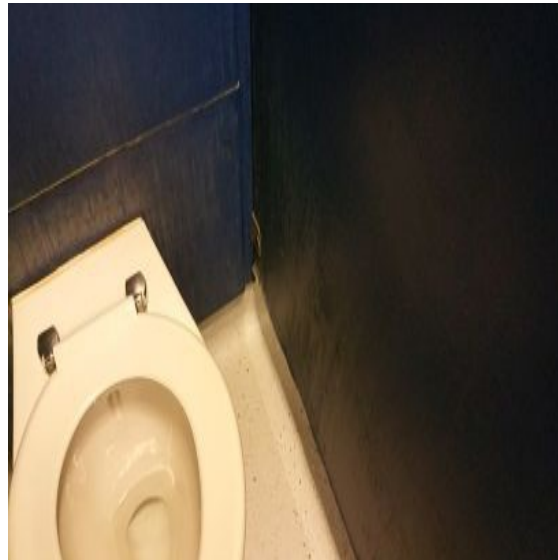
Code: IW00004994
Element: 06 Sanitary services
Subelement: 06.01 Cubicle Walling
Item: 06.01.01
Condition: C Poor
Priority: 03 Desirable - Within 3 to 5 years

Site: SIT0311 CURRIE HIGH SCHOOL
Building: BLD00567
Room:
Cost: £19756.80
Remedy: Renew
Defect: Delaminating
Defect Location: Boys toilets and vanity units

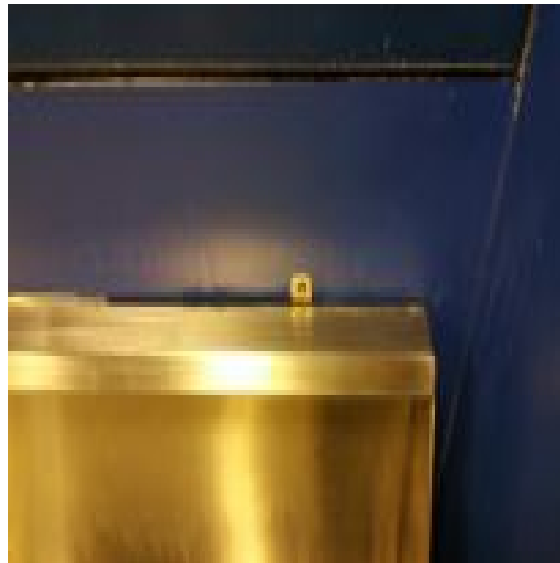
Code: IW00005432
Element: 06 Sanitary services
Subelement: 06.03 Toilets
Item: 06.03.02
Condition: C Poor
Priority: 03 Desirable - Within 3 to 5 years

Site: SIT0311 CURRIE HIGH SCHOOL
Building: BLD00567
Room:
Cost: £10536.96
Remedy: Line walling with hygiene boards.
Defect: Urinals in main pupil toilets need to be improved through introduction of hygiene wall lining board.
Defect Location: Top edge of urinal

Comments: Toilets have a dark oppressive colour scheme which could be made better and easier to clean with introduction of Respotex or similar lining board bonded over.

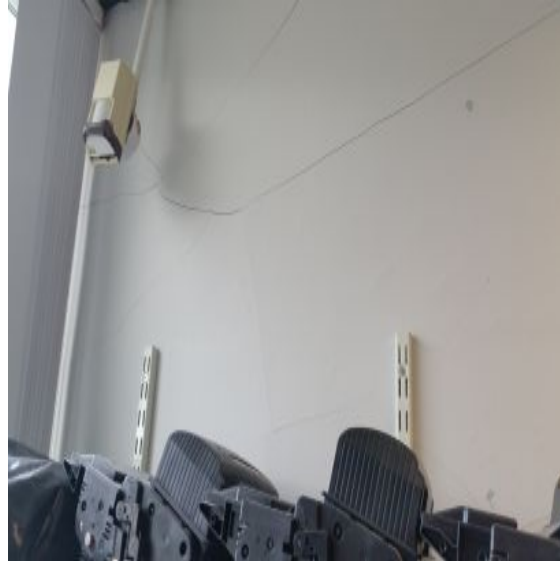
Code: IW00018194
Element: 10 Fixed internal furniture and fittings
Subelement: 10.01 Fixed Furniture
Item: 10.01.02
Condition: D Bad

Defect: Most cupboard spaces throughout the school are poorly designed and have inappropriate spur shelving units. Fixed benches have poor floor fixings, fixed kitchen features have a ceramic tiled finish.

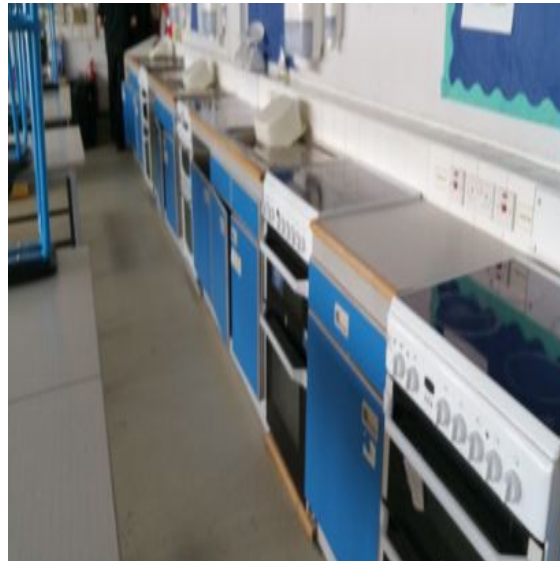
Code: IW00018122
Element: 10 Fixed internal furniture and fittings
Subelement: 10.01 Fixed Furniture
Item: 10.01.03
Condition: D Bad

Site: SIT0311 CURRIE HIGH SCHOOL
Building: BLD00567
Room:
Cost: £66281.73
Remedy: Remove existing stations and fit new replacements to suit layout preferred by school.
Defect: Home economics area requires major upgrade. Layout is poor, units are in poor condition, hygiene is poor, lighting poor, thermal comfort poor, ventilation poor, floor structure and finish is poor.
Defect Location: Main tower block

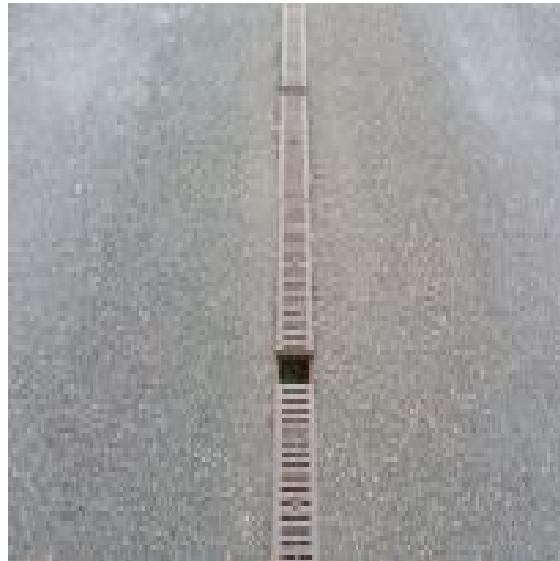
Code: IW00018123
Element: 11 External Areas
Subelement: 11.01 Paths & Paved Pedestrian Areas
Item: 11.01.01
Condition: D Bad
Priority: 02 Essential - Within 2 years

Site: SIT0311 CURRIE HIGH SCHOOL
Building: BLD00567
Room:
Cost: £66281.73
Remedy: Mark up pedestrian routes clearly and install railings where there is level changes exceeding 600mm.
Defect: Most pathways are in good condition but some better line marking at vehicular areas and some handrails at drops/level changes are required. Equalities Act crossing is very poor.
Defect Location: Entire school

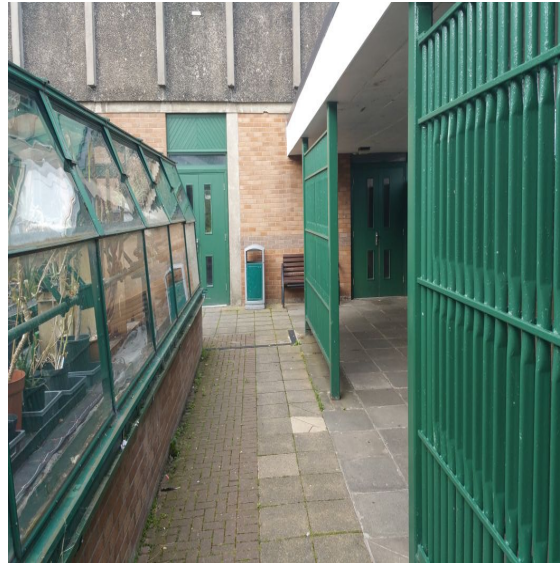
Code: IW00000901
Element: 02 Floors and stairs
Subelement: 02.02 Floor structure
Item: 02.02.01
Condition: D Bad
Priority: 02 Essential - Within 2 years

Site: SIT0311 CURRIE HIGH SCHOOL
Building: BLD02417
Room:
Cost: £5790.28
Remedy: Entire area needs tanked and slabs reinstated.
Defect: Floor of greenhouse and surrounding area forms roof of plant room below. This area is tanked and covered in paving slabs which are ineffective
Defect Location: Greenhouse floor to North of main building

Comments: Previous efforts have failed. This needs to be undertaken by a specialist firm.
