The Council has undertaken a number of structural surveys of the main building in Currie High School in 2017, in response to a leak in the home economics department. The results of those surveys are included in this document. To summarise, this document includes:

Currie High School Structural Appraisal – Reinforced Concrete Floors

**REPORT ON INSPECTION AND TESTING OF
REINFORCED CONCRETE FLOOR SLABS AT
CURRIE HIGH SCHOOL, EDINBURGH.**

**Report on Inspection and Testing of Reinforced Concrete Floor Slabs at
Currie High School, Edinburgh.**

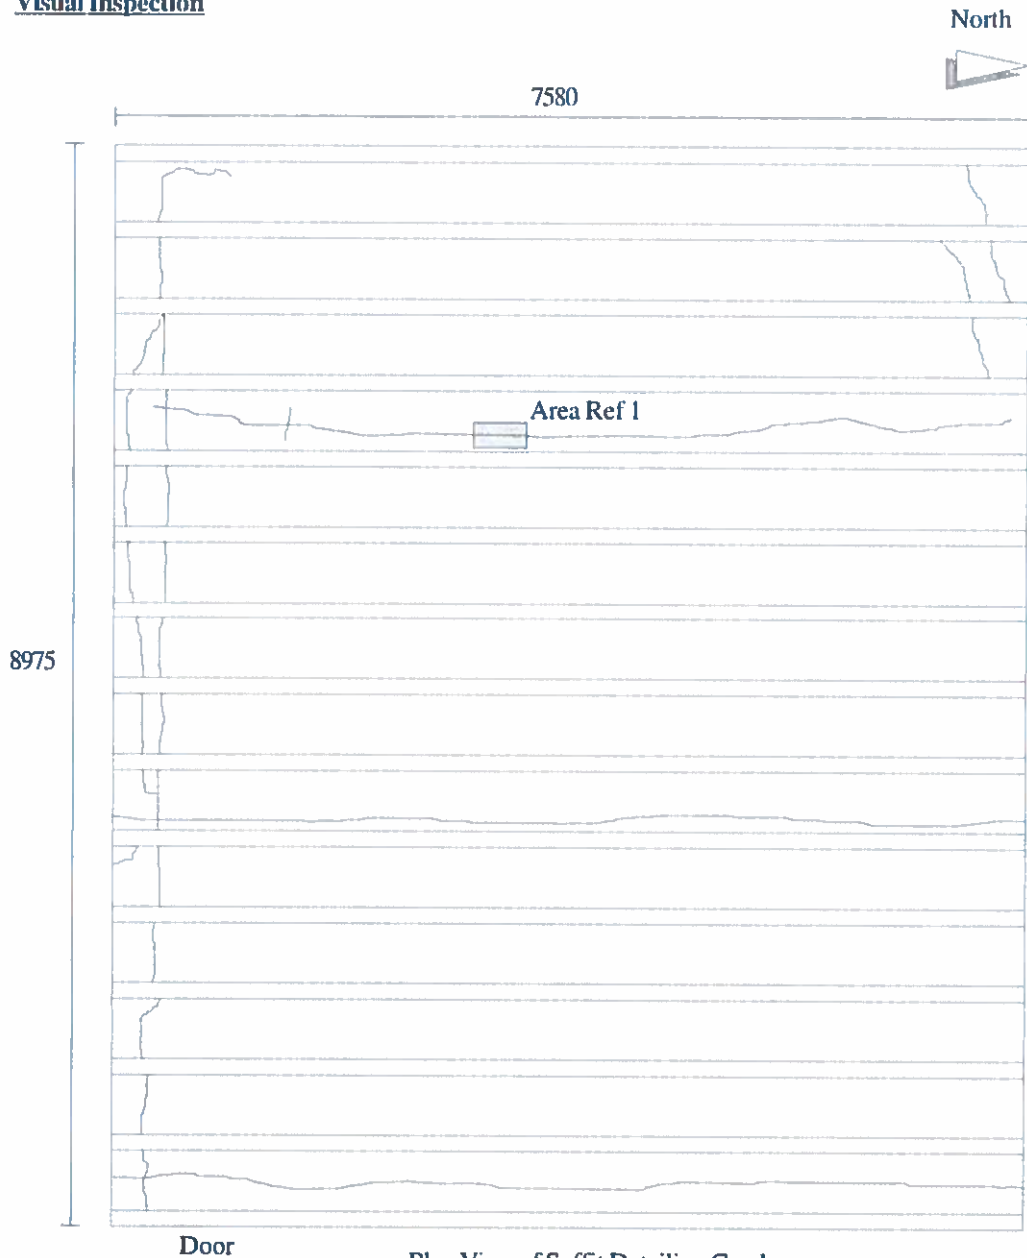
Plan View of Soffit Detailing Cracks

A crack 5mm wide was visible adjacent to the west face of the 5th rib from the east side. This crack extends over the full width of the room. It was noted to be narrower towards the ends. Smaller cracks, up to 1.5mm wide were noted in the centre of the 1st and 11th troughs also spanning width of room. See plates 1 to 9.

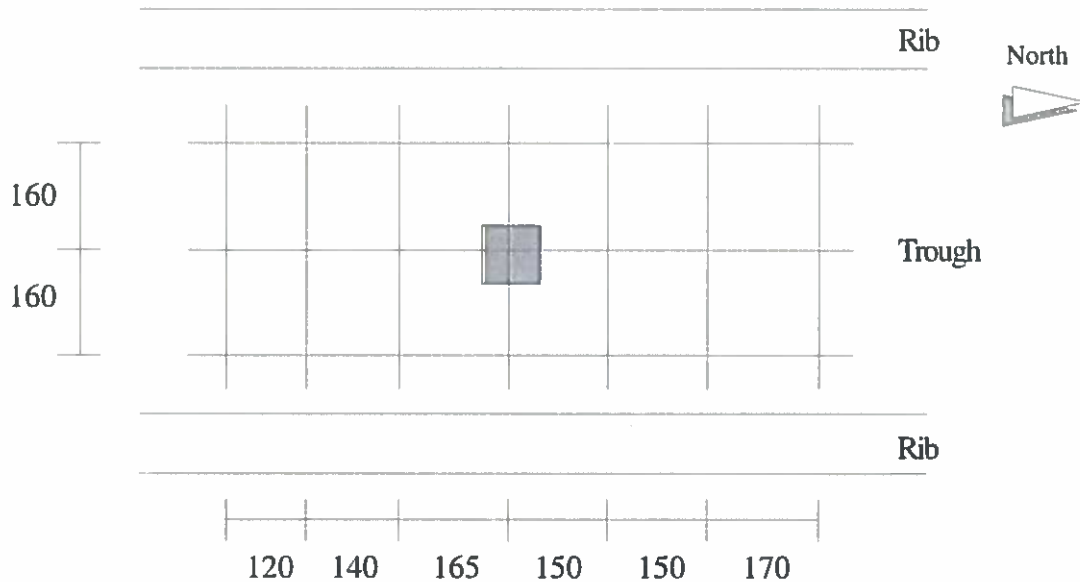
Part Plan Detailing Layout of Reinforcement to Soffit of Floor Slab

3mm diameter smooth round bars in both directions exhibiting surface corrosion. 12mm concrete cover. See plates 10 to 13.

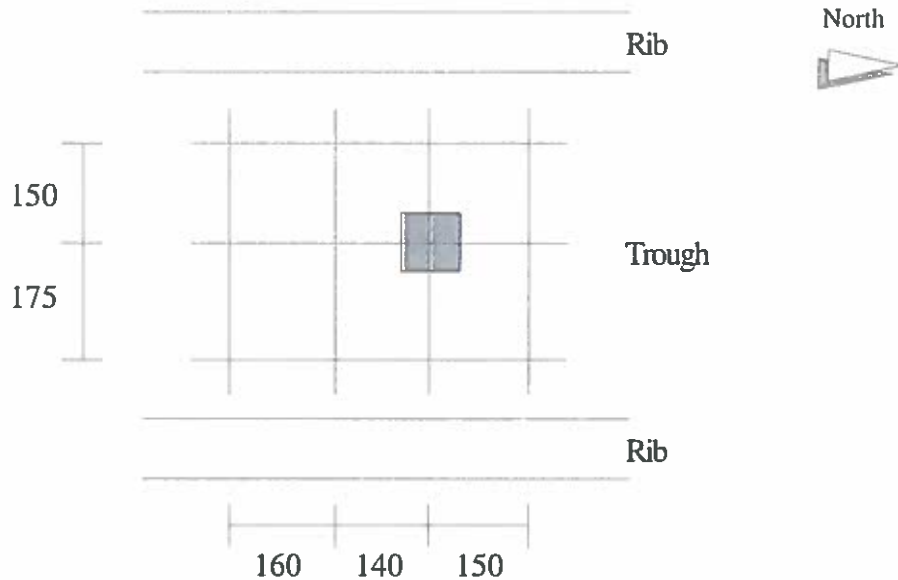
Part Plan Detailing Layout of Reinforcement to Soffit of Floor Slab

3mm diameter smooth round bars in both directions exhibiting surface corrosion. 9mm concrete cover. See plate 33.

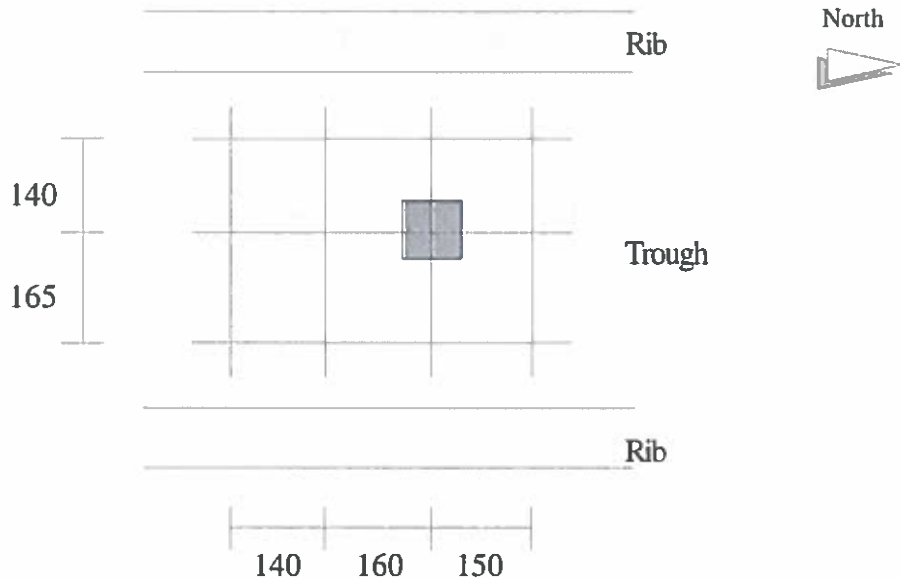
Part Plan Detailing Layout of Reinforcement to Soffit of Floor Slab

3mm diameter smooth round bars in both directions exhibiting surface corrosion. 12mm concrete cover. See plates 40 and 41.

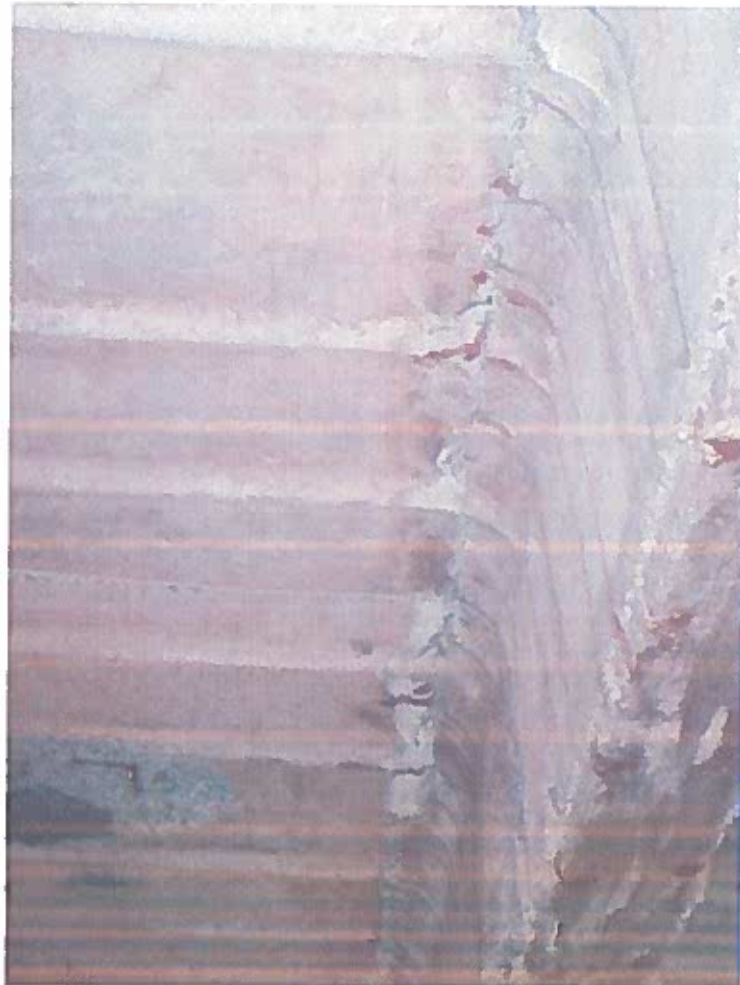
Plate 1.

**Area 1, Soffit of Slab
General View Exhibiting Cracking**

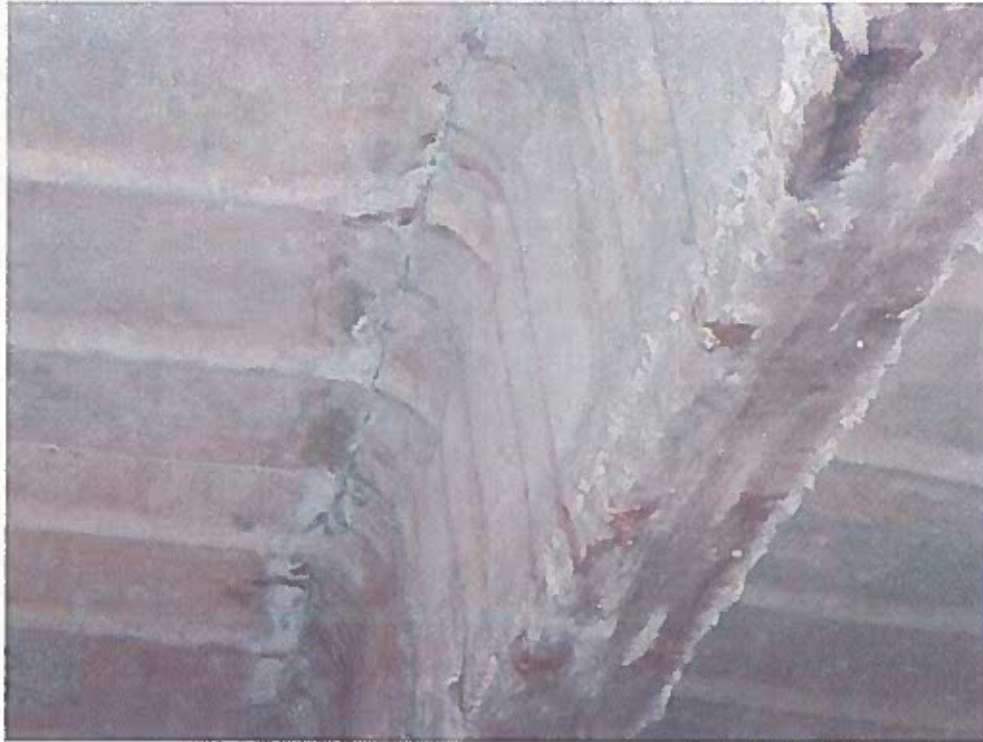
Plate 2.

**Area 1, Soffit of Slab
General View Exhibiting Cracking**

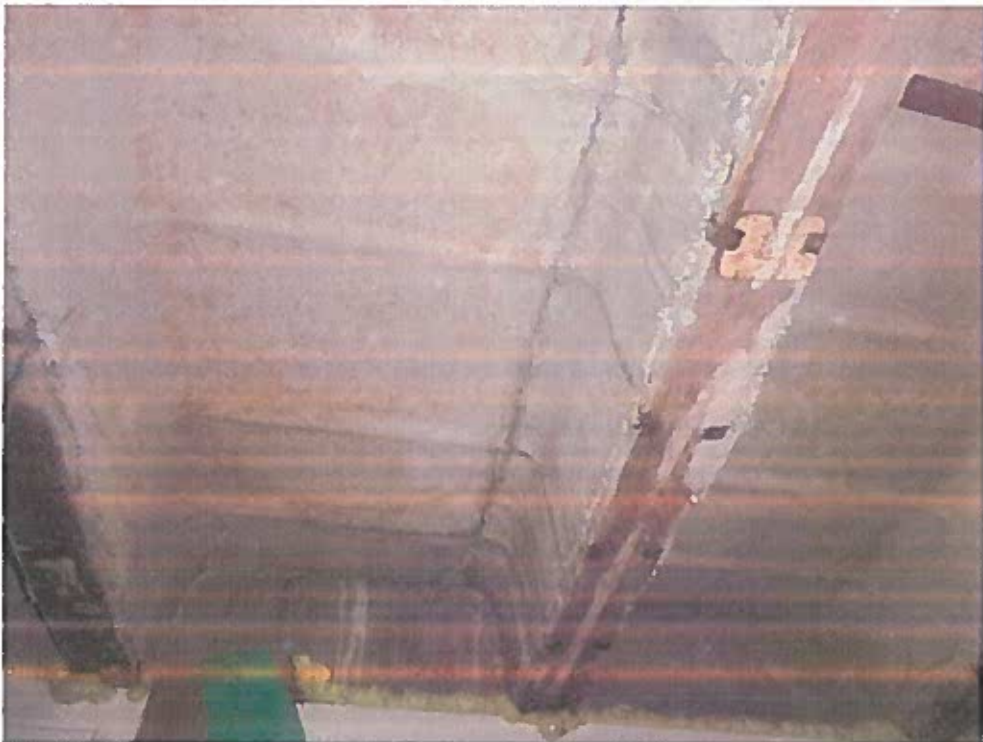
Plate 3.

**Area 1, Soffit of Slab
General View Exhibiting Cracking**

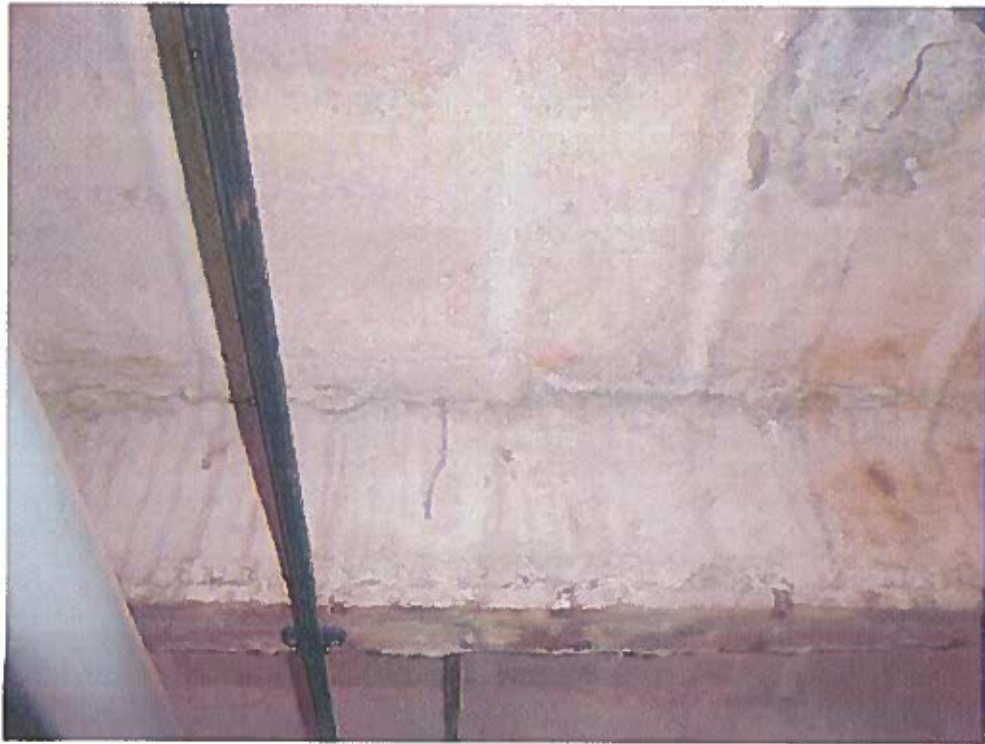
Plate 4.

**Area 1, Soffit of Slab
General View Exhibiting Cracking**

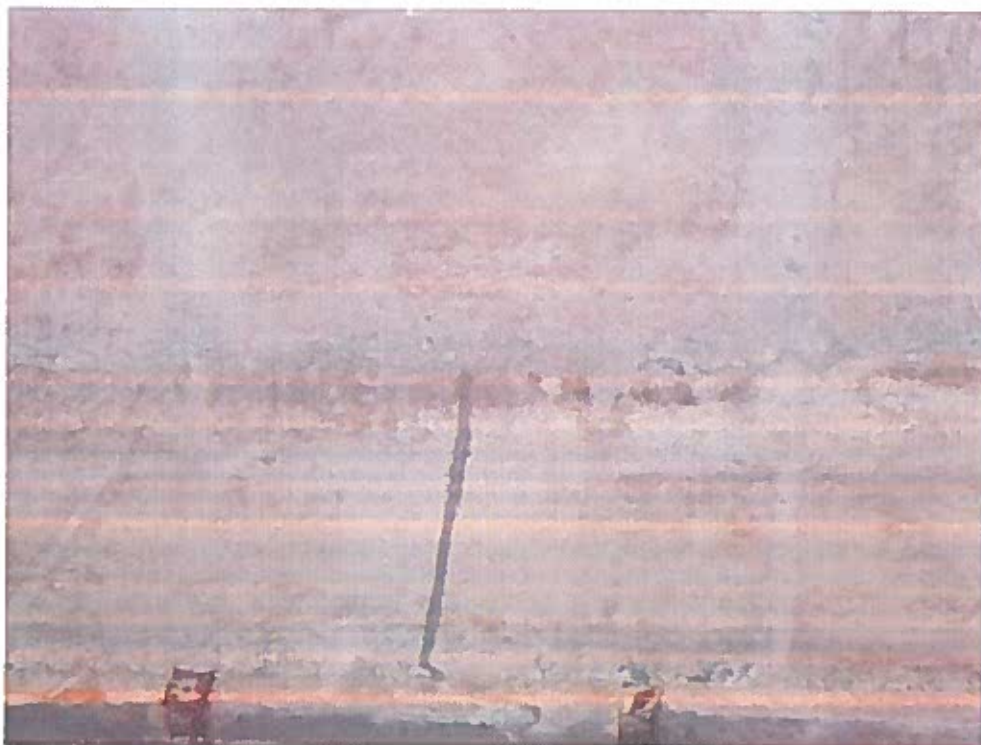
Plate 5.

**Area 1, Soffit of Slab
General View Exhibiting Cracking**

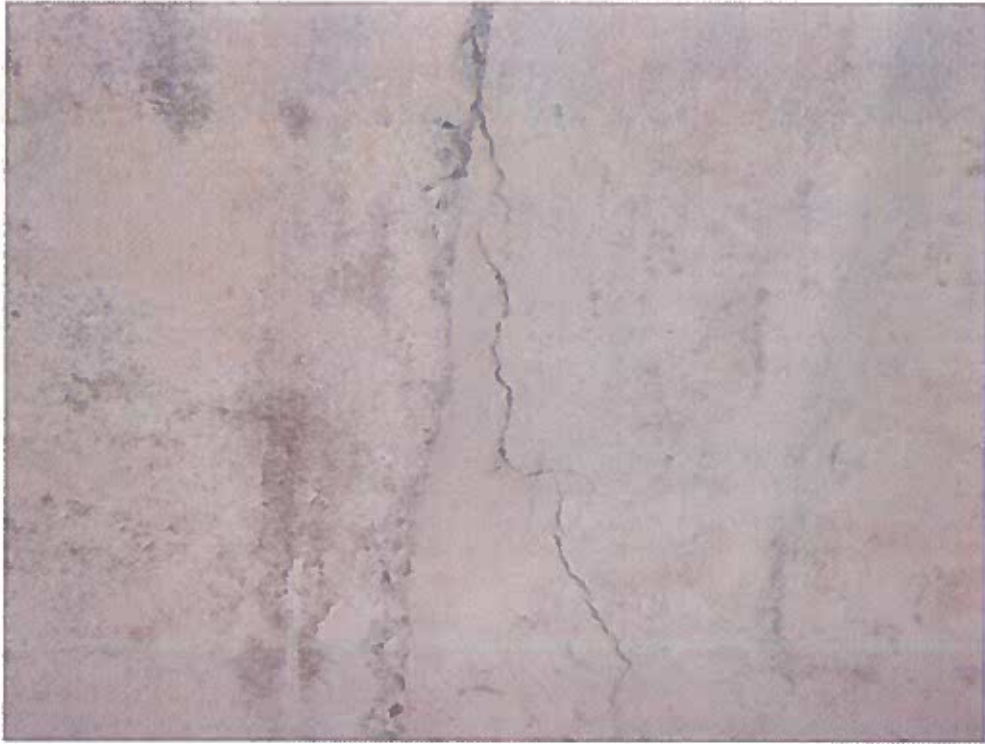
Plate 6.

**Area 1, Soffit of Slab
Close Up of Crack**

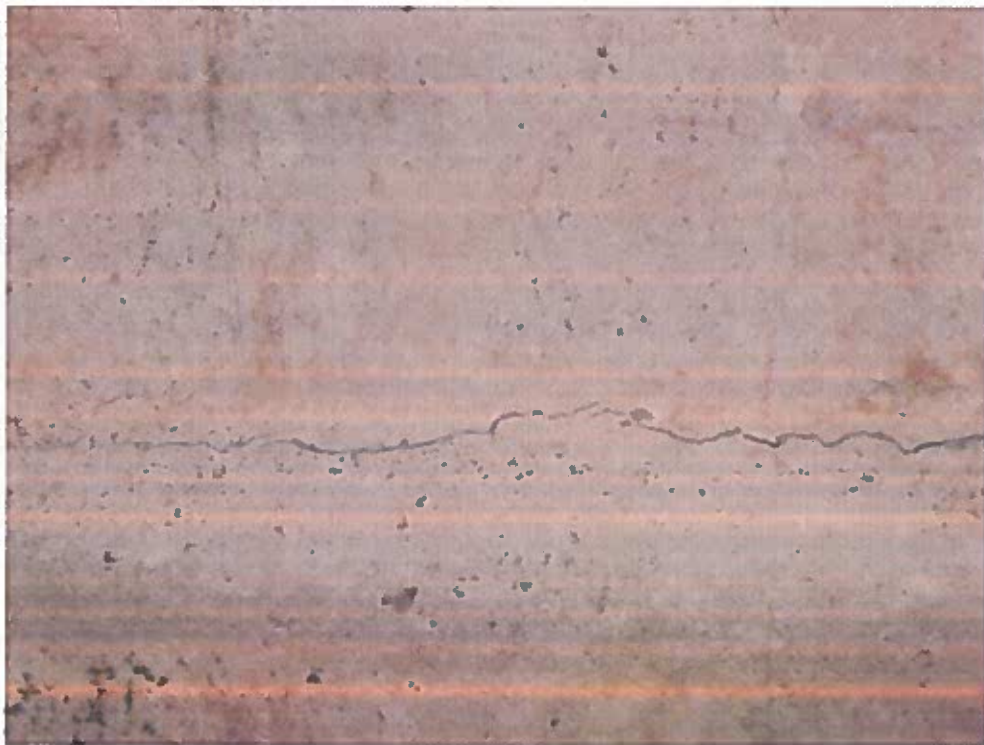
Plate 7.

**Area 1, Soffit of Slab
Close Up of Crack**

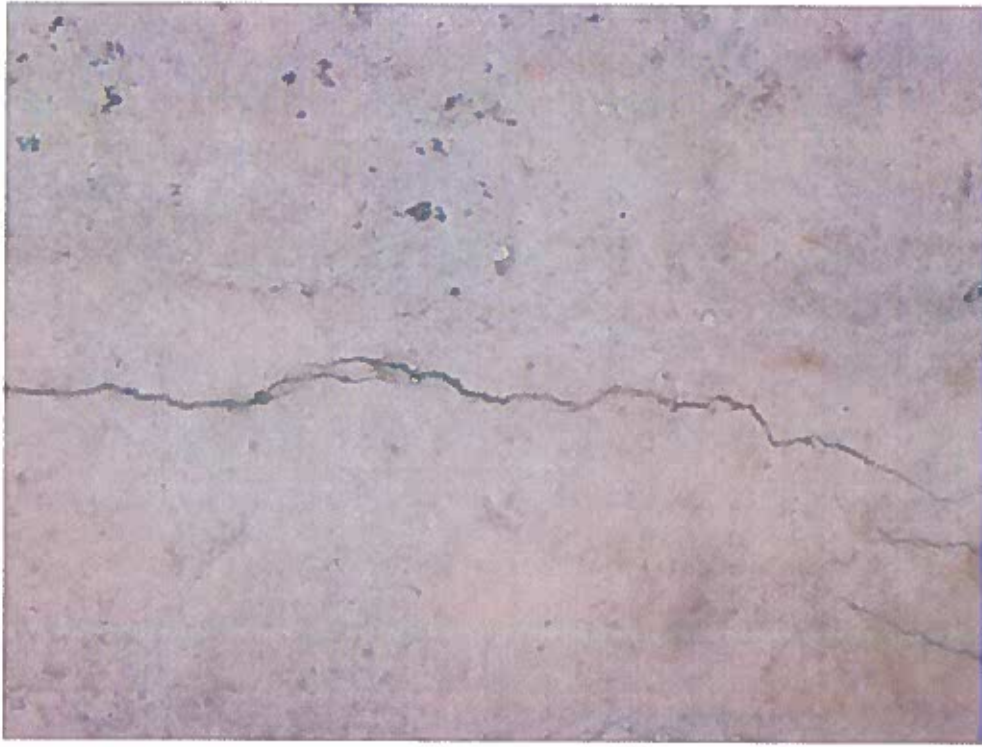
Plate 8.

**Area 1, Soffit of Slab
Close Up of Crack**

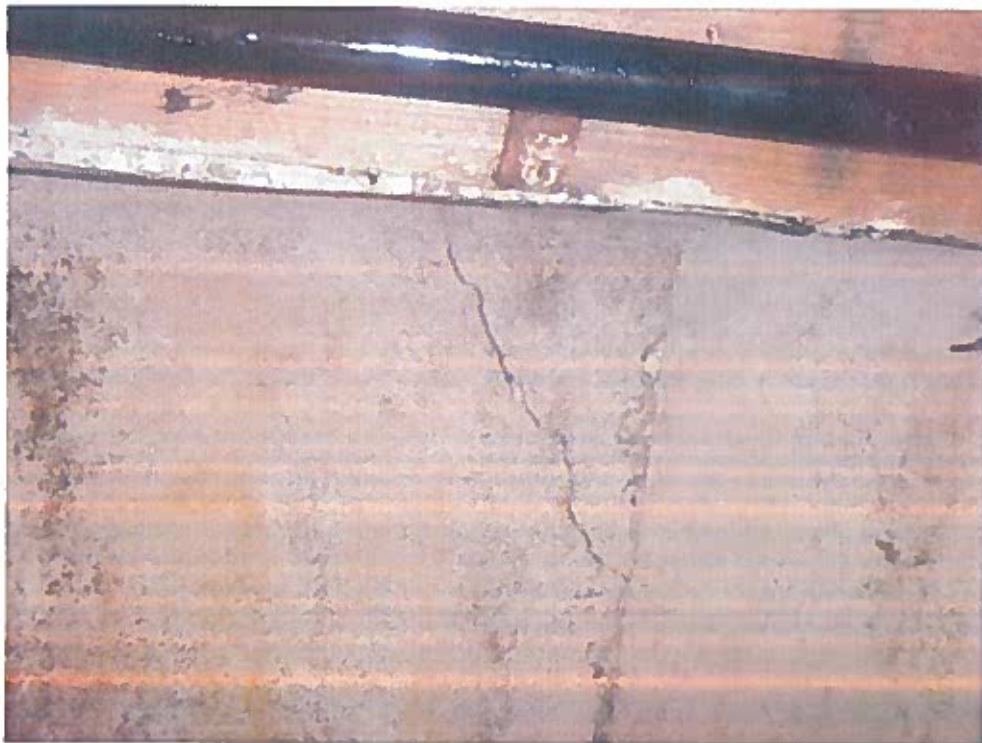
Plate 9.

**Area 1, Soffit of Slab
Close Up of Crack**

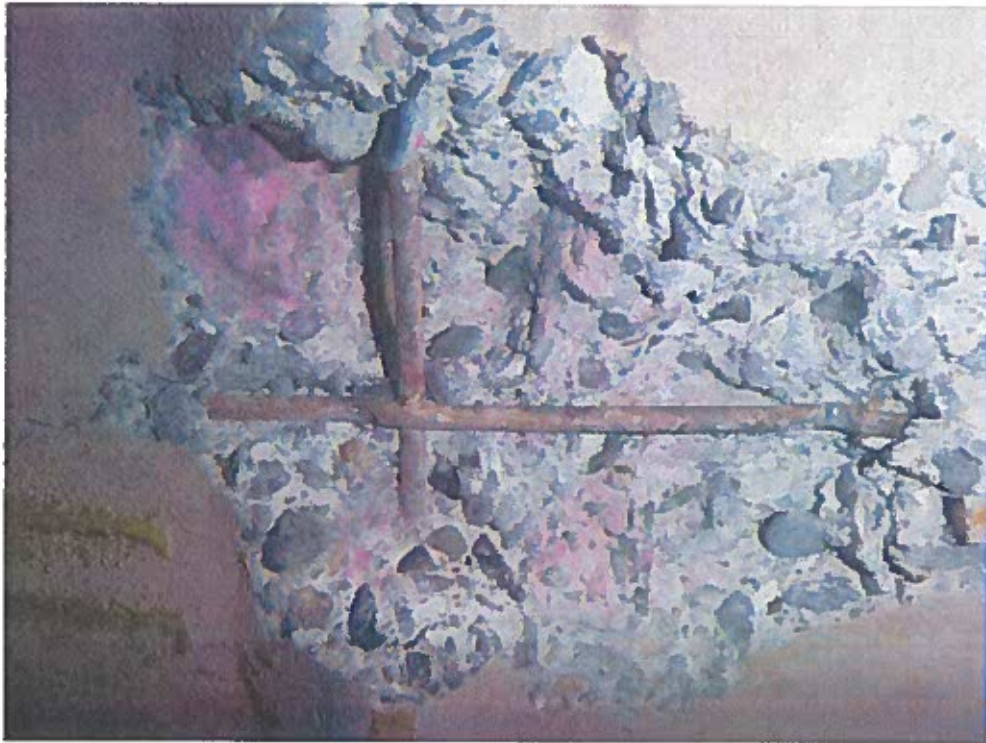
Plate 12. Area 1, Soffit of Slab
Concrete Cover Removed to Expose Reinforcement

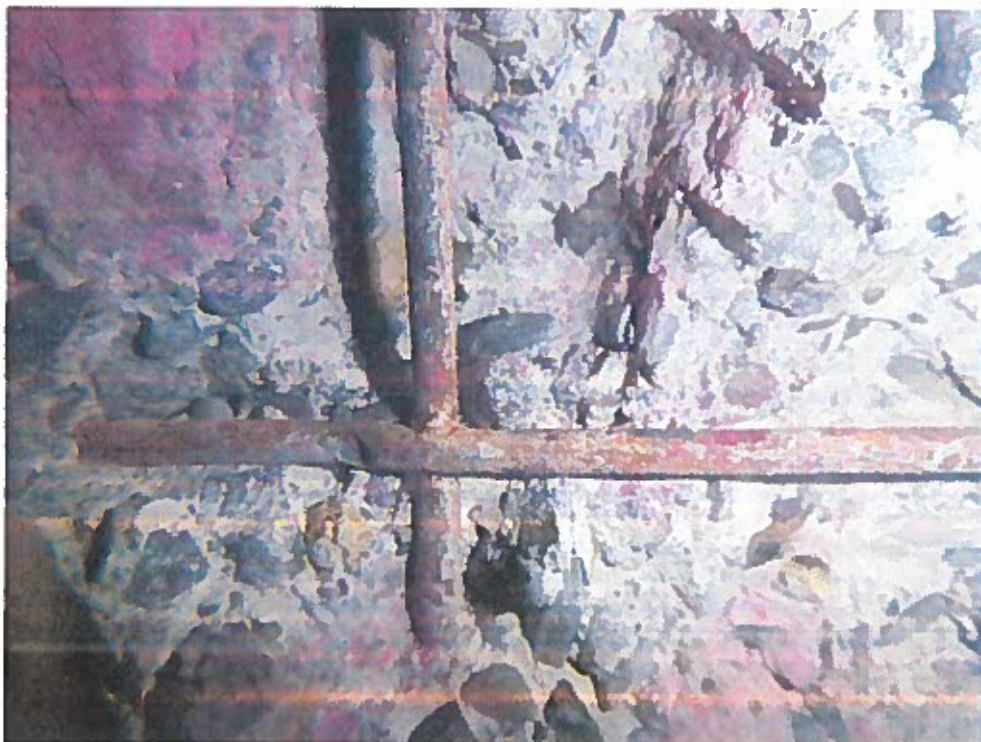
Plate 13. Area 1, Soffit of Slab
Concrete Cover Removed to Expose Reinforcement

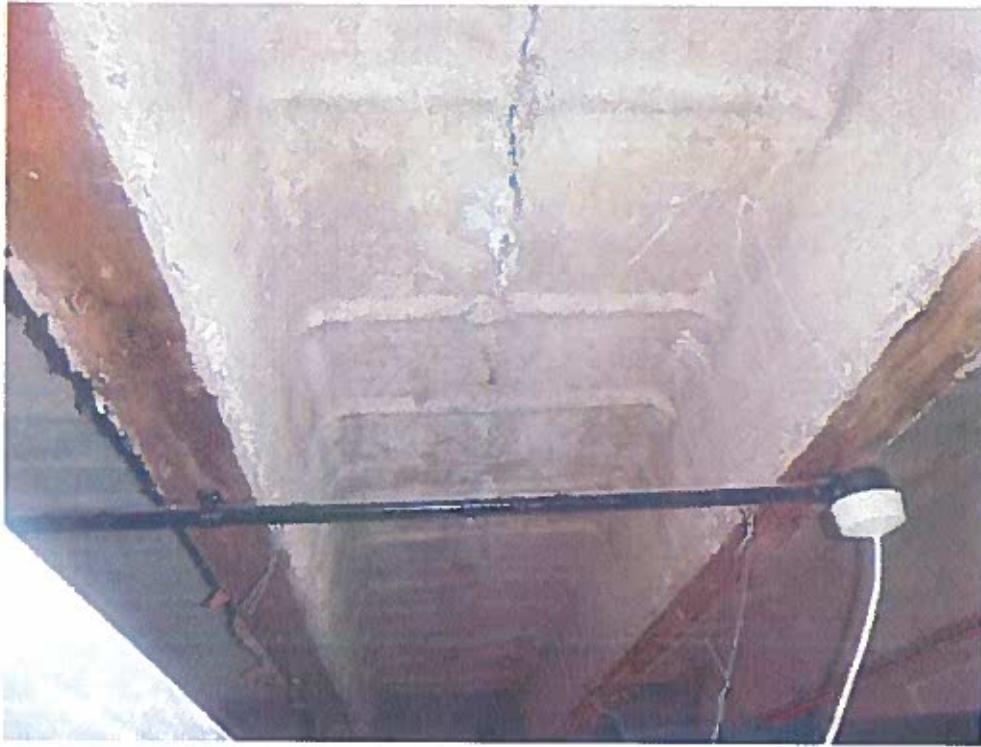
Plate 20.

**Area 2, Soffit of Slab
General View Exhibiting Cracking**

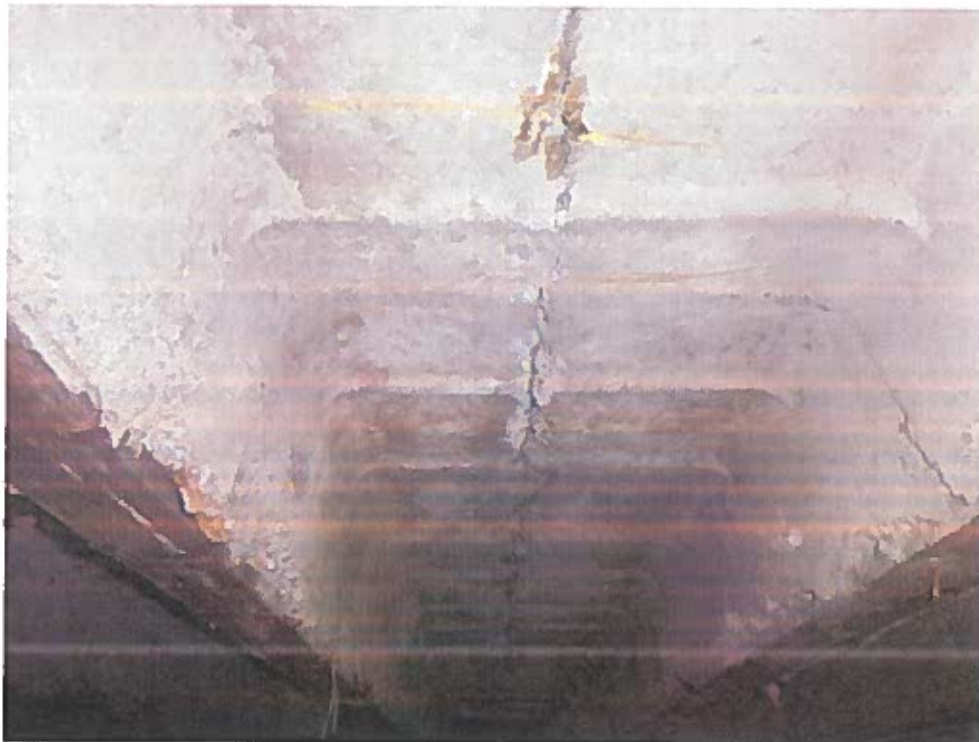
Plate 21.

**Area 2, Soffit of Slab
General View Exhibiting Cracking**

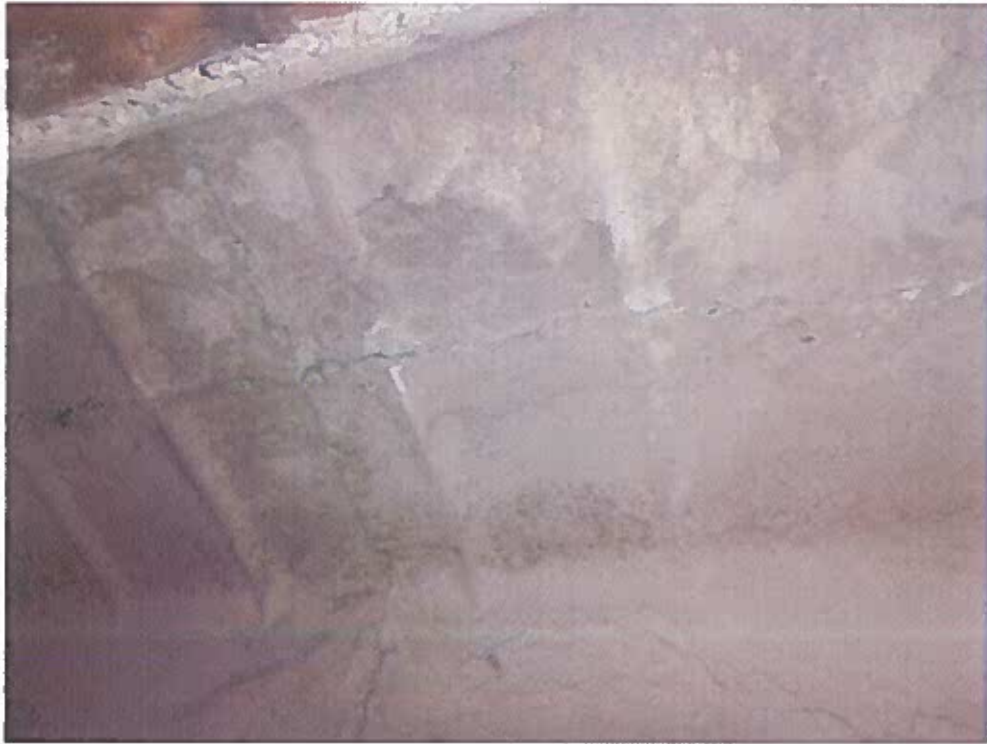
Plate 22.

**Area 2, Soffit of Slab
General View Exhibiting Cracking**

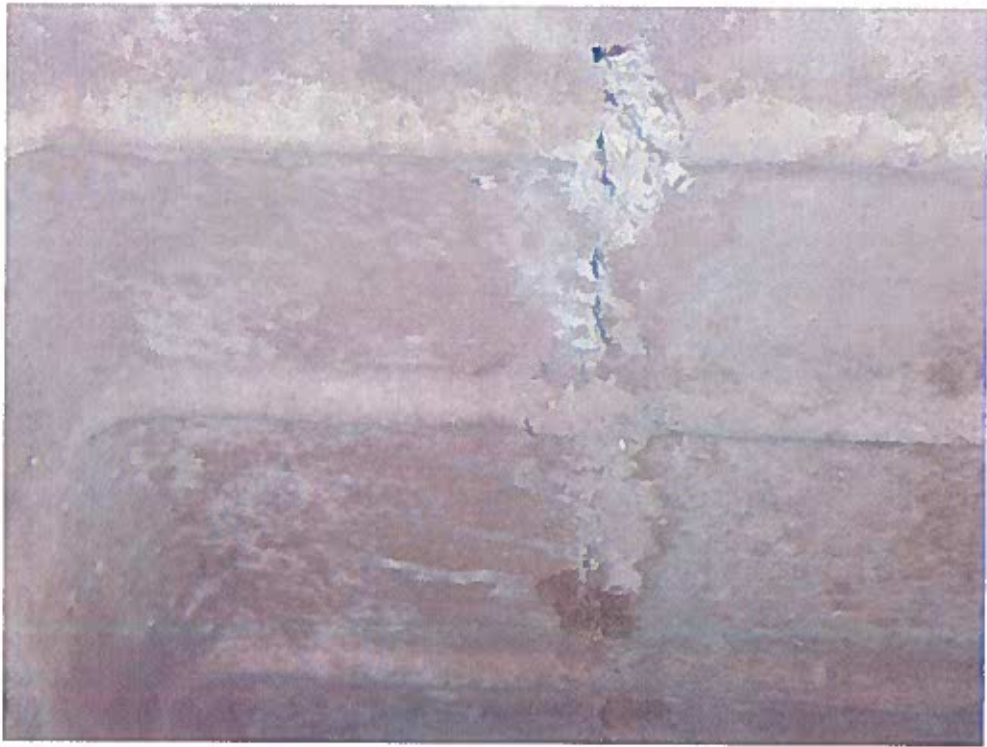
Plate 24.

**Area 2, Soffit of Slab
General View Exhibiting Cracking**

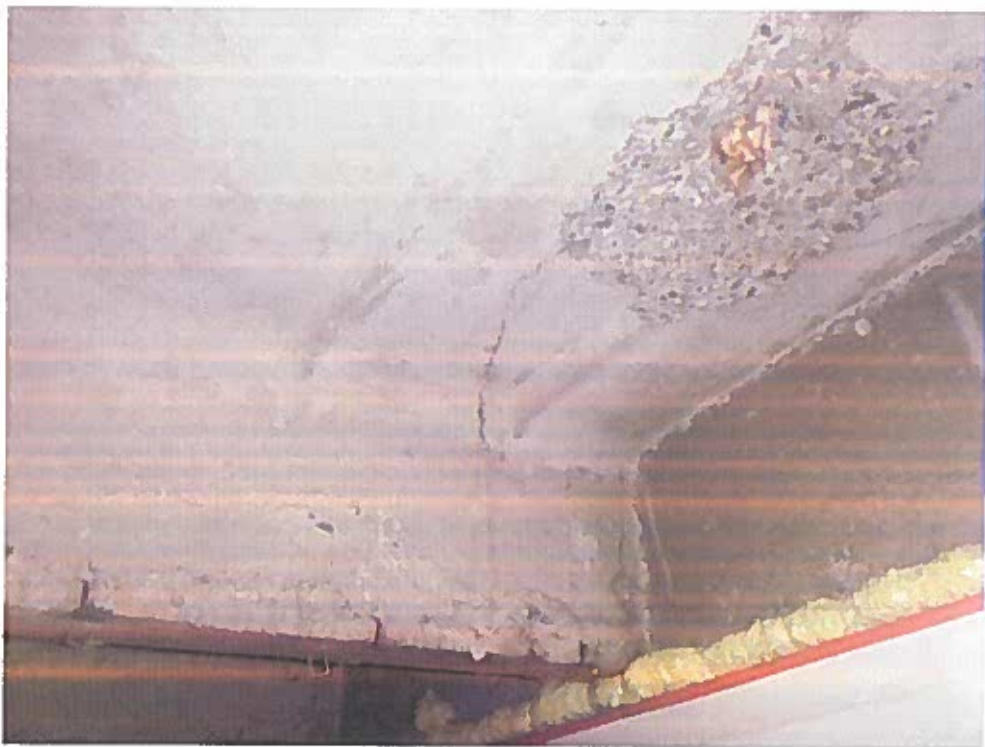
Plate 25.

**Area 2, Soffit of Slab
Large Area of Spalled Concrete Due to
Service Access and Adjacent Crack**

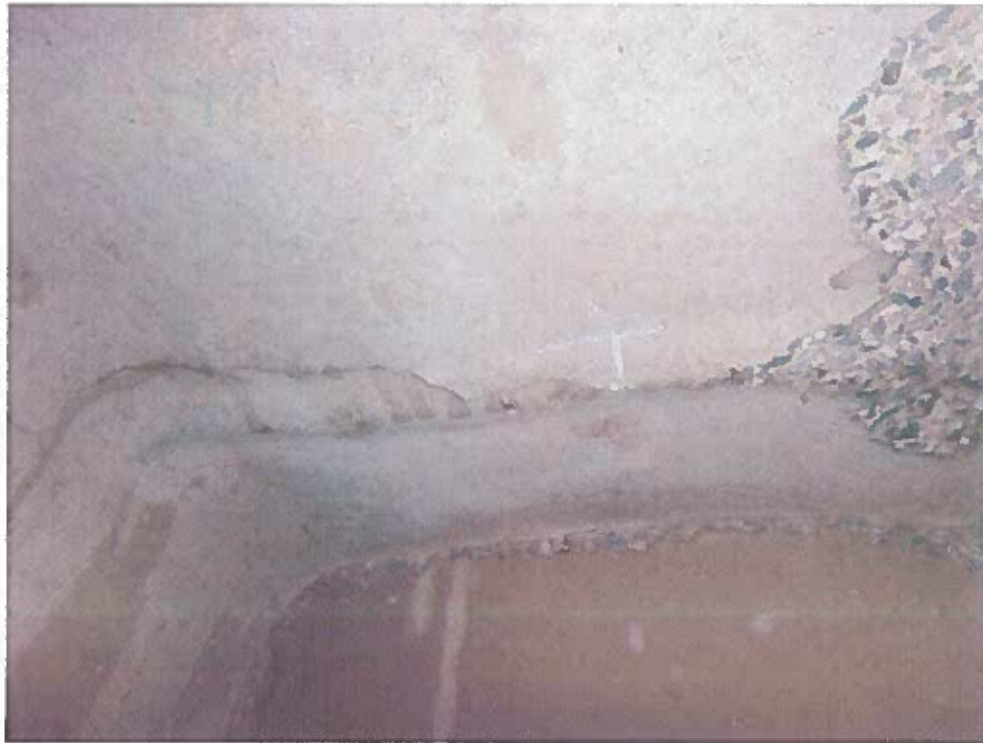
Plate 26.

**Area 2, Soffit of Slab
Large Area of Spalled Concrete Due to
Service Access and Adjacent Crack**

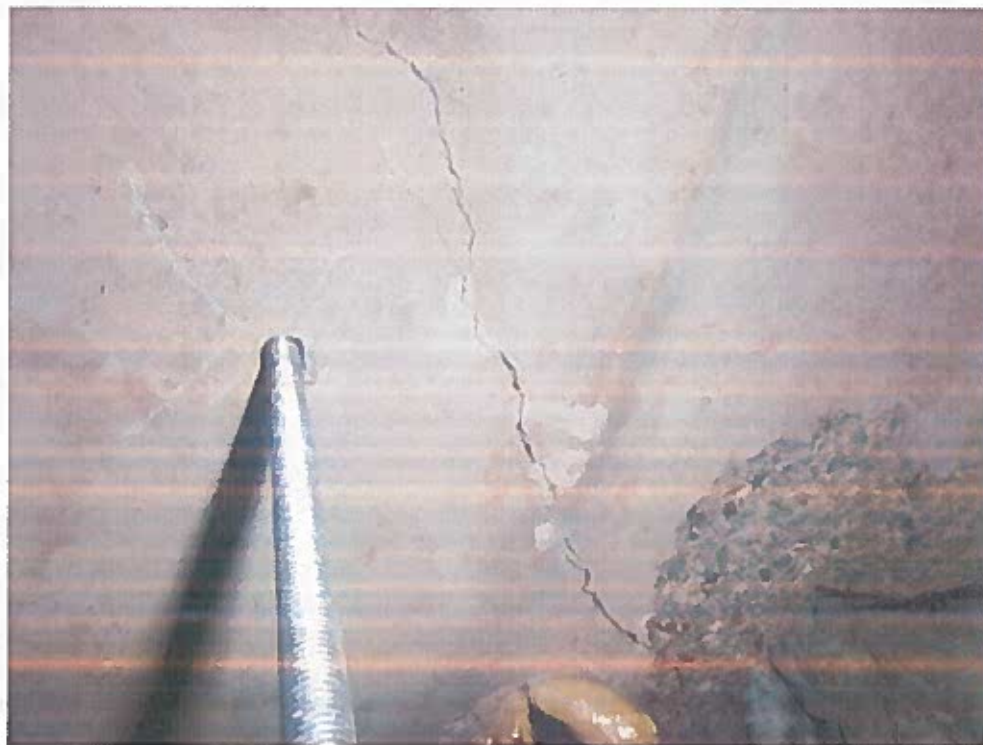
Plate 27.

**Area 2, Soffit of Slab
Large Area of Spalled Concrete Due to
Service Access and Adjacent Crack**

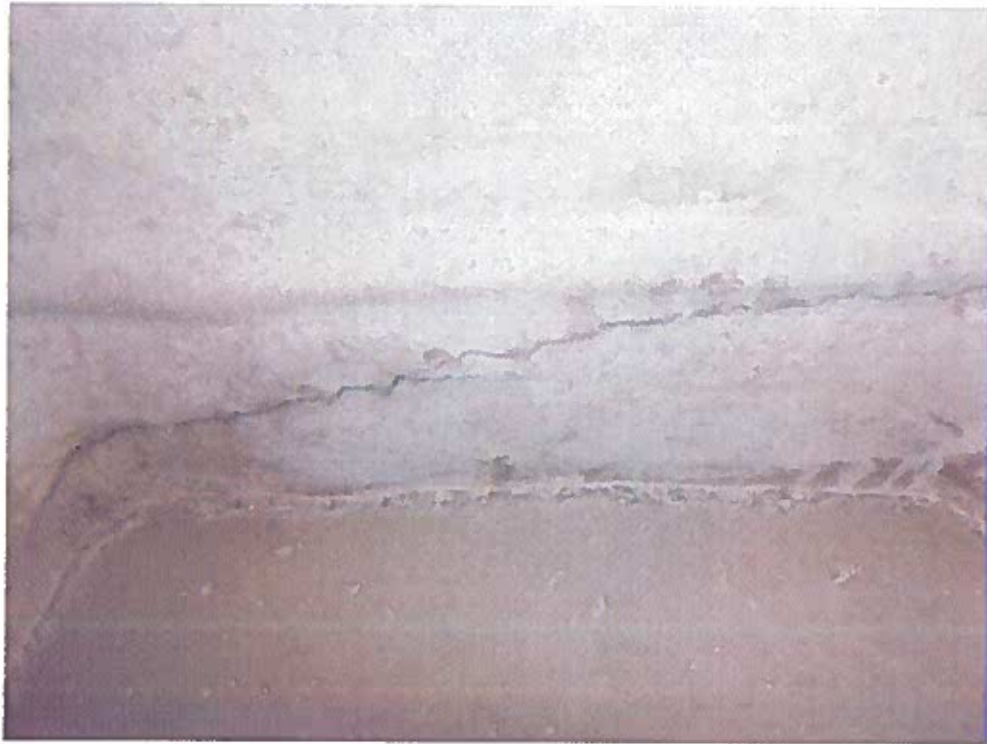
Plate 28.

**Area 2, Soffit of Slab
Close Up of Crack**

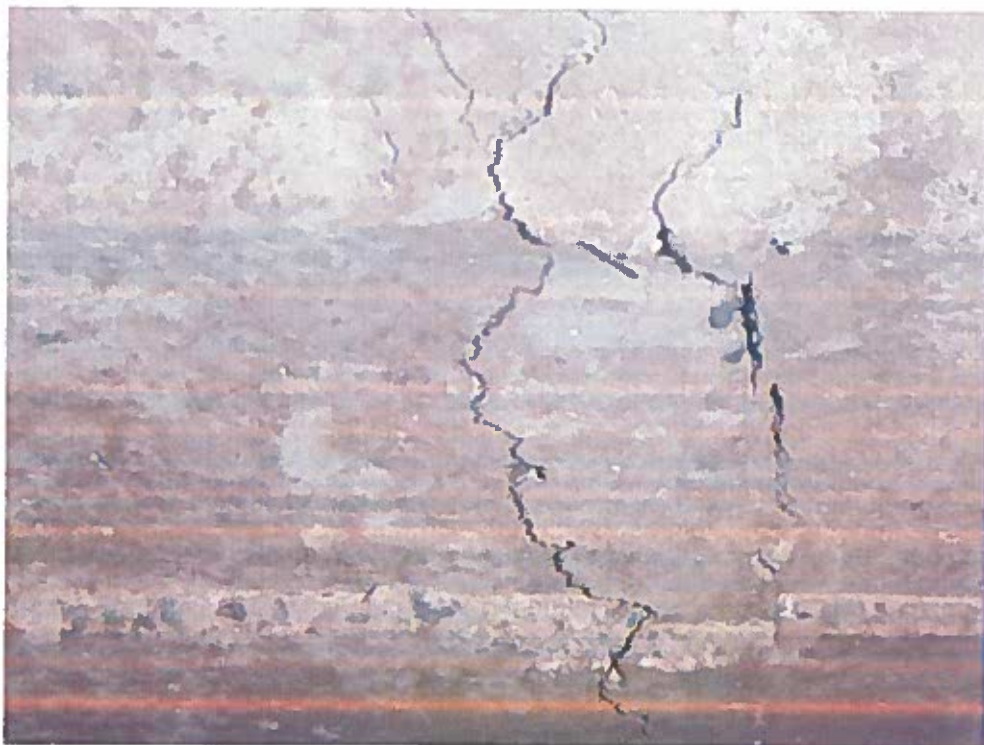
Plate 29.

**Area 2, Soffit of Slab
Close Up of Crack**

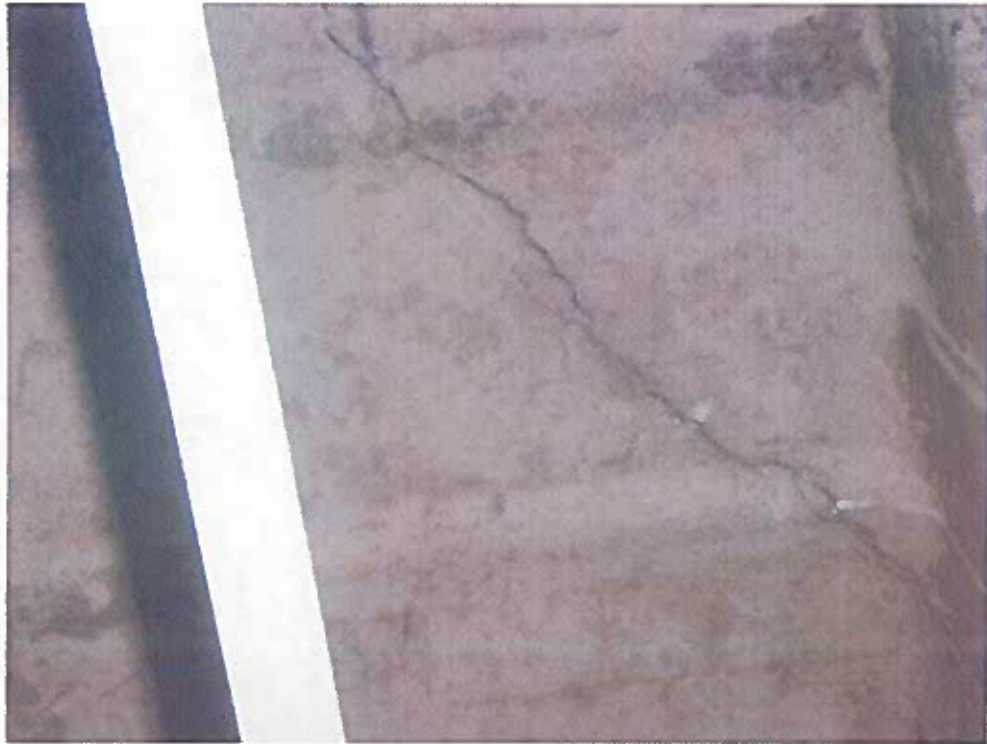
Plate 30.

**Area 2, Soffit of Slab
Close Up of Crack**

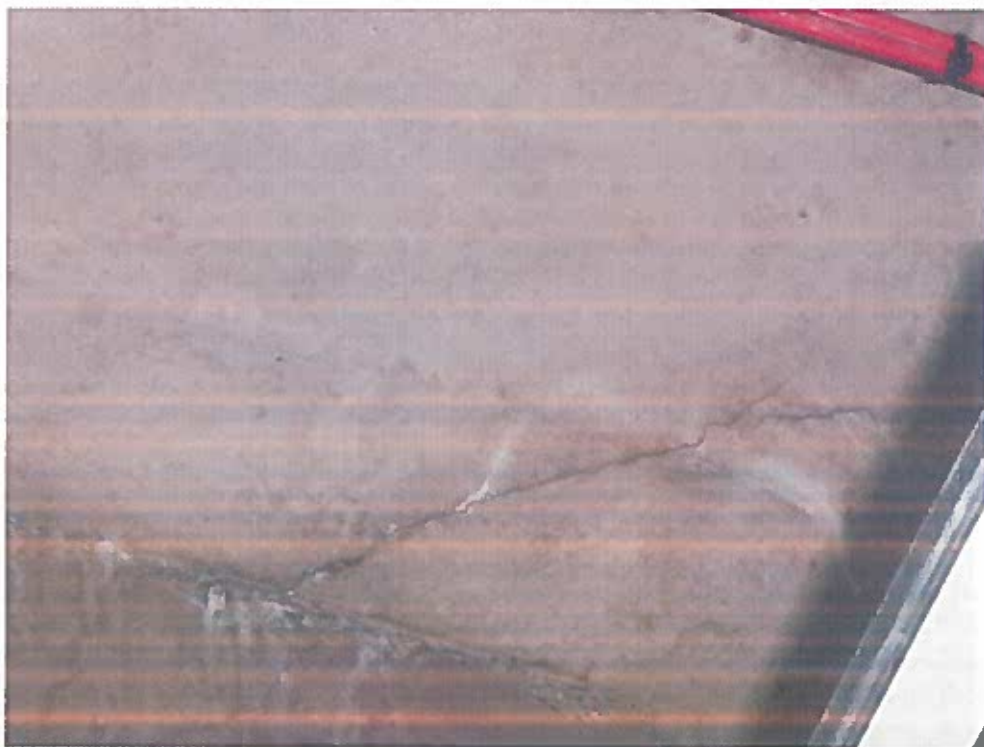
Plate 31.

**Area 2, Soffit of Slab
Close Up of Crack**

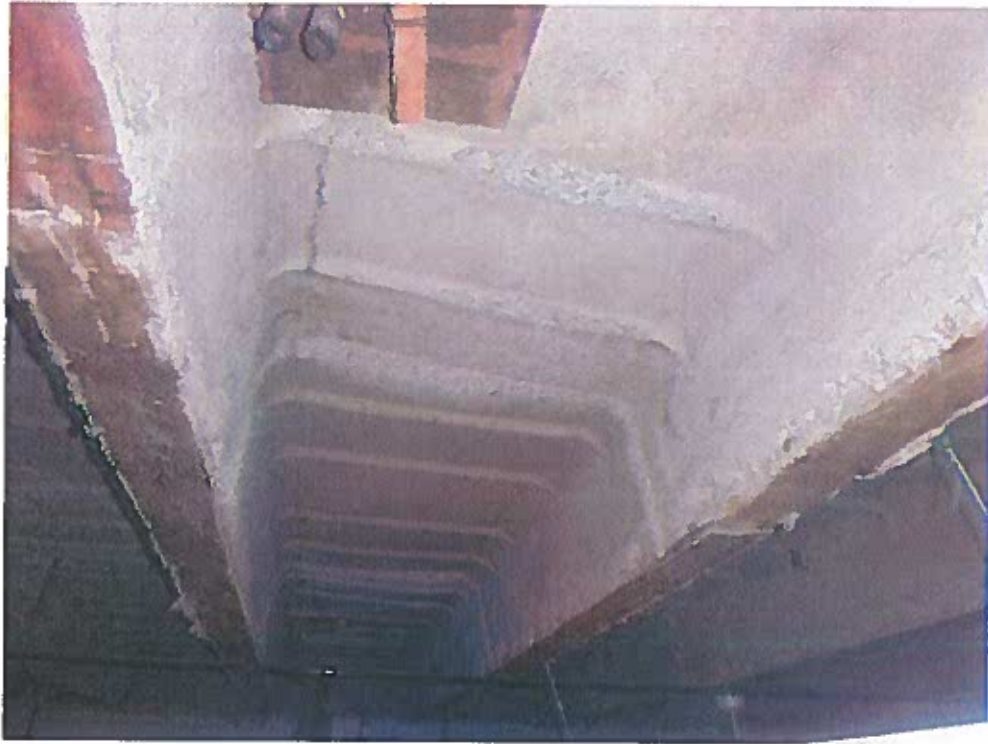
Plate 36.

**Area 3, Soffit of Slab
General View Exhibiting Cracking**

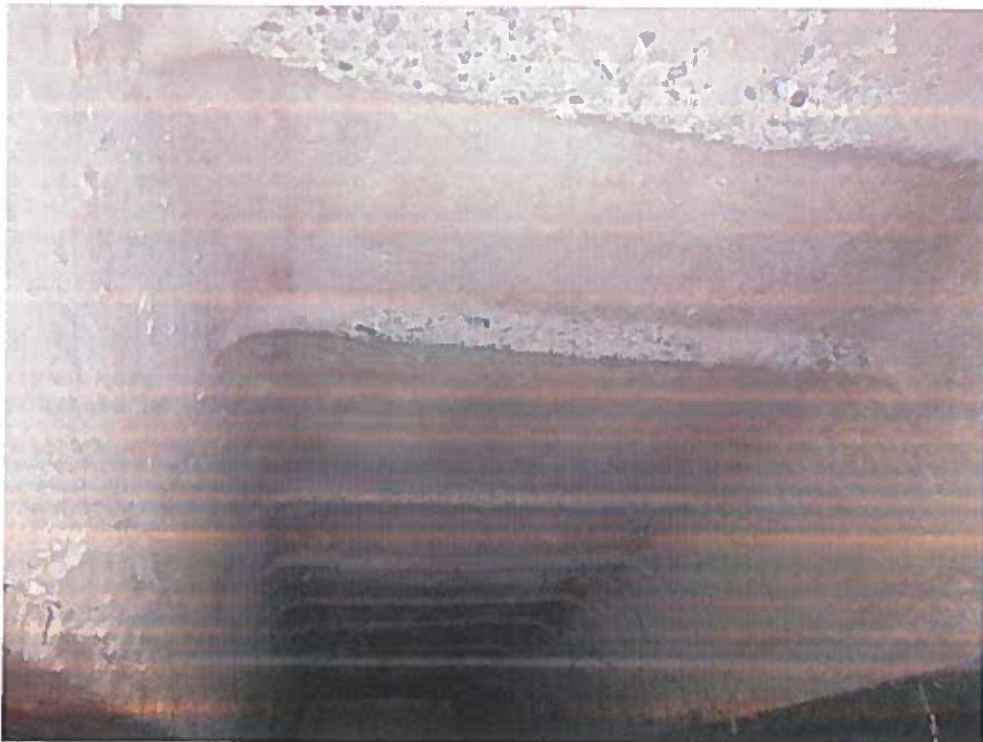
Plate 37.

**Area 3, Soffit of Slab
General View Exhibiting Cracking**

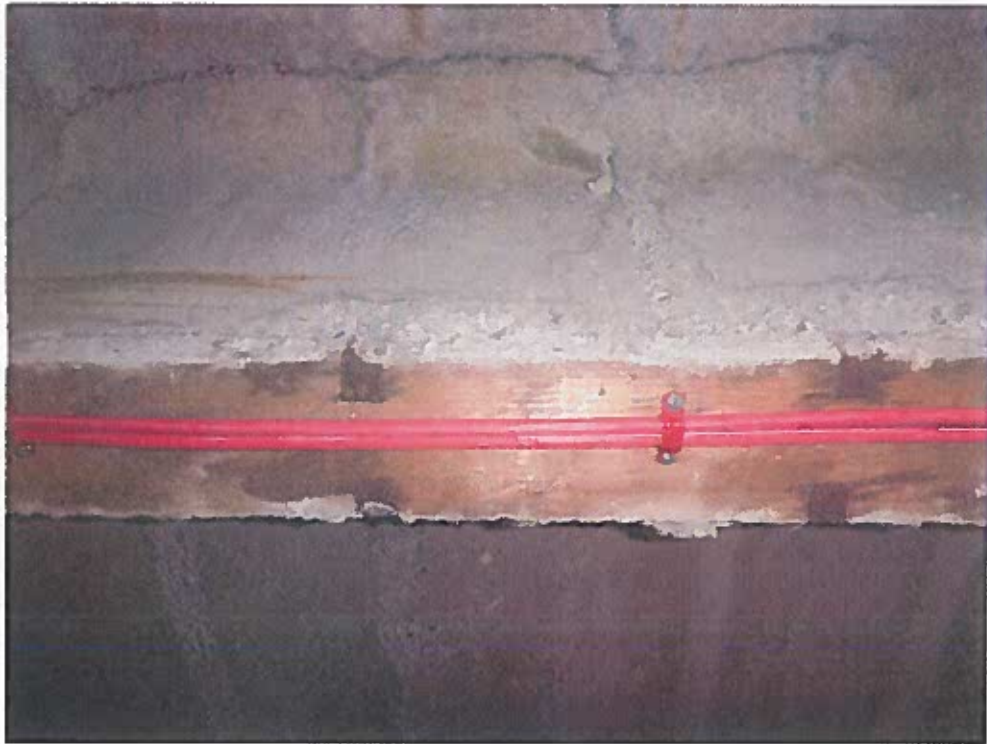
Plate 38.

**Area 3, Soffit of Slab
Close Up of Crack**

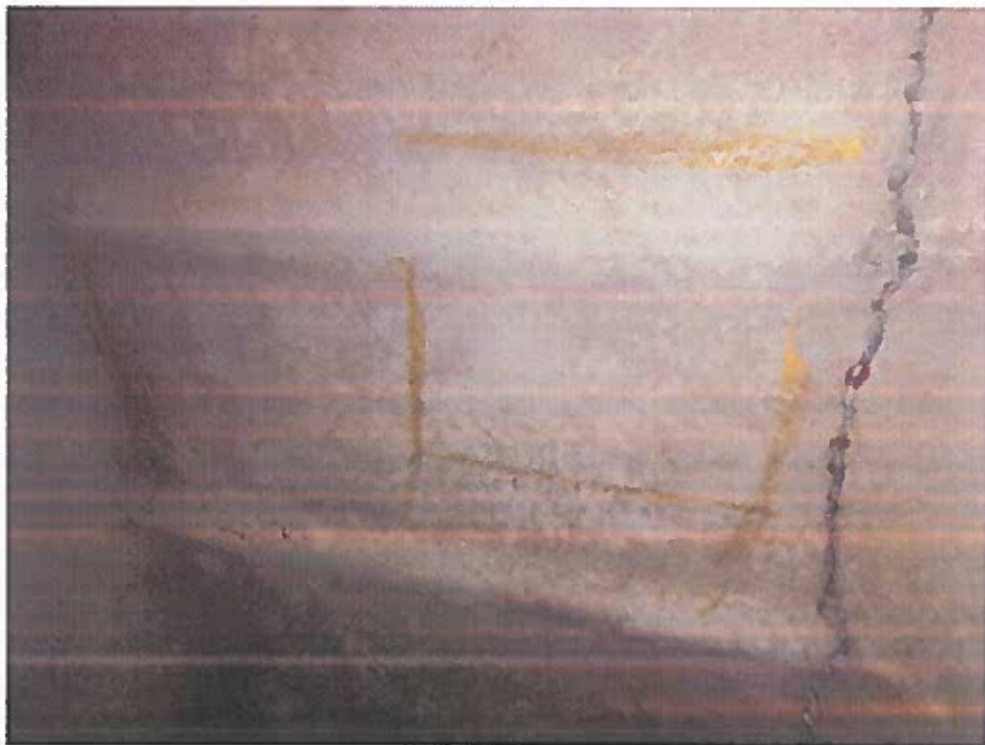
Plate 39.

**Area 3, Soffit of Slab
Close Up of Crack**
