The Council has undertaken a number of structural surveys of the main building in Currie High School in 2017, in response to a leak in the home economics department. The results of those surveys are included in this document. To summarise, this document includes:

Currie High School Structural Appraisal – Reinforced Concrete Floors

**REPORT ON INSPECTION AND TESTING OF
REINFORCED CONCRETE FLOOR SLABS AT
CURRIE HIGH SCHOOL, EDINBURGH.**

**Report on Inspection and Testing of Reinforced Concrete Floor Slabs at
Currie High School, Edinburgh.**

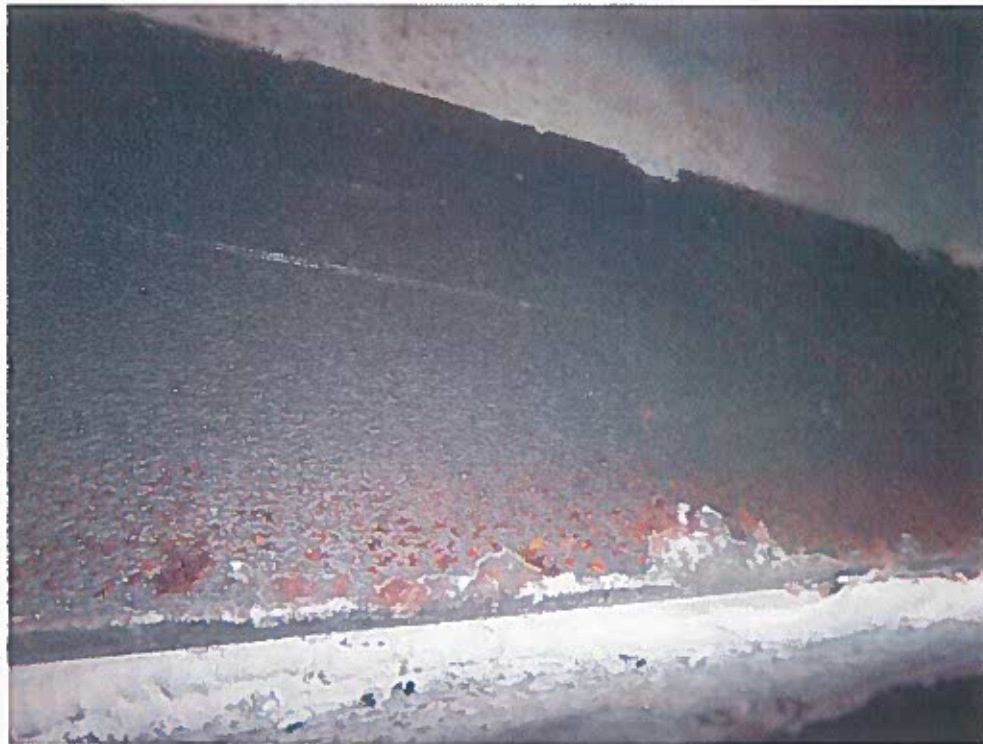
Plate 42.

**Area 4, Rib
Metal Plate Along Vertical Face of Rib**

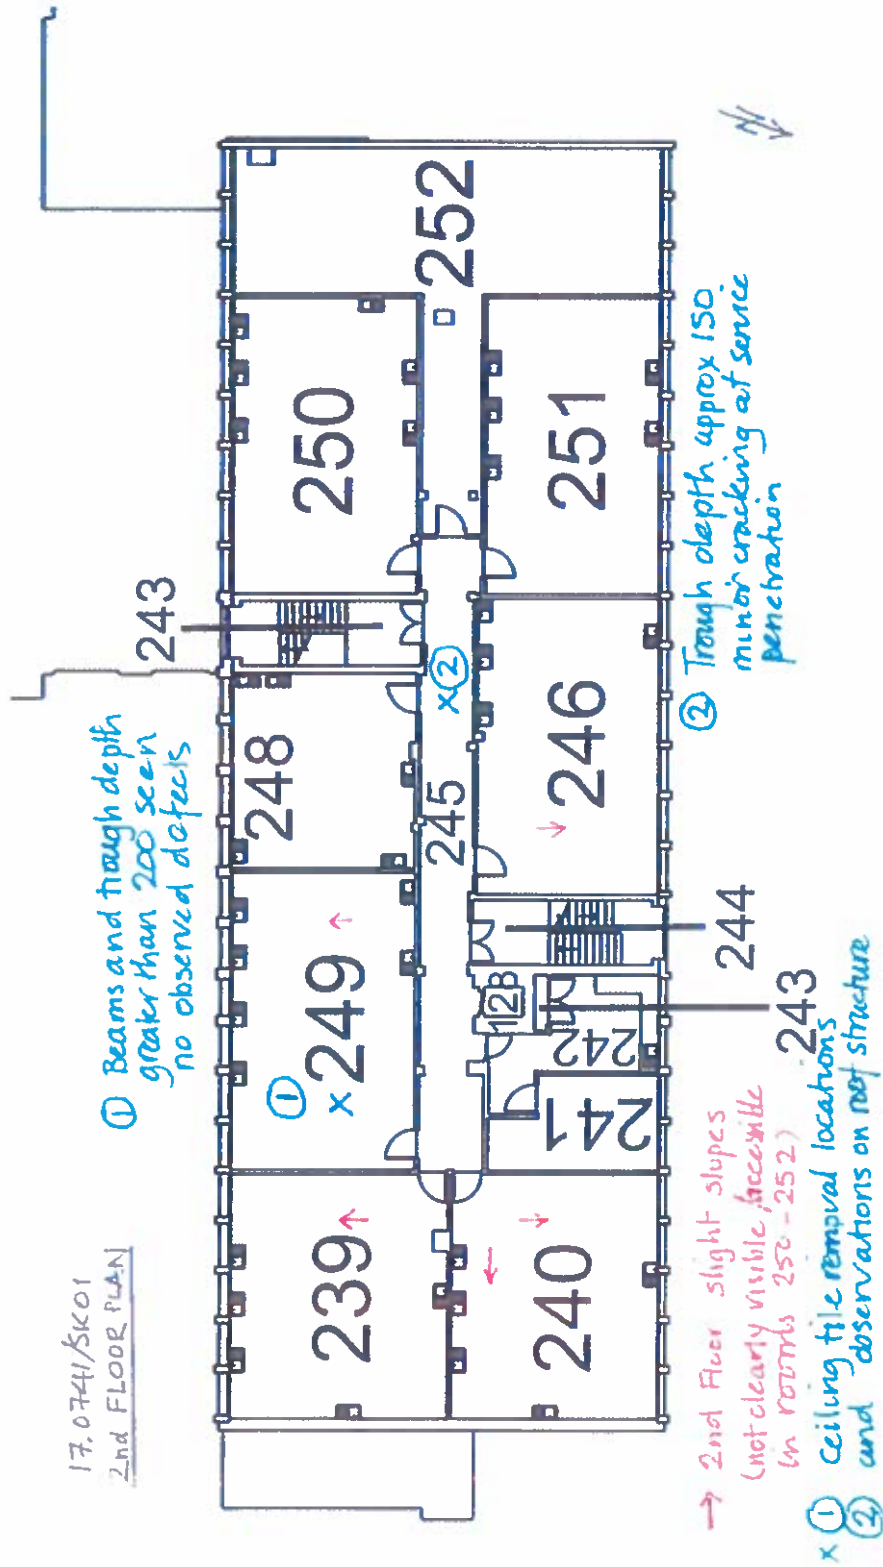
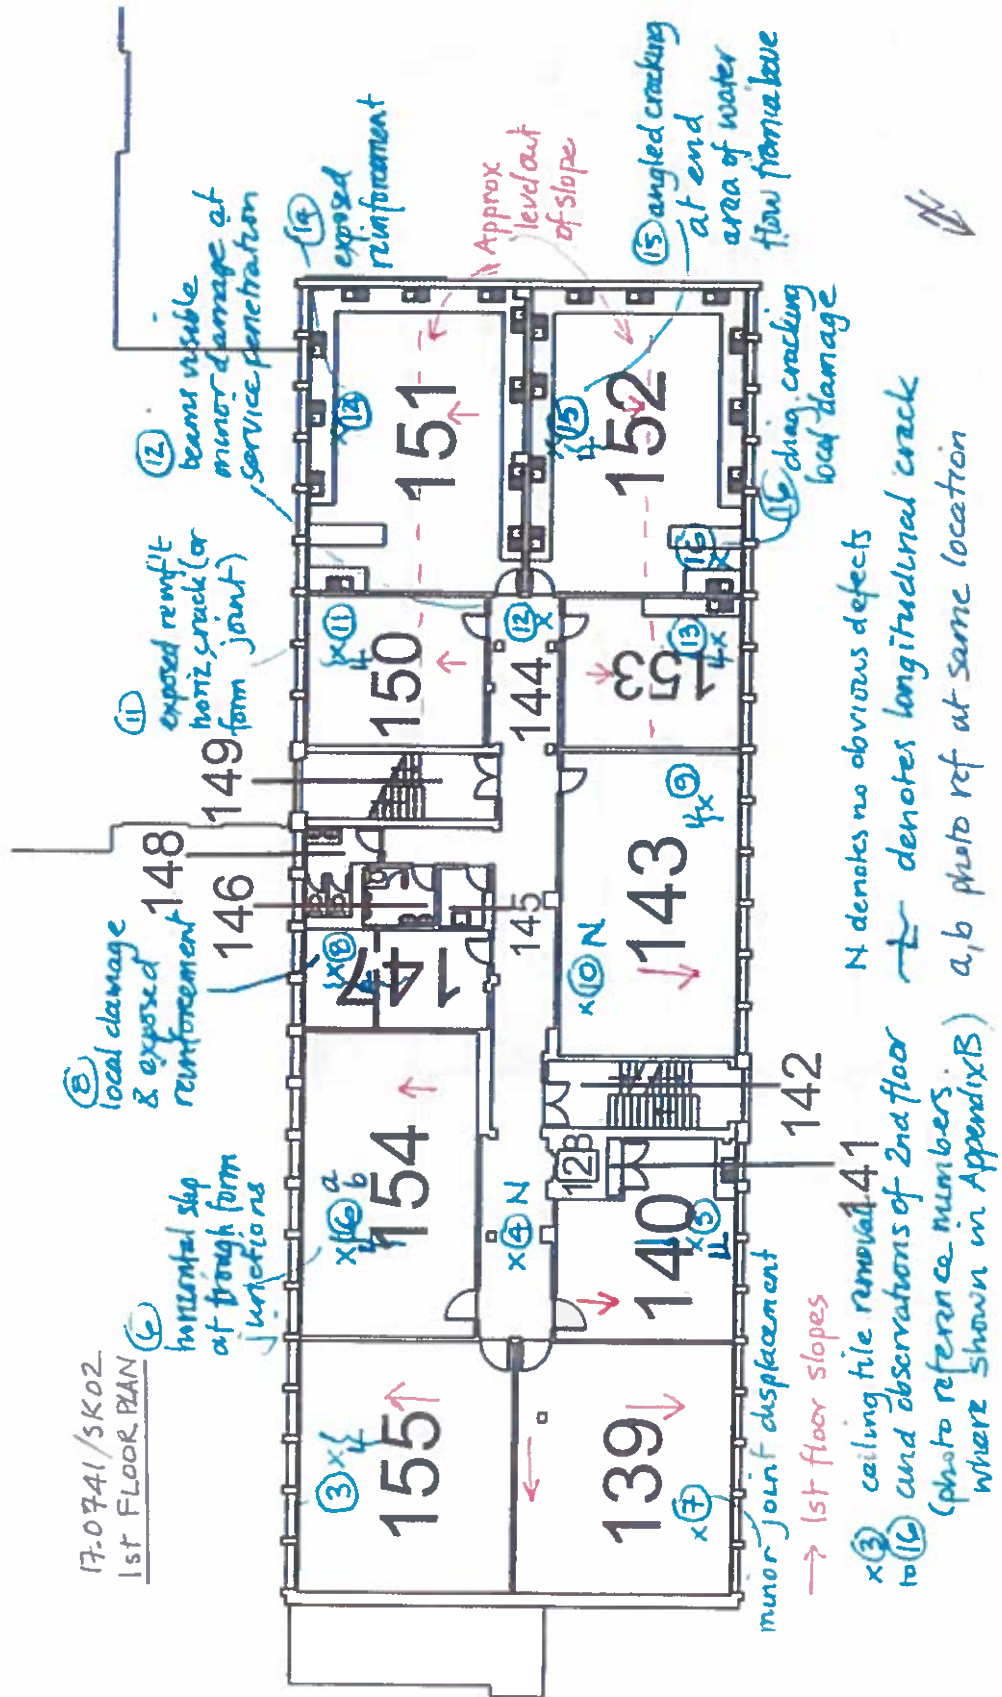
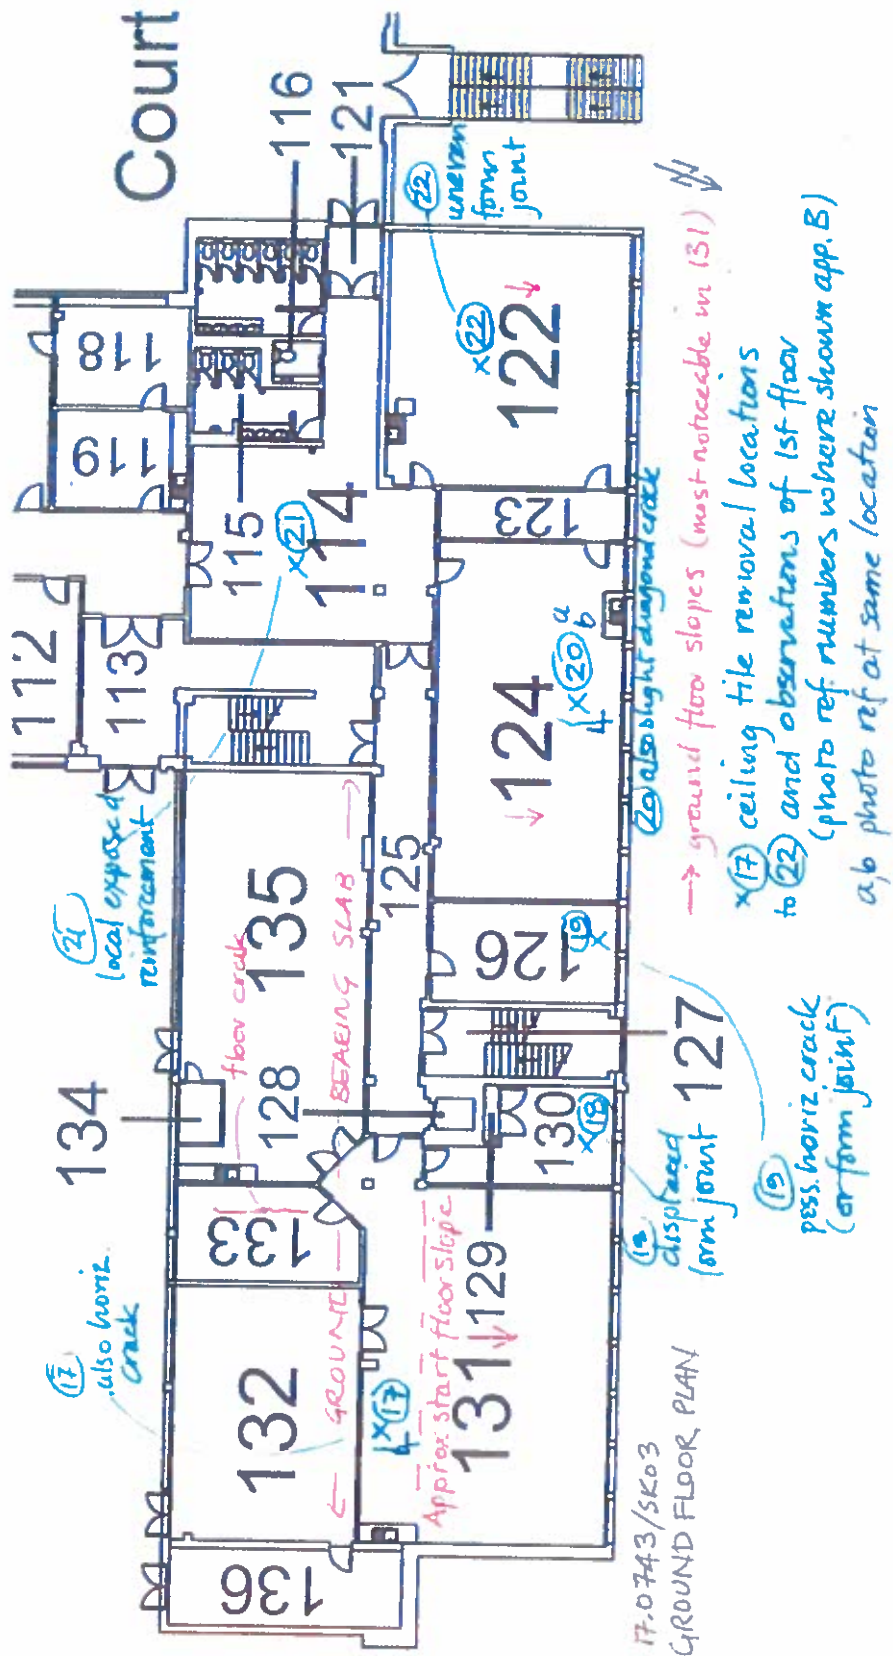
The sketches in Appendix A show the location of observed defects based on sample locations in most available rooms. Fine longitudinal cracking parallel to the north / south span direction of the trough flooring occurs in several areas. The crack line is generally near the centre of the high part of the trough. Some areas display what appears to be cracks across the troughs. There are local minor defects of damaged concrete around service penetrations and a few associated diagonal cracks. Small diameter reinforcement is visible locally at a few damaged areas at the top of the troughs. The few floor cracks visible on the south side of the ground floor are more likely to be at joints in the ground bearing slab.
