CS000866

Survey Description	Survey Date	Survey Status	Surveyor	Organisation
<p>BLOCK A: 1970S CONCRETE FRAME TWO STOREY BUILDING. RENDERED BRICK INFILL PANELS WITH INVERTED FLAT ROOF. TIMBER INFILL PANELS WITH SINGLE GLAZED WINDOW UNITS</p> <p>BLOCK B&amp;C: 1970S CONSTRUCTION CONCRETE FRAME BUILDING WITH 4 STOREY TOWER SECTION AND SINGLE STOREY BLOCK C. CONCRETE CLADDING AND RENDERED BRICK INFILL. FLAT ROOF WITH MINERAL FELT AND GRP LIQUID APPLIED SYSTEMS. ALUMINIUM POWDER COATED DOUBLE GLAZED WINDOWS AND DOORS.</p> <p>BLOCK D: SINGLE AND TWO STOREY SECTIONS. CONCRETE FRAMED WITH RENDERED BRICK INFILLS, VERTICAL CLADDING. MINERAL FELT FLAT ROOF. POWDERCOATED ALUMINIUM WINDOWS AND TIMBER DOORS.</p> <p>BLOCK E: SINGLE STOREY SECTIONS. CONCRETE FRAMED WITH RENDERED BRICK INFILLS. MINERAL FELT FLAT ROOF. POWDERCOATED ALUMINIUM WINDOWS AND DOORS. BLOCK F: TU MINERAL FELT FLAT ROOF COMPOSITE BOARDING CLADDING THE EXTERIOR. SINGLE GLAZED METAL WINDOWS AND TIMBER DOOR SETS</p>	<p>07/08/2017</p>	<p>COMPLETE</p>	<p>F&amp;G</p>	<p>F&amp;G</p>

## Edinburgh - City Of Edinburgh Council

<b>Site</b>	SIT1186 WESTER HAILES EDUCATION CENTRE - WHEC
<b>Address</b>	5  EDINBURGH LOTHIAN EH14 2SU
<b>N

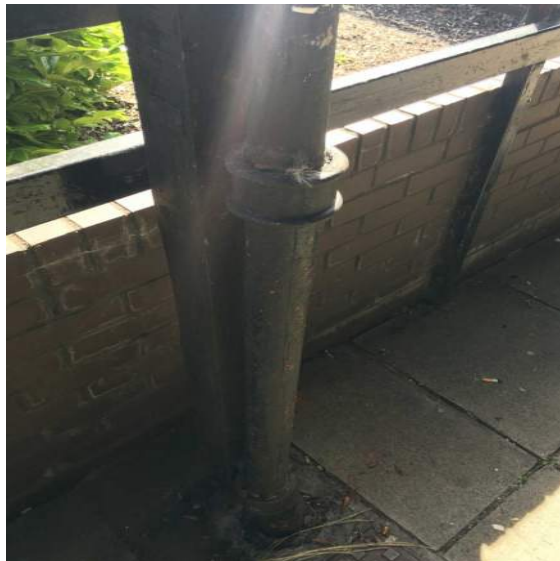
**Code:** IW00015063  
**Element:** 09 Redecorations  
**Subelement:** 09.01 External Decoration  
**Item:** 09.01.01  
**Condition:** B Satisfactory  
**Priority:** 03 Desirable - Within 3 to 5 years

**Site:** SIT1186 WESTER HAILES EDUCATION CENTRE - WHEC  
**Building:**  
**Room:**  
**Cost:** £737.58  
**Remedy:**  
**Defect:** Paint wear to cast iron work.  
**Defect Location:** Canopy walkways.

**Comments:** Decorate in line with recommended timber decorations to canopies.

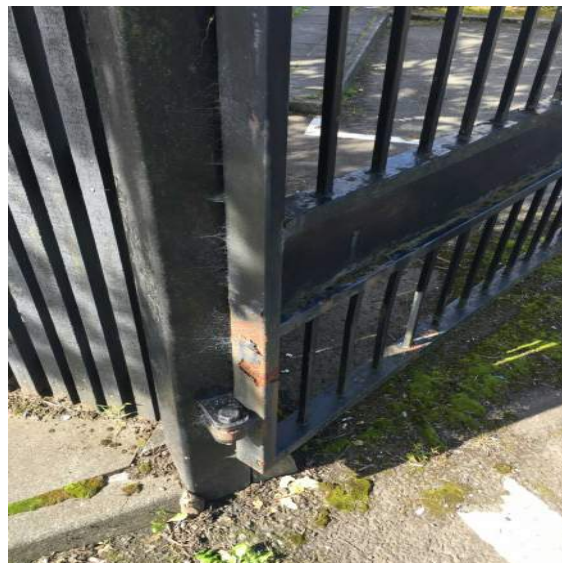
**Code:** IW00015059  
**Element:** 09 Redecorations  
**Subelement:** 09.01 External Decoration  
**Item:** 09.01.02  
**Condition:** C Poor  
**Priority:** 02 Essential - Within 2 years

**Site:** SIT1186 WESTER HAILES EDUCATION CENTRE - WHEC  
**Building:**  
**Room:**  
**Cost:** £11261.37  
**Remedy:**  
**Defect:** Poor paint finish to external metalwork.  
**Defect Location:** Site wide.

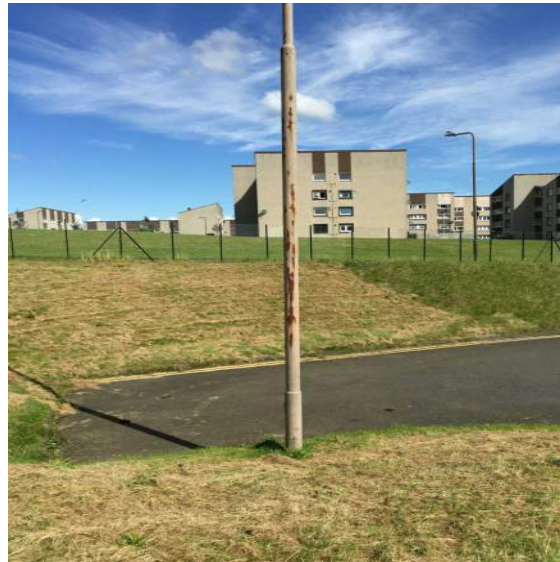
**Code:** IW00015072  
**Element:** 09 Redecorations  
**Subelement:** 09.01 External Decoration  
**Item:** 09.01.02  
**Condition:** C Poor  
**Priority:** 02 Essential - Within 2 years

**Site:** SIT1186 WESTER HAILES EDUCATION CENTRE - WHEC  
**Building:**  
**Room:**  
**Cost:** £460.99  
**Remedy:**  
**Defect:** Paint wear to lamp post.  
**Defect Location:** Northwest corner.

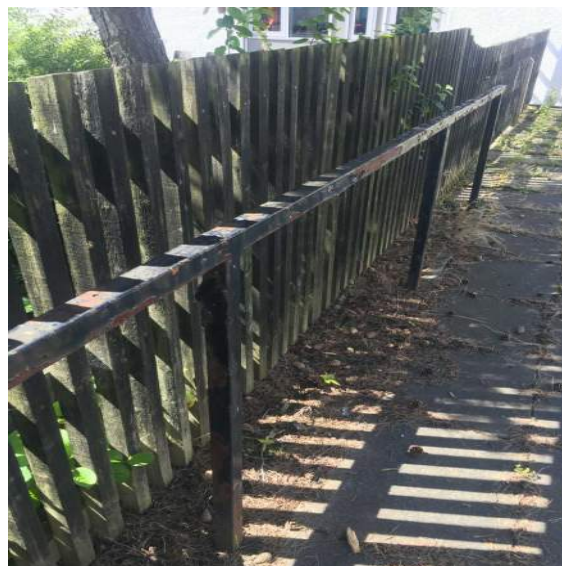
**Code:** IW00015073  
**Element:** 09 Redecorations  
**Subelement:** 09.01 External Decoration  
**Item:** 09.01.05  
**Condition:** B Satisfactory  
**Priority:** 03 Desirable - Within 3 to 5 years

**Site:** SIT1186 WESTER HAILES EDUCATION CENTRE - WHEC  
**Building:**  
**Room:**  
**Cost:** £1975.68  
**Remedy:**  
**Defect:** Poor paint to external timber handrails, fences and site furniture.  
**Defect Location:** Central pedestrian areas.

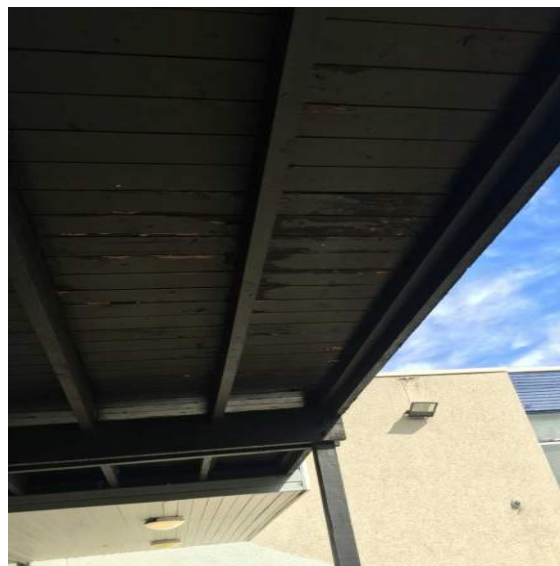
**Code:** IW00015061  
**Element:** 09 Redecorations  
**Subelement:** 09.01 External Decoration  
**Item:** 09.01.05  
**Condition:** C Poor  
**Priority:** 03 Desirable - Within 3 to 5 years

**Site:** SIT1186 WESTER HAILES EDUCATION CENTRE - WHEC  
**Building:**  
**Room:**  
**Cost:** £6519.74  
**Remedy:** Redecorate all external timber work.  
**Defect:** Paint wear to external timbers.  
**Defect Location:** Canopy walkway soffits, front entrance infills, external handrails. Site wide.

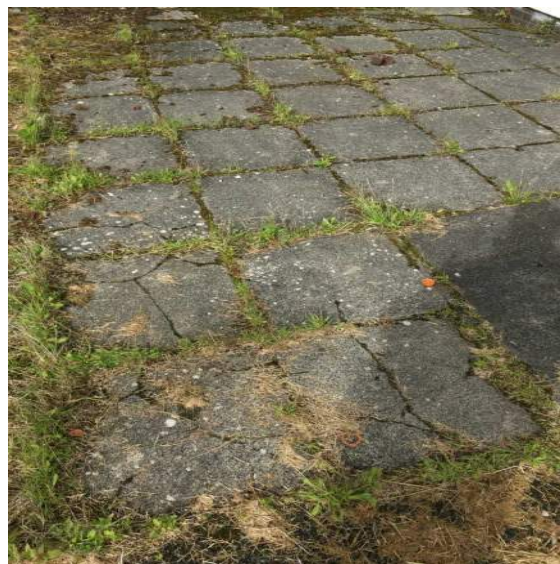
**Code:** IW00014621  
**Element:** 11 External Areas  
**Subelement:** 11.04 Roads & Car Parks  
**Item:** 11.04.05  
**Condition:** C Poor  
**Priority:** 02 Essential - Within 2 years

**Site:** SIT1186 WESTER HAILES EDUCATION CENTRE - WHEC  
**Building:**  
**Room:**  
**Cost:** £17254.27  
**Remedy:** 3 - Generally paved areas. 4 - Repair fence and decorate. 6 - Repair brickwork,  
**Defect:** 1 - Cracked concrete slabs and vegetation to slabs 2 - Broken and displaced paving stones. 3 - Blocked site drainage noted throughout. 4 - Damaged fencing. 5 - Poor surface to road leading to running track, from adjacent public road. Consider surfacing in tarmac.  
**Defect Location:** 1 - Rear of Block E 2 - Central site circulation areas, nw corner and se corner of block a. 3 - Generally paved areas. 4 - Block a, north east corner. 5 - Front entrance roadway area off adjacent public road.

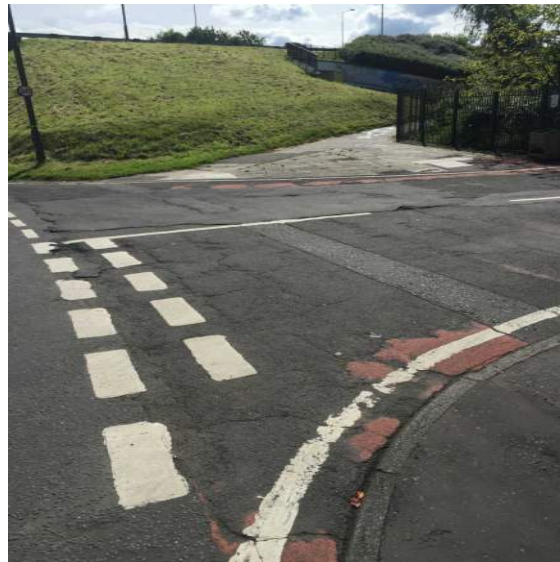
**Code:** IW00015069  
**Element:** 11 External Areas  
**Subelement:** 11.04 Roads & Car Parks  
**Item:** 11.04.05  
**Condition:** B Satisfactory  
**Priority:** 03 Desirable - Within 3 to 5 years

**Site:** SIT1186 WESTER HAILES EDUCATION CENTRE - WHEC  
**Building:**  
**Room:**  
**Cost:** £7375.87  
**Remedy:**  
**Defect:** Wear to tarmac at main entrance roadway. May need resurfacing, year 3.  
**Defect Location:** 1 - front entrance roadway area off adjacent public road.  
2 - South turning bay, block b and c rear. Northwest gated entrance.

**Comments:** Subject to later condition review.

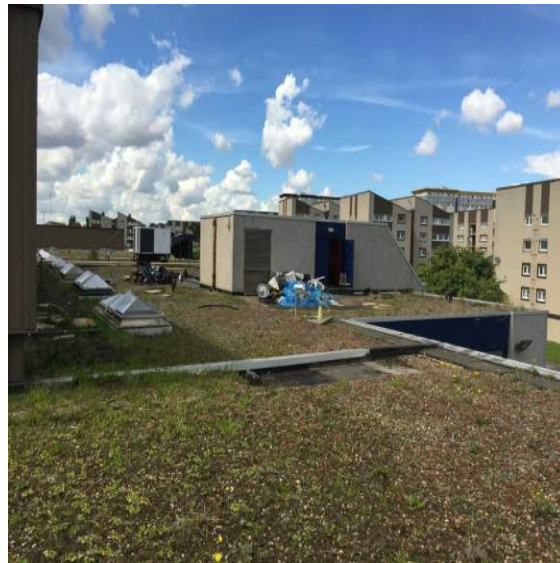
**Code:** IW00015074  
**Element:** 01 Roofs  
**Subelement:** 01.05 Roof Coverings  
**Item:** 01.05.05  
**Condition:** C Poor

**Defect:** Poorly conditioned roof, with long history of sporadic water ingress. Replace with new built up flat roof.

**Defect Location:** Block a roofs, excluding central plant room roof and west extension roof.

**Remedy:** 1 - Allow for replacement of roof domes 2 - Allow for replacement, upgrade of roof insulation. 3 - Allow for replacement of defective flashings, trims, gaskets, capping and other such detailing.

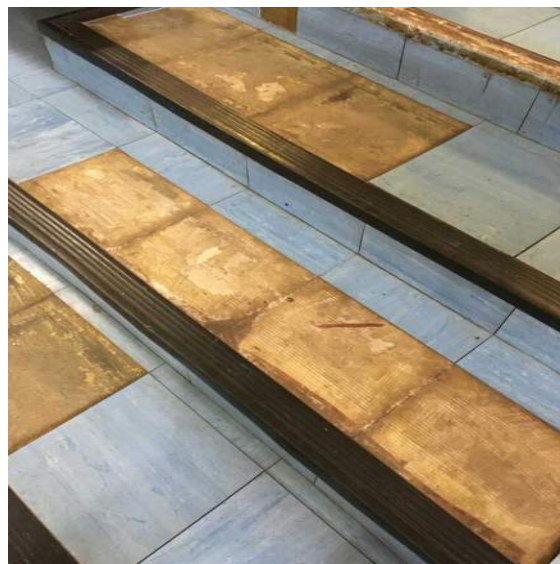
**Code:** IW00015140  
**Element:** 02 Floors and stairs  
**Subelement:** 02.01 Floor Finishes  
**Item:** 02.01.07  
**Condition:** C Poor  
**Priority:** 02 Essential - Within 2 years

**Site:** SIT1186 WESTER HAILES EDUCATION CENTRE - WHEC  
**Building:** BLD00251  
**Room:**  
**Cost:** £223778.68  
**Remedy:** 2 - Strip out and replace non slip floor sheet to diving area.  
**Defect:** 1 - Defective vinyl floor finish (tiled or sheet) 2 - Wear to non slip stair covering in swimming pool 3 - Expected wear to the carpets 4 - Defective or badly worn carpet finish (tiled or broadloom) 5 - Defective or missing stair nosings  
**Defect Location:** 1 - 041, 062, 085-089, 072-073, 121-124, 147, 157-158, 165-172, 184-198, 025, 018,060,131, 160, 173 (Stairs) 2 - Swimming Pool; diving area 3 - 022 4 - 119, 125-130, 132-146, 148 5 - 025, 018, 060, 131, 160, 173

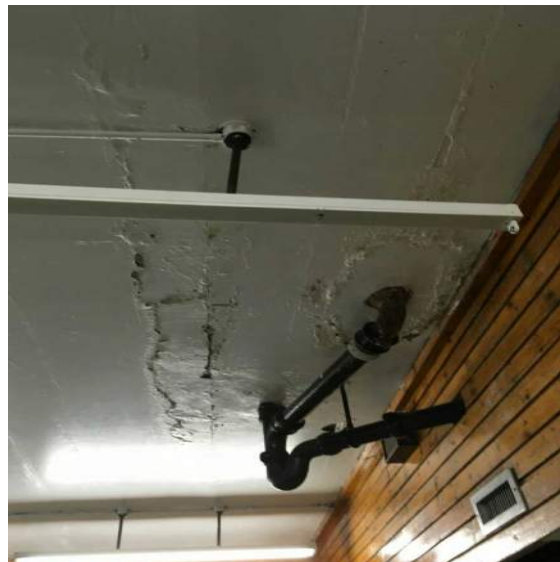
**Code:** IW00015119  
**Element:** 03 Ceilings  
**Subelement:** 03.02 Ceiling Structure  
**Item:** 03.02.02  
**Condition:** C Poor

**Defect:** 1 - Damage to ceiling from internal drainage leak. Investigate cause of leak and undertake remedial repairs to ceiling finish. 2 - Defective Fibre based board system; rescue any loose panels to ceiling 3 - Defective Fibre based board system with tired appearance. 4 - Staining to ceiling tiles from historic roof leaks 5 - Defective Grid System, tired and dated appearance

**Defect Location:** 1 - 074 197 2 - Squash courts 3 - 176-183 4 - 188 5 - various rooms

**Site:** SIT1186 WESTER HAILES EDUCATION CENTRE - WHEC  
**Building:** BLD00251  
**Room:**  
**Cost:** £248527.37  
**Remedy:** 1 - Take down mineral fibre ceiling and renew allowance for additional investigation works to leak and replacement of mineral fibre ceiling tiles

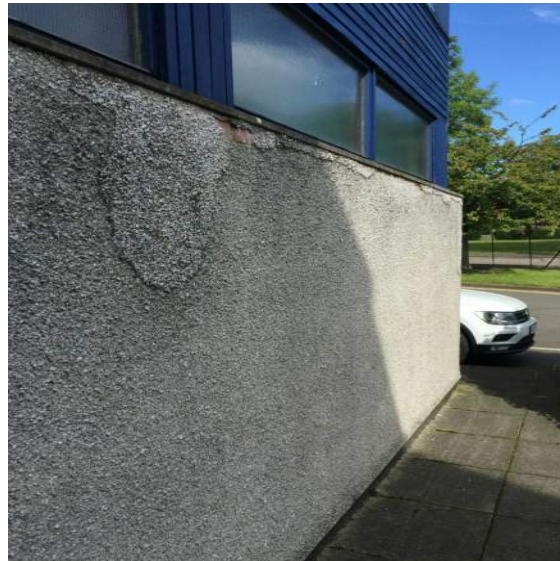
**Code:** IW00015062  
**Element:** 04 External walls windows and doors  
**Subelement:** 04.01 Ext Doors Glazing & Framing  
**Item:** 04.01.09  
**Condition:** C Poor  
**Priority:** 02 Essential - Within 2 years

1 - Damaged render at various areas. Signs of cracked and bossed render. 2 - Poorly conditioned external doorsets. 3 - Damaged plant room door.  
1 - Sporadically around building perimeters. 2 - West rear elevation, South elevation central area. 3 - Roof level plant room

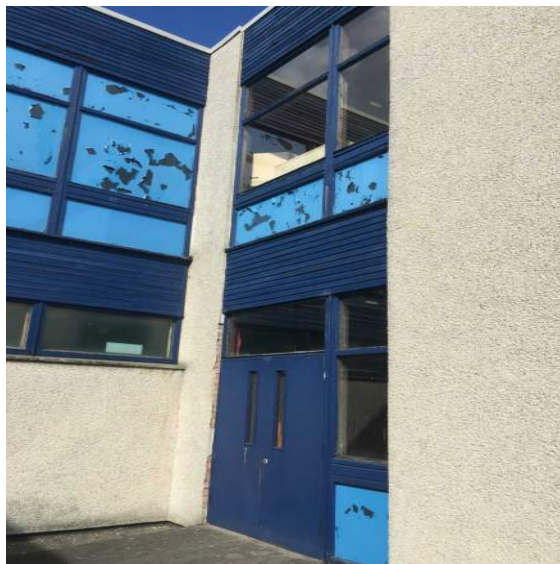
**Code:** IW00015057  
**Element:** 04 External walls windows and doors  
**Subelement:** 04.04 Ext Walls Structure & Foundations  
**Item:** 04.04.01  
**Condition:** C Poor

**Site:** SIT1186 WESTER HAILES EDUCATION CENTRE - WHEC  
**Building:** BLD00251  
**Room:**  
**Cost:** £362208.00  
**Remedy:** Replace all infills with suitably configured glazed curtain walling, to incorporate openable windows as necessary.  
**Defect:** All external timber glazed infills and associated windows and fascias in very poor condition.  
**Defect Location:** All building perimeters.

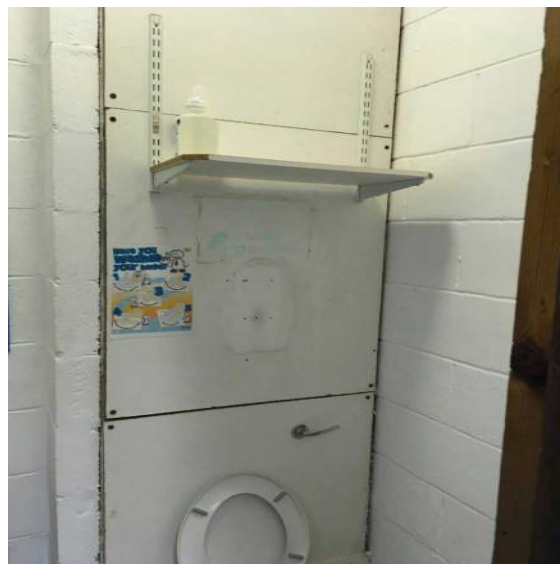
**Code:** IW00015115  
**Element:** 06 Sanitary services  
**Subelement:** 06.03 Toilets  
**Item:** 06.03.03  
**Condition:** C Poor  
**Priority:** 02 Essential - Within 2 years

**Site:** SIT1186 WESTER HAILES EDUCATION CENTRE - WHEC  
**Building:** BLD00251  
**Room:**  
**Cost:** £12051.64  
**Remedy:**  
**Defect:** 1 - Defective IPS panels to rear of toilet 2 - WC seat defective or missing  
**Defect Location:** 1 - 056, 194, 197 2 - 197

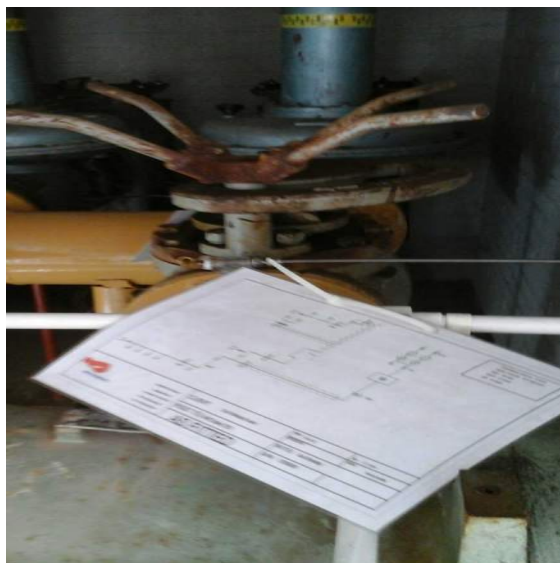
**Code:** IW00014809  
**Element:** 07 Mechanical services  
**Subelement:** 07.03 Gas / Oil / Fuel Services  
**Item:** 07.03.03  
**Condition:** D Bad  
**Priority:** 01 Urgent

**Site:** SIT1186 WESTER HAILES EDUCATION CENTRE - WHEC  
**Building:** BLD00251  
**Room:**  
**Cost:** £2634.24  
**Remedy:** Replace corroded parts with new  
**Defect:** The existing Gas supply pipework has become corroded or has been damaged., The existing in line Gas manual and automatic shut off valves have become damaged or may no longer functioning as expected.

**Defect Location:** 206 gas meter room

**Comments:** Incoming mains gas pipework and associated valves heavily corroded and require replacement.

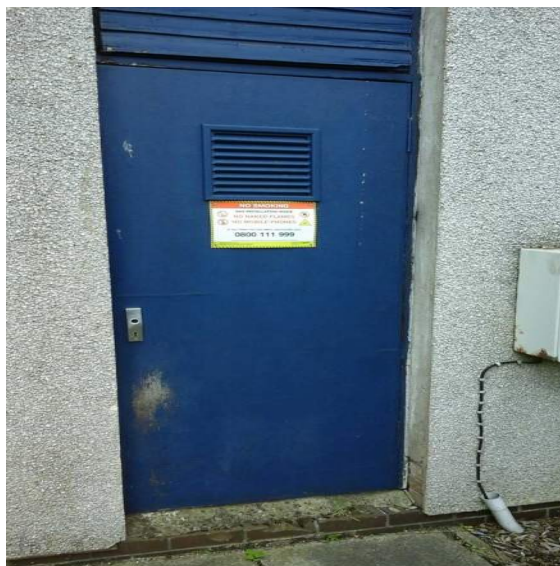
**Code:** IW00014811  
**Element:** 07 Mechanical services  
**Subelement:** 07.03 Gas / Oil / Fuel Services  
**Item:** 07.03.03  
**Condition:** C Poor

**Comments:** Current ventilation provision inadequate and does not comply with current building regulations. Only means of ventilation is small grille on door.

**Site:** SIT1186 WESTER HAILES EDUCATION CENTRE - WHEC  
**Building:** BLD00251  
**Room:**  
**Cost:** £658.56  
**Remedy:** Provide adequate high and low level ventilation to gas meter room.  
**Defect:** Inadequate ventilation provided to gas meter house.  
**Defect Location:** 068 gas meter room

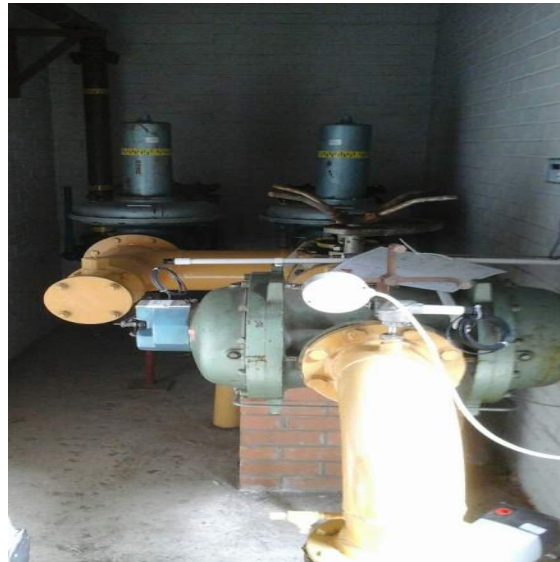
**Code:** IW00014810  
**Element:** 07 Mechanical services  
**Subelement:** 07.03 Gas / Oil / Fuel Services  
**Item:** 07.03.03  
**Condition:** B Satisfactory  
**Priority:** 03 Desirable - Within 3 to 5 years

**Site:** SIT1186 WESTER HAILES EDUCATION CENTRE - WHEC  
**Building:** BLD00251  
**Room:**  
**Cost:** £2634.24  
**Remedy:** Replace with new  
**Defect:** Gas meter near end of design life.  
**Defect Location:** 068 gas meter room

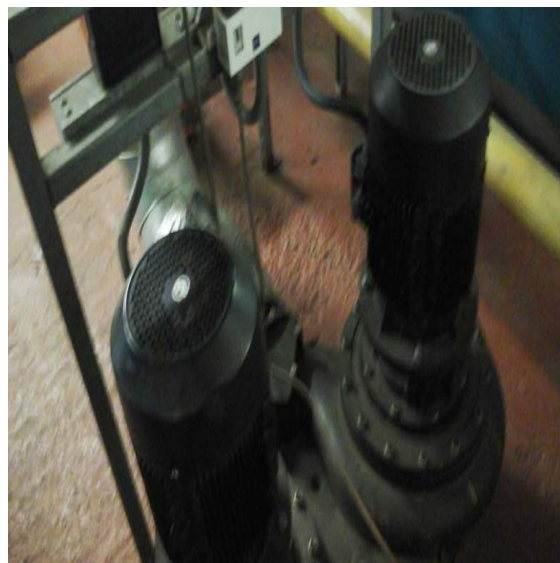
**Code:** IW00014815  
**Element:** 07 Mechanical services  
**Subelement:** 07.05 Heating  
**Item:** 07.05.01  
**Condition:** C Poor

**Site:** SIT1186 WESTER HAILES EDUCATION CENTRE - WHEC  
**Building:** BLD00251  
**Room:**  
**Cost:** £10010.11  
**Remedy:** 1 - Remove existing pumpset and replace with new. 2 - Make connection water tight 3 - Complete installation  
**Defect:** 1 - 1No of twin pumpset not operational, second pump noisy. 2 - Leak in 3PV connection. 3 - Radiator installation incomplete  
**Defect Location:** 1 - 068 boiler room 2 - 003 external store 3 - 028 Children & families occ. Ther.

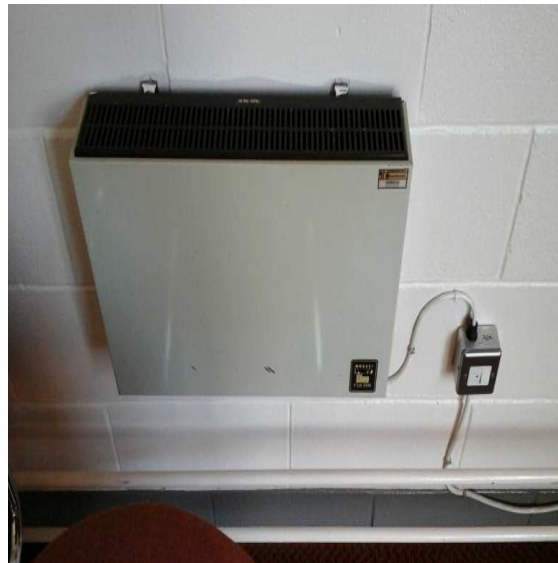
**Code:** IW00014831  
**Element:** 07 Mechanical services  
**Subelement:** 07.05 Heating  
**Item:** 07.05.02  
**Condition:** C Poor  
**Priority:** 02 Essential - Within 2 years

**Site:** SIT1186 WESTER HAILES EDUCATION CENTRE - WHEC  
**Building:** BLD00251  
**Room:**  
**Cost:** £2107.39  
**Remedy:**  
**Defect:** The existing electrically powered fan assisted wall mounted heaters are nearing or at the end of their CIBSE Economic Life of 10 years  
**Defect Location:** 130 conference room

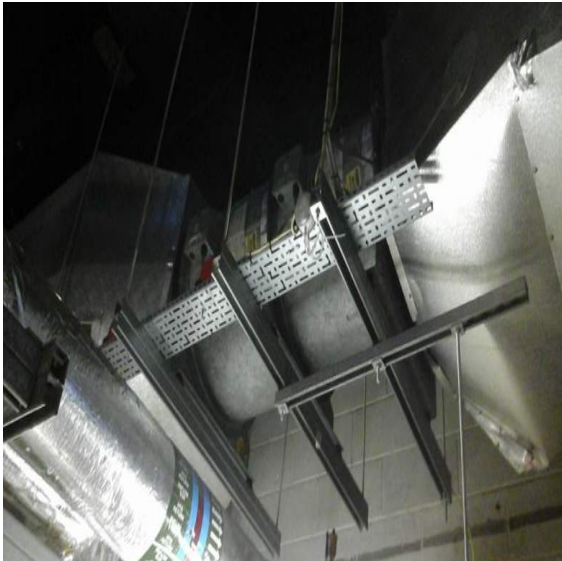
<b>Code:</b>	IW00014805	<b>Site:</b>	SIT1186 WESTER HAILES EDUCATION CENTRE - WHEC
<b>Element:</b>	07 Mechanical services	<b>Building:</b>	BLD00251
<b>Subelement:</b>	07.07 Ventilation and Air Conditioning	<b>Room:</b>	
<b>Item:</b>	07.07.02	<b>Cost:</b>	£2634.24
<b>Condition:</b>	C Poor	<b>Remedy:</b>	Investigate why fan does not work, repair or replace as necessary.
<b>Priority:</b>	02 Essential - Within 2 years	<b>Defect:</b>	1No of a twin supply fan not operational.
<b>Comments:</b>	Facilities manager reported that one of the twin fans is not operational.		
<b>Photo:</b>

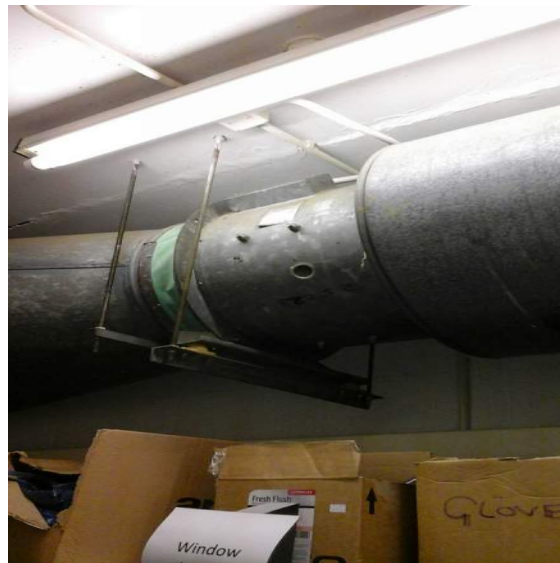
<b>Code:</b>	IW00014800	<b>Site:</b>	SIT1186 WESTER HAILES EDUCATION CENTRE - WHEC
<b>Element:</b>	07 Mechanical services	<b>Building:</b>	BLD00251
<b>Subelement:</b>	07.07 Ventilation and Air Conditioning	<b>Room:</b>	
<b>Item:</b>	07.07.02	<b>Cost:</b>	£987.84
<b>Condition:</b>	B Satisfactory	<b>Remedy:</b>	
<b>Priority:</b>	03 Desirable - Within 3 to 5 years	<b>Defect:</b>	The existing Wall/Window/Ceiling mounted extract fans are approaching the end of their CIBSE Economic Life of 15 years.

**Comments:** Extract fan appears to be near end of economic life, however in satisfactory working condition and fully operational.

**Defect Location:** 1 - 038 store 7.22 2 - Roof plant

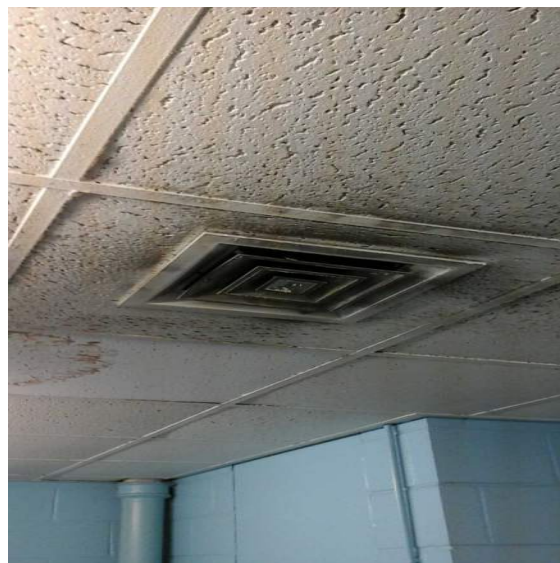
**Code:** IW00014836  
**Element:** 07 Mechanical services  
**Subelement:** 07.07 Ventilation and Air Conditioning  
**Item:** 07.07.03  
**Condition:** C Poor

**Comments:** 1 - Diffusers & grilles dirty & noisy throughout the building. 2 - AHU found open during survey.

**Defect:** 1 - Dirt build-up on grilles/diffusers 2 - AHU not operational, service door missing.

**Defect Location:** 1 - Throughout 2 - Roof plant

**Site:** SIT1186 WESTER HAILES EDUCATION CENTRE - WHEC  
**Building:** BLD00251  
**Room:**  
**Cost:** £13171.20  
**Remedy:** 1 - Clean and maintain ventilation grilles/diffusers. 2 - Investigate problems with the AHU, repair or replace as necessary.

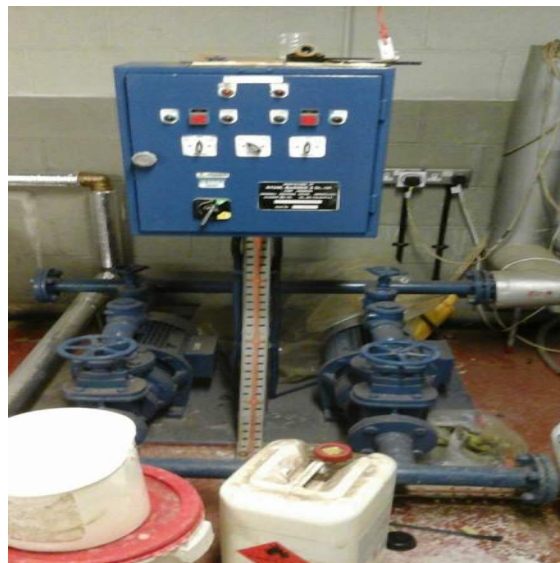
**Code:** IW00014822  
**Element:** 07 Mechanical services  
**Subelement:** 07.08 Water Services  
**Item:** 07.08.03  
**Condition:** C Poor  
**Priority:** 02 Essential - Within 2 years

Facilities manager noted that the set will be replaced in the coming weeks. The new set was already on site: Wilo COR-2 MHE803-2G

**Site:** SIT1186 WESTER HAILES EDUCATION CENTRE - WHEC  
**Building:** BLD00251  
**Room:**  
**Cost:** £10536.96  
**Remedy:** Replace with new  
**Defect:** Cold water booster set beyond end of economic life.  
**Defect Location:** 067 plant

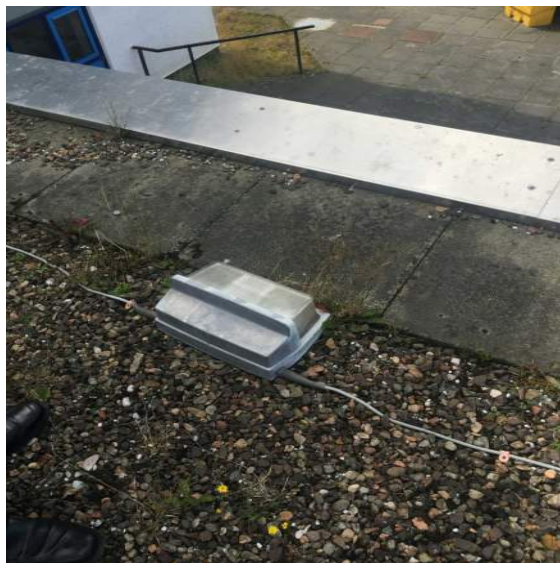
**Site:** SIT1186 WESTER HAILES EDUCATION CENTRE - WHEC  
**Building:** BLD00251  
**Room:**  
**Cost:** £329.28  
**Remedy:** Reattach as before, test and certify.  
**Defect:** Detached flood light.  
**Defect Location:** Roof level overlooking central pedestrian area.

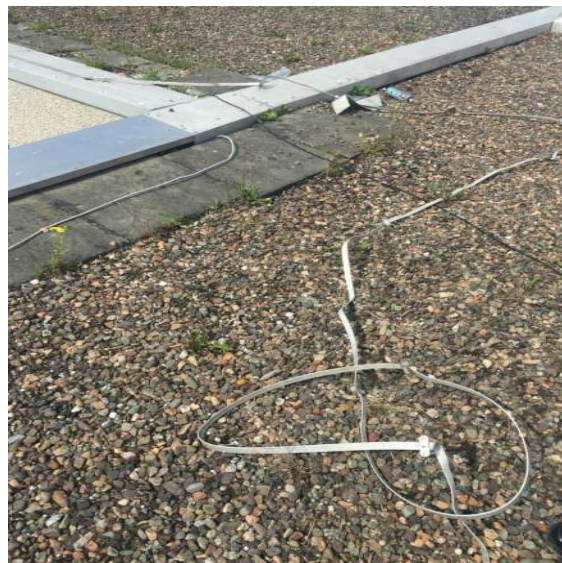
**Site:** SIT1186 WESTER HAILES EDUCATION CENTRE - WHEC  
**Building:** BLD00251  
**Room:**  
**Cost:** £329.28  
**Remedy:** Reattach and repair length of lightning protection band.  
**Defect:** Detached lightning protection  
**Defect Location:** Roof level overlooking central pedestrian area.

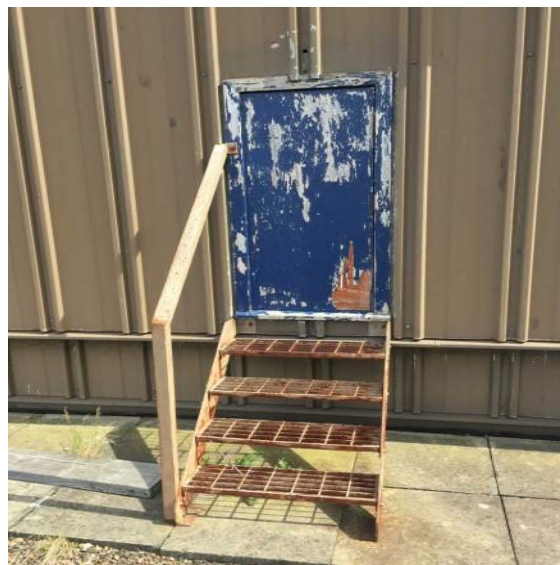
**Site:** SIT1186 WESTER HAILES EDUCATION CENTRE - WHEC  
**Building:** BLD00251  
**Room:**  
**Cost:** £1165.65  
**Remedy:** 2 - Prepare and decorate louvred metal vent panels.  
**Defect:** 1 - Poorly conditioned access steps 2 - Defective painter work to doors  
**Defect Location:** 1 - Roof level plant room 2 - Loading and service area elevations.

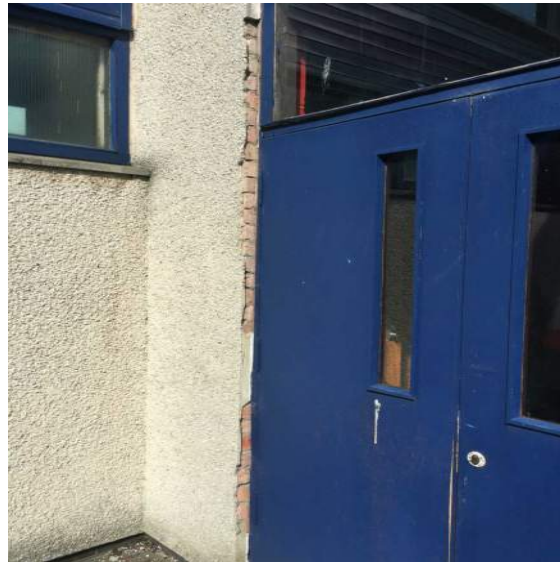
**Site:** SIT1186 WESTER HAILES EDUCATION CENTRE - WHEC  
**Building:** BLD00251  
**Room:**  
**Cost:** £2370.81  
**Remedy:**  
**Defect:** Paint wear to external doorsets.  
**Defect Location:** All building perimeters.

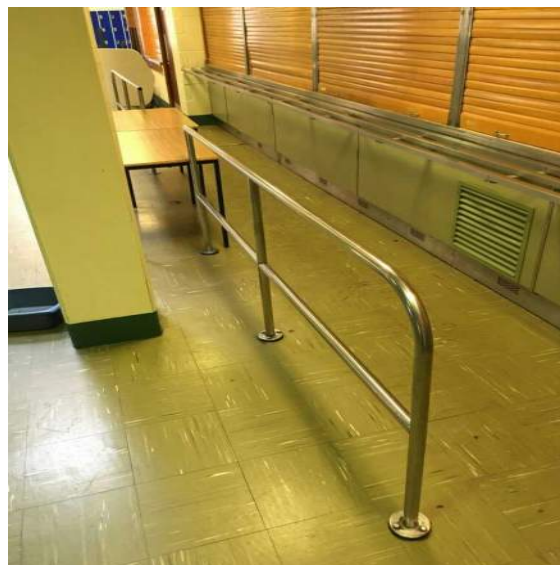
**Site:** SIT1186 WESTER HAILES EDUCATION CENTRE - WHEC  
**Building:** BLD00251  
**Room:**  
**Cost:** £856.12  
**Remedy:** 1 - Rescue handrail to floor 2 - Remove damaged section of seating and replace  
**Defect:** 1 - Stainless steel handrail loose where fixed to the floor. 2 - Damage to viewing area benches  
**Defect Location:** 1 - 166 2 - 165 Gallery

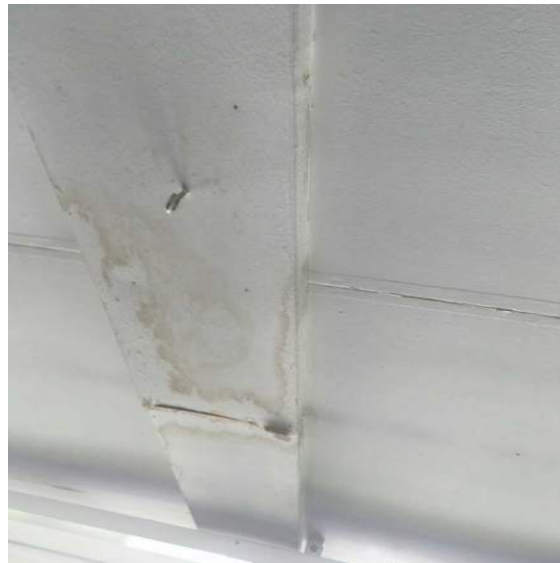
**Site:** SIT1186 WESTER HAILES EDUCATION CENTRE - WHEC  
**Building:** BLD02329  
**Room:**  
**Cost:** £58440.61  
**Remedy:**  
**Defect:** 1 - Water ingress to ceiling, poor roof condition and ponding to roof. 2 - fascia boards - Rotten and poor condition 3 - Missing end caps to gutters  
**Defect Location:** External

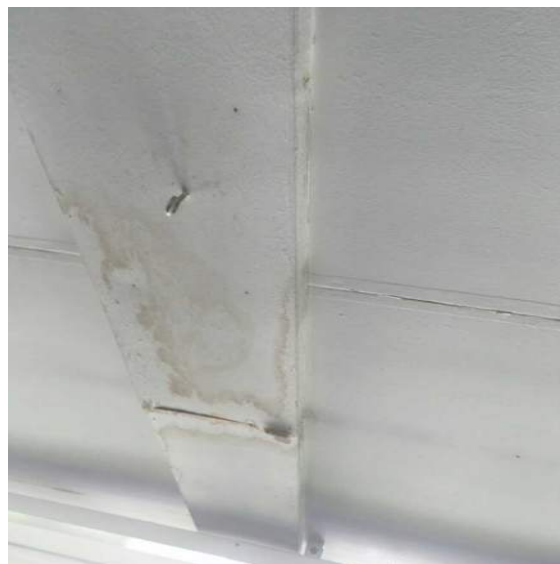
**Site:** SIT1186 WESTER HAILES EDUCATION CENTRE - WHEC  
**Building:** BLD02329  
**Room:**  
**Cost:** £1185.40  
**Remedy:**  
**Defect:** Water stained panelling  
**Defect Location:** 011 006

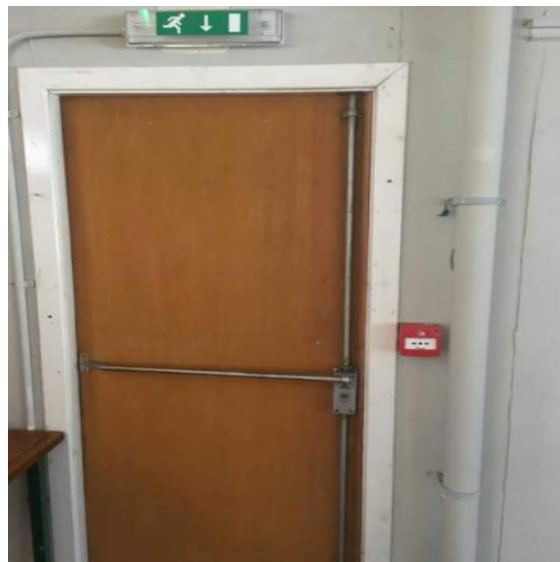
**Site:** SIT1186 WESTER HAILES EDUCATION CENTRE - WHEC  
**Building:** BLD02329  
**Room:**  
**Cost:** £237.08  
**Remedy:**  
**Defect:** Defective fire escape ironmongery  
**Defect Location:** 011

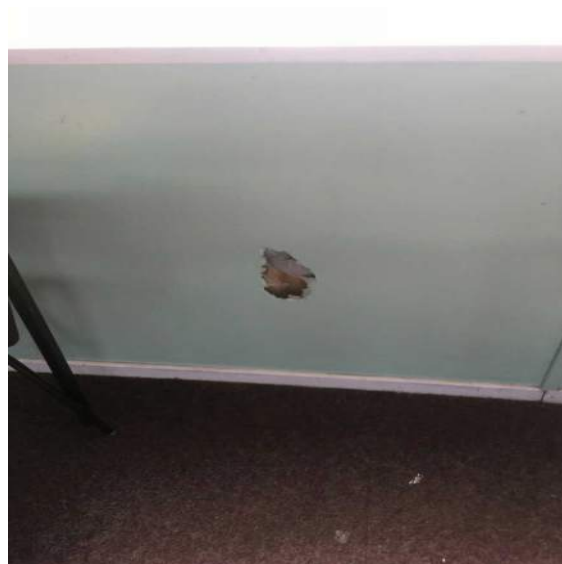
**Site:** SIT1186 WESTER HAILES EDUCATION CENTRE - WHEC  
**Building:** BLD02329  
**Room:**  
**Cost:** £480.74  
**Remedy:**  
**Defect:** 1 - Hole to plaster wall 2 - Damaged glass to internal door 3 - Damaged veneer to door  
**Defect Location:** 1 - 011 2 - 011 3 - 006

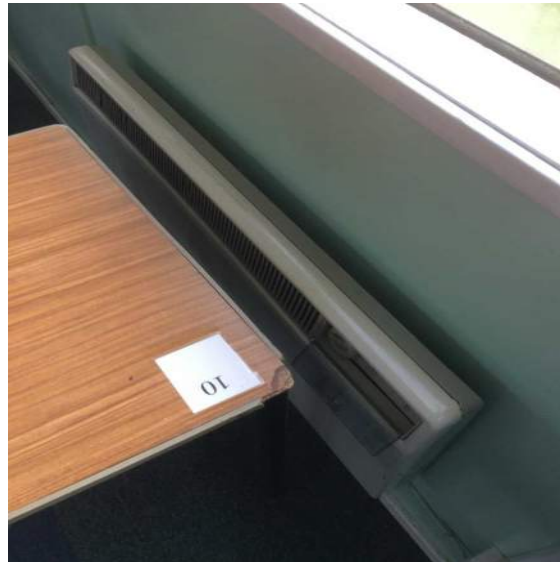
**Site:** SIT1186 WESTER HAILES EDUCATION CENTRE - WHEC  
**Building:** BLD02329  
**Room:**  
**Cost:** £842.95  
**Remedy:** New electric heaters  
**Defect:** Age expiring and visually poor heaters  
**Defect Location:** Throughout classrooms

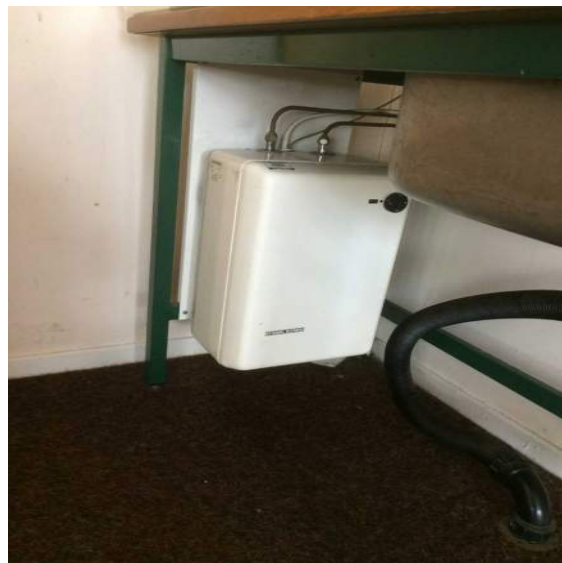
**Site:** SIT1186 WESTER HAILES EDUCATION CENTRE - WHEC  
**Building:** BLD02329  
**Room:**  
**Cost:** £1185.40  
**Remedy:** New water heater  
**Defect:** Age expiring water heater  
**Defect Location:** Under sinks

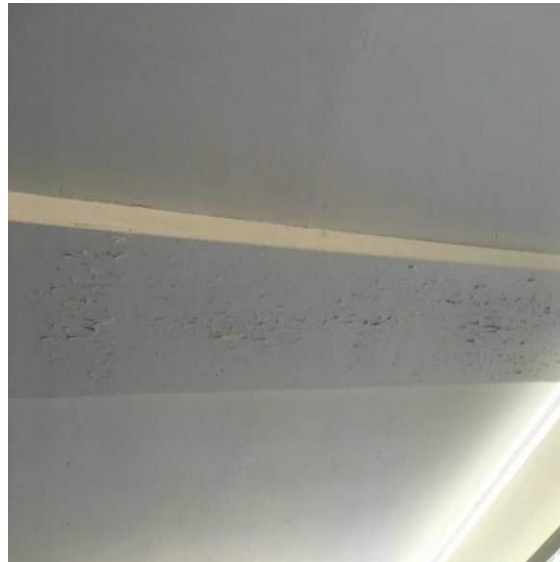
**Site:** SIT1186 WESTER HAILES EDUCATION CENTRE - WHEC  
**Building:** BLD02329  
**Room:**  
**Cost:** £31.60  
**Remedy:**  
**Defect:** Flaking paint to ceiling  
**Defect Location:** 005 001

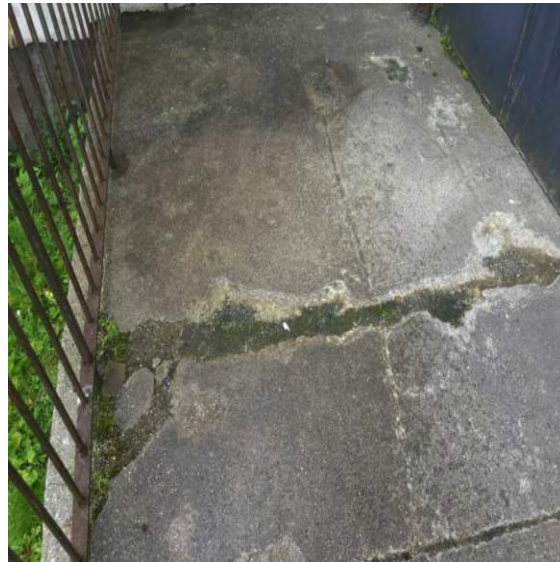
**Site:** SIT1186 WESTER HAILES EDUCATION CENTRE - WHEC  
**Building:** BLD02329  
**Room:**  
**Cost:** £197.56  
**Remedy:**  
**Defect:** Damaged concrete to ramp  
**Defect Location:** External ramp

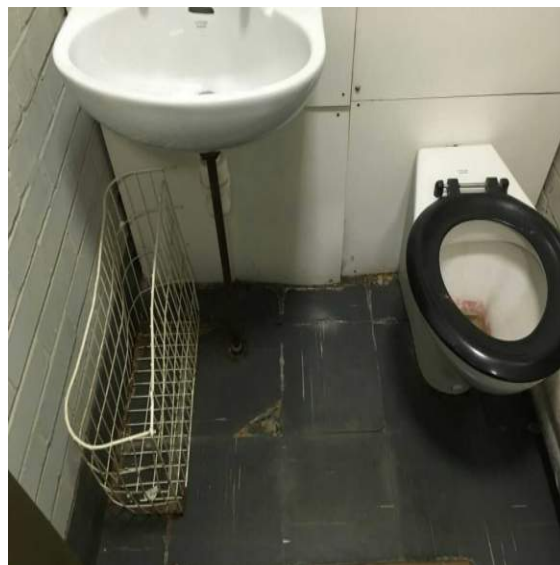
**Site:** SIT1186 WESTER HAILES EDUCATION CENTRE - WHEC  
**Building:** BLD02330  
**Room:**  
**Cost:** £2304.96  
**Remedy:**  
**Defect:** 1 - Damaged vinyl floor tiles 2 - Missing tiles to floor 3 - Defective vinyl floor finish (tiled or sheet) 4 - Defective or badly worn carpet finish (tiled or broadloom)  
**Defect Location:** 1 - 007 2 - 011 013 014 3 - 005 4 - 016

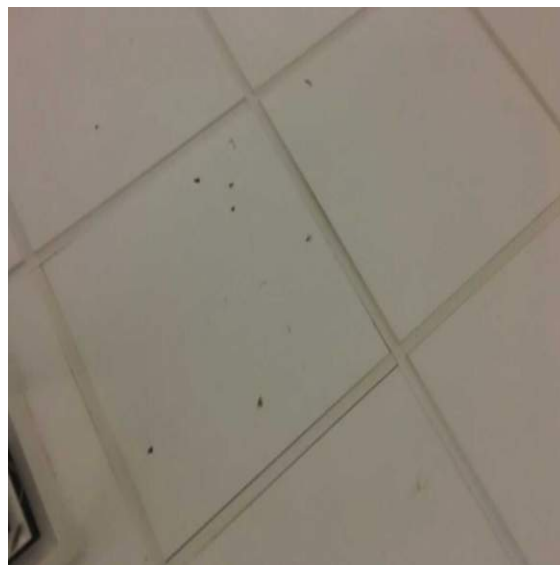
**Site:** SIT1186 WESTER HAILES EDUCATION CENTRE - WHEC  
**Building:** BLD02330  
**Room:**  
**Cost:** £2370.81  
**Remedy:** 2 - Inspect aboveceiling tile for leaks and undertake work as required including replacement of ceiling tile.  
**Defect:** 1 - Impact damage to ceiling tiles 2 - Water stained ceiling tile  
**Defect Location:** 1 - 004 002 017 2 - 002

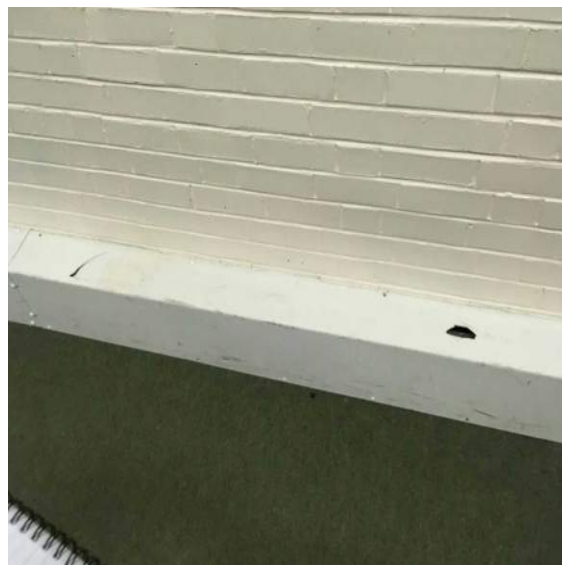
**Site:** SIT1186 WESTER HAILES EDUCATION CENTRE - WHEC  
**Building:** BLD02330  
**Room:**  
**Cost:** £500.50  
**Remedy:** Renew pipework boxing  
**Defect:** 1 - Damaged boxing to pipework 2 - Damaged or defective ironmongery or other furniture and fittings to door. Yale lock loose  
**Defect Location:** 1 - 004 017 2 - 003

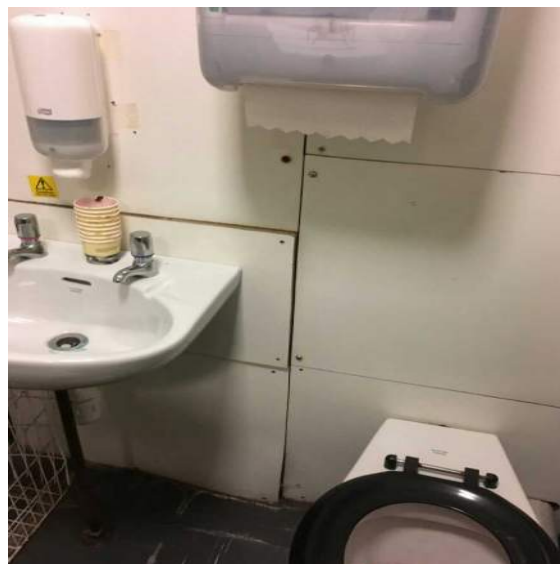
**Site:** SIT1186 WESTER HAILES EDUCATION CENTRE - WHEC  
**Building:** BLD02330  
**Room:**  
**Cost:** £921.98  
**Remedy:**  
**Defect:** Defective cubicle walling/partition  
**Defect Location:** 007 008

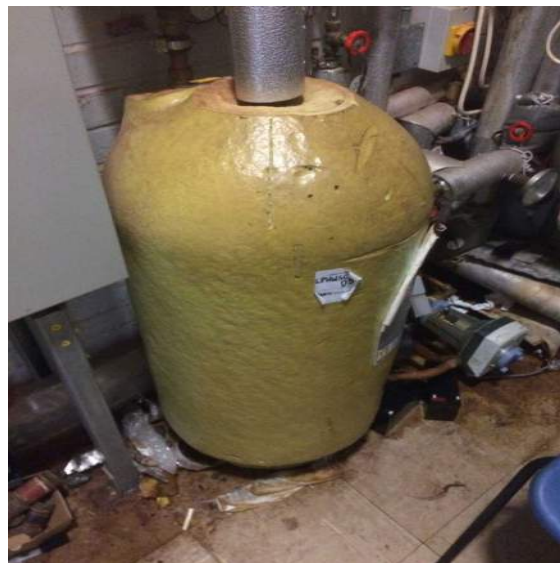
**Site:** SIT1186 WESTER HAILES EDUCATION CENTRE - WHEC  
**Building:** BLD02330  
**Room:**  
**Cost:** £2528.87  
**Remedy:** NewWater heater  
**Defect:** Visually poor hot water cylinder  
**Defect Location:** Store cupboard

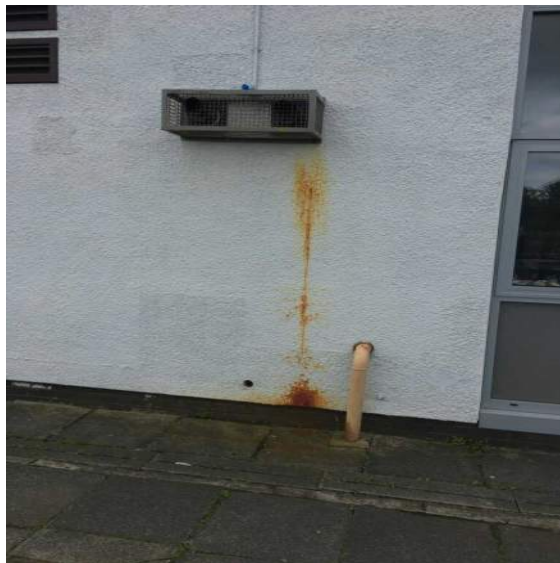
**Site:** SIT1186 WESTER HAILES EDUCATION CENTRE - WHEC  
**Building:** BLD02330  
**Room:**  
**Cost:** £4135.75  
**Remedy:** 1 - Coat metal fixing to cage 2 - Defective painterwork to timber doors and lining sets 3 - Defective painter work to external render /roughcast  
**Defect:** 1 - Rust staining to wall from cage 2 - Defective painterwork to timber doors and lining sets 3 - Defective painter work to external render /roughcast  
**Defect Location:** 1 - Side elevation 2/3 - External

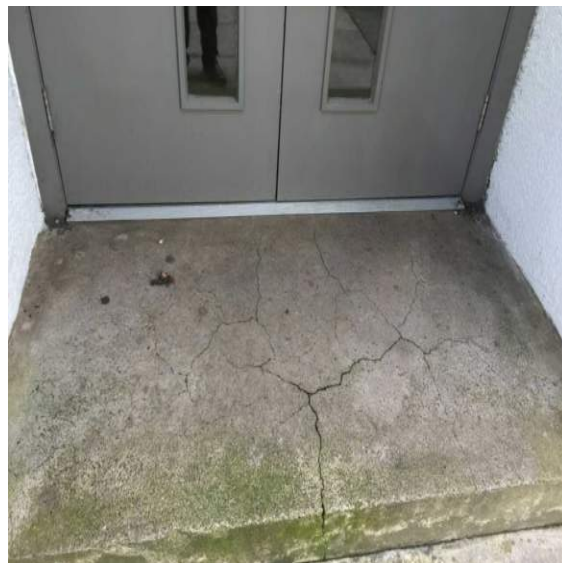
**Site:** SIT1186 WESTER HAILES EDUCATION CENTRE - WHEC  
**Building:** BLD02330  
**Room:**  
**Cost:** £131.71  
**Remedy:**  
**Defect:** Cracked concrete  
**Defect Location:** Main entrance

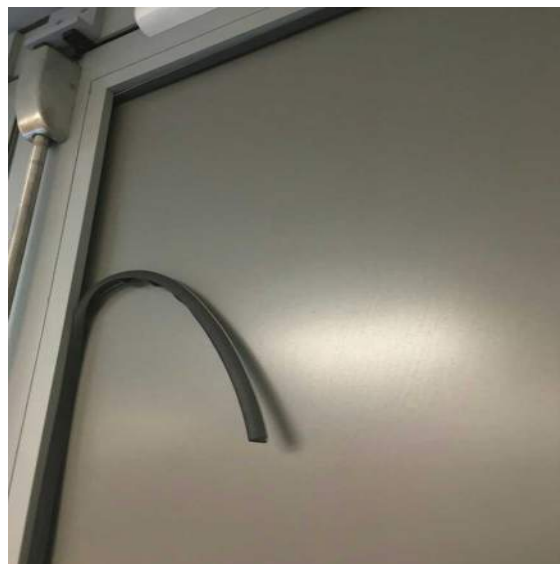
**Site:** SIT1186 WESTER HAILES EDUCATION CENTRE - WHEC  
**Building:** BLD02331  
**Room:**  
**Cost:** £487.33  
**Remedy:** 1 - Replace seals to doors  
**Defect:** 1 - Seal to door dislodged 2 - Pointing in poor condition below concrete slab  
**Defect Location:** 1 - 034 029 2 - 002

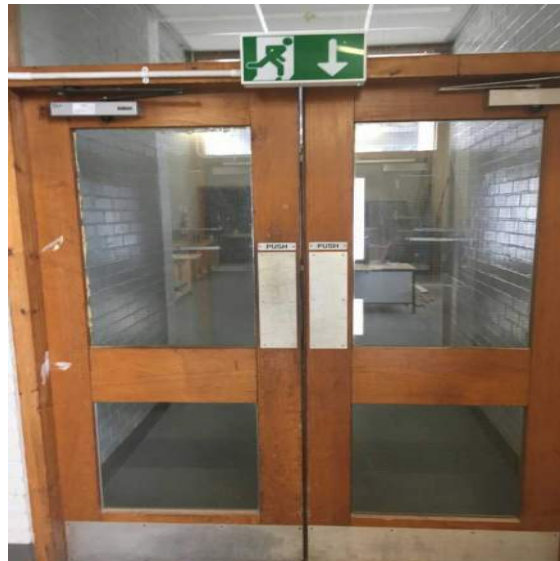
**Site:** SIT1186 WESTER HAILES EDUCATION CENTRE - WHEC  
**Building:** BLD02331  
**Room:**  
**Cost:** £7059.76  
**Remedy:** 2 - Renew pipework boxing 3 - Infill gap with fore resisting construction  
**Defect:** 1 - Damaged or defective timber internal door doors with large gaps at meeting rails 2 - Damaged boxing to pipework 3 - Penetration to walling 4 - Damaged or defective ironmongery or other furniture and fittings to door,  
**Defect Location:** 1 - 026 019 002 005 013 2 - 018 015 041 3 - 007 4 - 044

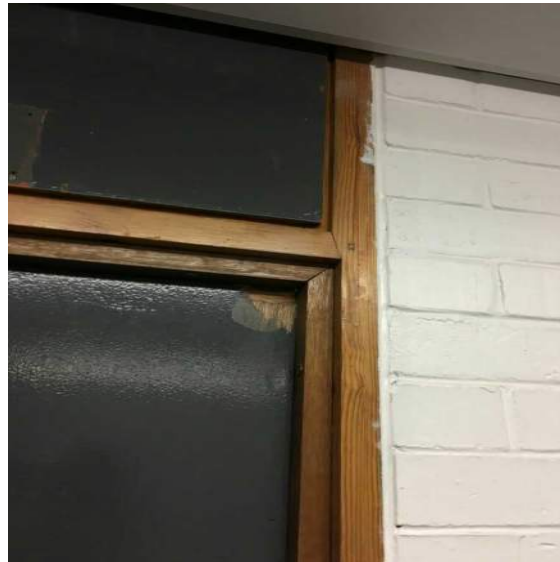
**Site:** SIT1186 WESTER HAILES EDUCATION CENTRE - WHEC  
**Building:** BLD02331  
**Room:**  
**Cost:** £237.08  
**Remedy:**  
**Defect:** Damaged timber door  
**Defect Location:** 022

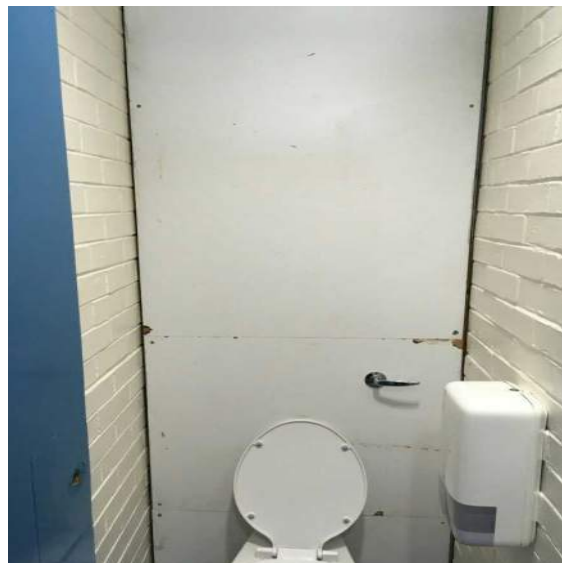
**Site:** SIT1186 WESTER HAILES EDUCATION CENTRE - WHEC  
**Building:** BLD02331  
**Room:**  
**Cost:** £1382.97  
**Remedy:**  
**Defect:** Defective cubicle walling/partition  
**Defect Location:** 020 023

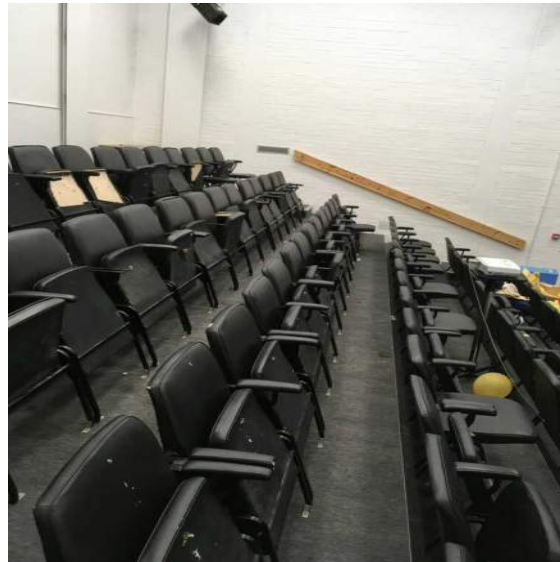
**Site:** SIT1186 WESTER HAILES EDUCATION CENTRE - WHEC  
**Building:** BLD02331  
**Room:**  
**Cost:** £6585.60  
**Remedy:** Allow for overhaul and repairs to seating  
**Defect:** Damaged seat and wear to searing  
**Defect Location:** 043

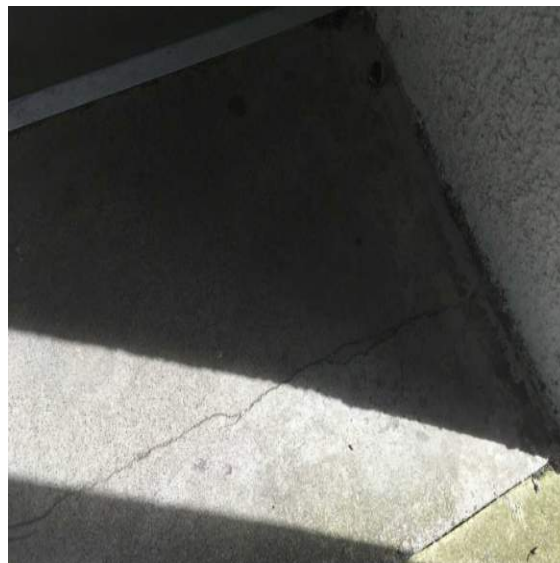
**Site:** SIT1186 WESTER HAILES EDUCATION CENTRE - WHEC  
**Building:** BLD02331  
**Room:**  
**Cost:** £263.42  
**Remedy:**  
**Defect:** Cracked concrete  
**Defect Location:** 002 019

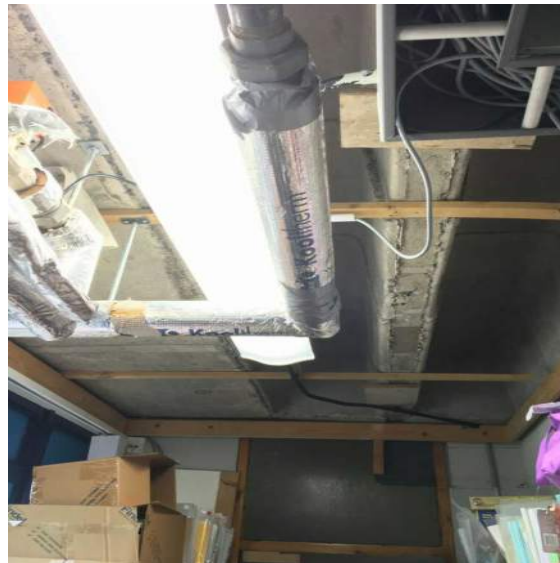
**Site:** SIT1186 WESTER HAILES EDUCATION CENTRE - WHEC  
**Building:** BLD02332  
**Room:**  
**Cost:** £2054.70  
**Remedy:** 1 - Install new suspended ceiling 3 - Install section of plasterboard to replace missing section and make decoration good.

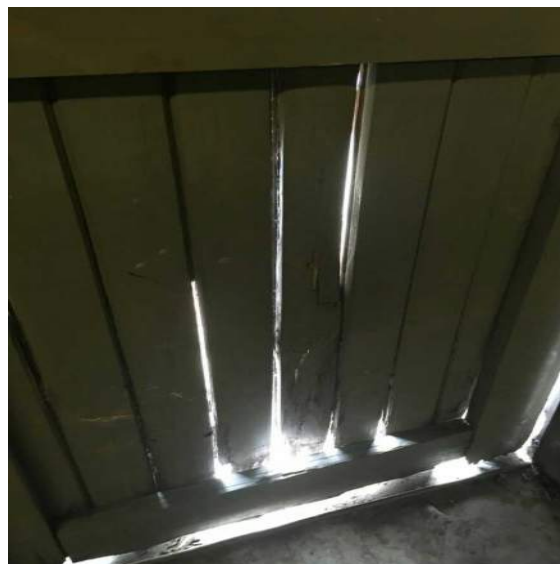
**Site:** SIT1186 WESTER HAILES EDUCATION CENTRE - WHEC  
**Building:** BLD02332  
**Room:**  
**Cost:** £987.84  
**Remedy:**  
**Defect:** Defective door which is rotten and requires replacement  
**Defect Location:** 3 roof top plant room

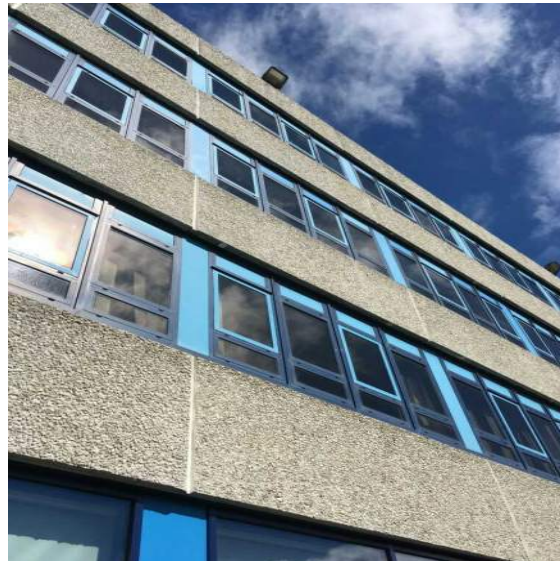
**Site:** SIT1186 WESTER HAILES EDUCATION CENTRE - WHEC  
**Building:** BLD02332  
**Room:**  
**Cost:** £156473.85  
**Remedy:** Refurbish all seals to window units to prevent wind driven water ingress.  
**Defect:** Defective double glazed unit, water ingress through defective external seals, causing damage to internal fabric and finish.  
**Defect Location:** 3rd, 2nd & 1st floor external
