CS000866

Survey Description	Survey Date	Survey Status	Surveyor	Organisation
<p>BLOCK A: 1970S CONCRETE FRAME TWO STOREY BUILDING. RENDERED BRICK INFILL PANELS WITH INVERTED FLAT ROOF. TIMBER INFILL PANELS WITH SINGLE GLAZED WINDOW UNITS</p> <p>BLOCK B&amp;C: 1970S CONSTRUCTION CONCRETE FRAME BUILDING WITH 4 STOREY TOWER SECTION AND SINGLE STOREY BLOCK C. CONCRETE CLADDING AND RENDERED BRICK INFILL. FLAT ROOF WITH MINERAL FELT AND GRP LIQUID APPLIED SYSTEMS. ALUMINIUM POWDER COATED DOUBLE GLAZED WINDOWS AND DOORS.</p> <p>BLOCK D: SINGLE AND TWO STOREY SECTIONS. CONCRETE FRAMED WITH RENDERED BRICK INFILLS, VERTICAL CLADDING. MINERAL FELT FLAT ROOF. POWDERCOATED ALUMINIUM WINDOWS AND TIMBER DOORS.</p> <p>BLOCK E: SINGLE STOREY SECTIONS. CONCRETE FRAMED WITH RENDERED BRICK INFILLS. MINERAL FELT FLAT ROOF. POWDERCOATED ALUMINIUM WINDOWS AND DOORS. BLOCK F: TU MINERAL FELT FLAT ROOF COMPOSITE BOARDING CLADDING THE EXTERIOR. SINGLE GLAZED METAL WINDOWS AND TIMBER DOOR SETS</p>	<p>07/08/2017</p>	<p>COMPLETE</p>	<p>F&amp;G</p>	<p>F&amp;G</p>

## Edinburgh - City Of Edinburgh Council

<b>Site</b>	SIT1186 WESTER HAILES EDUCATION CENTRE - WHEC
<b>Address</b>	5  EDINBURGH LOTHIAN EH14 2SU
<b>N

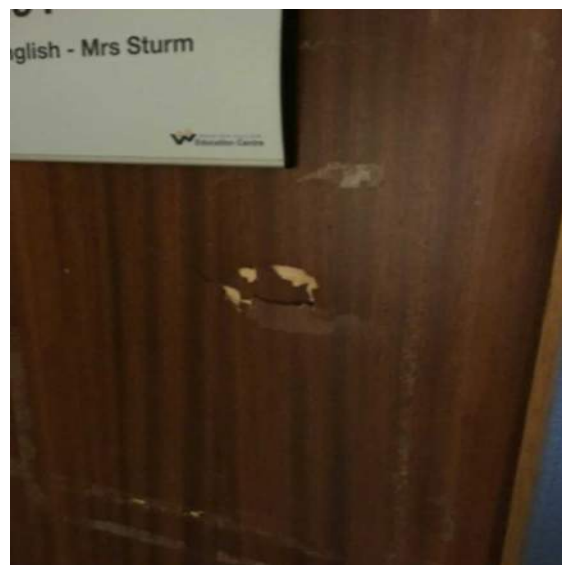
**Site:** SIT1186 WESTER HAILES EDUCATION CENTRE - WHEC  
**Building:** BLD02332  
**Room:**  
**Cost:** £17991.85  
**Remedy:** 3 - Strip out and remove water damaged sills and replace with new. 4 - Remove loose damaged blockwork and pointing. Reinststate with new blockwork and pointing.  
**Defect:** 1 - Damaged or defective timber internal door 2 - Replace missing kick plate to door 3 - Rotten and warped MDF internal sill caused by water ingress from leaking window units.  
**Defect Location:** 1 - Various locations throughout, 088, 089 2 - 029 3 - Various locations throughout 3rd, 2nd & 1st floors to perimeter of building

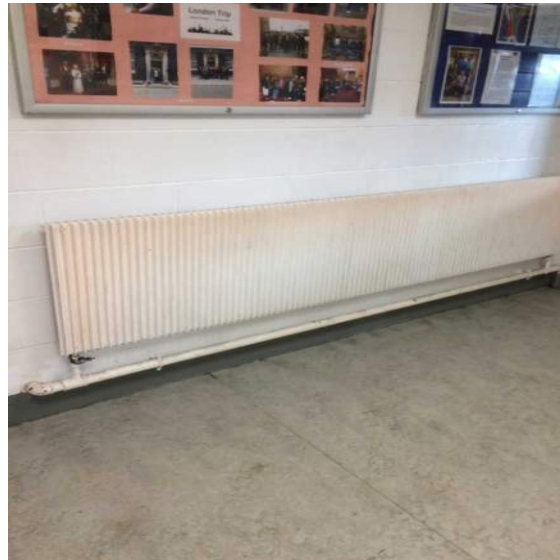
**Site:** SIT1186 WESTER HAILES EDUCATION CENTRE - WHEC  
**Building:** BLD02332  
**Room:**  
**Cost:** £1317.12  
**Remedy:** TRVs to be installed  
**Defect:** TRVs missing on several radiators throughout school  
**Defect Location:** Throughout school

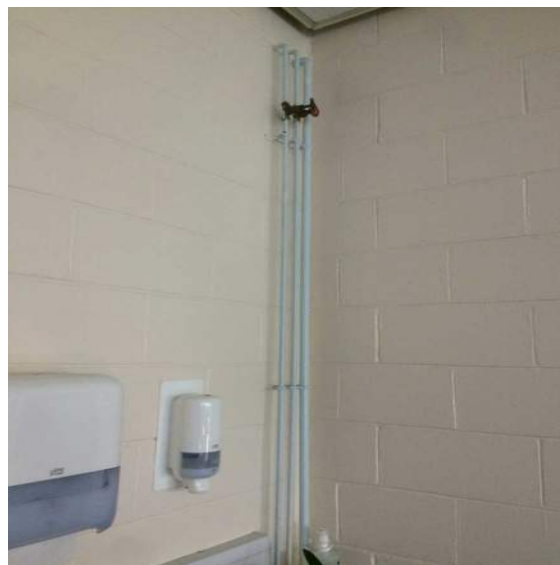
**Site:** SIT1186 WESTER HAILES EDUCATION CENTRE - WHEC  
**Building:** BLD02332  
**Room:**  
**Cost:** £110677.59  
**Remedy:** 1 - Insulation to be installed on all water services pipework 2 - Insulate pipework in exposed areas  
**Defect:** 1 - No insulation on exposed pipework 2 - No insulation on dhw pipework flow or return  
**Defect Location:** 1 - All exposed areas 2 - Exposed areas
