Materials Audit

City of Edinburgh Council

November 2023

GRANTON WATERFRONT MATERIALS AUDIT

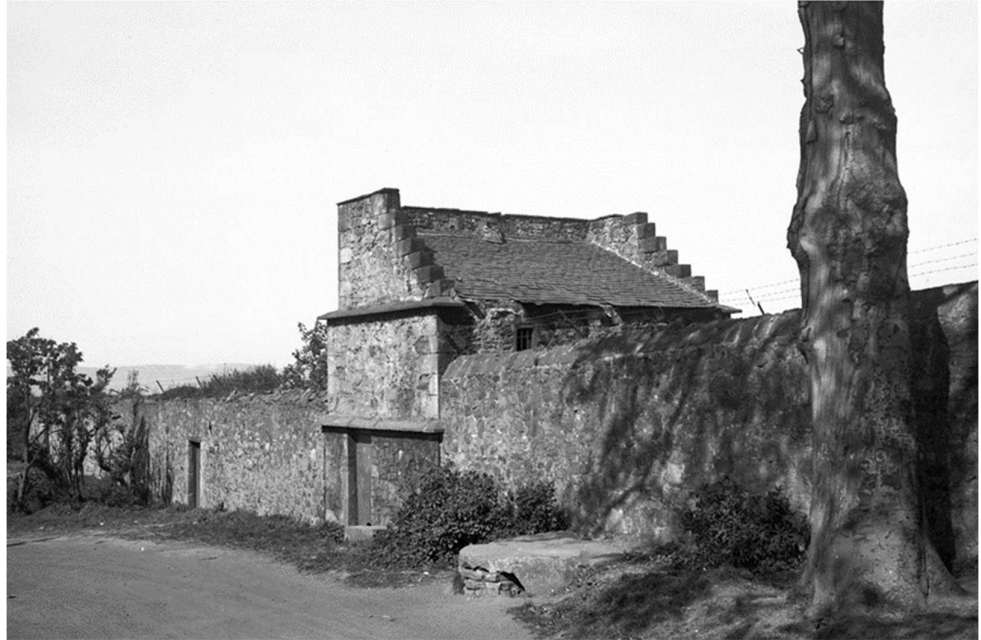
Figure 28: Doocot at Granton Castle Walled Garden (Canmore 2023)

The doocot had its roof replaced in 2016 and as such is in fair condition however, there is vegetation growing out of some on the mortar joints which will be allowing mortar ingress.

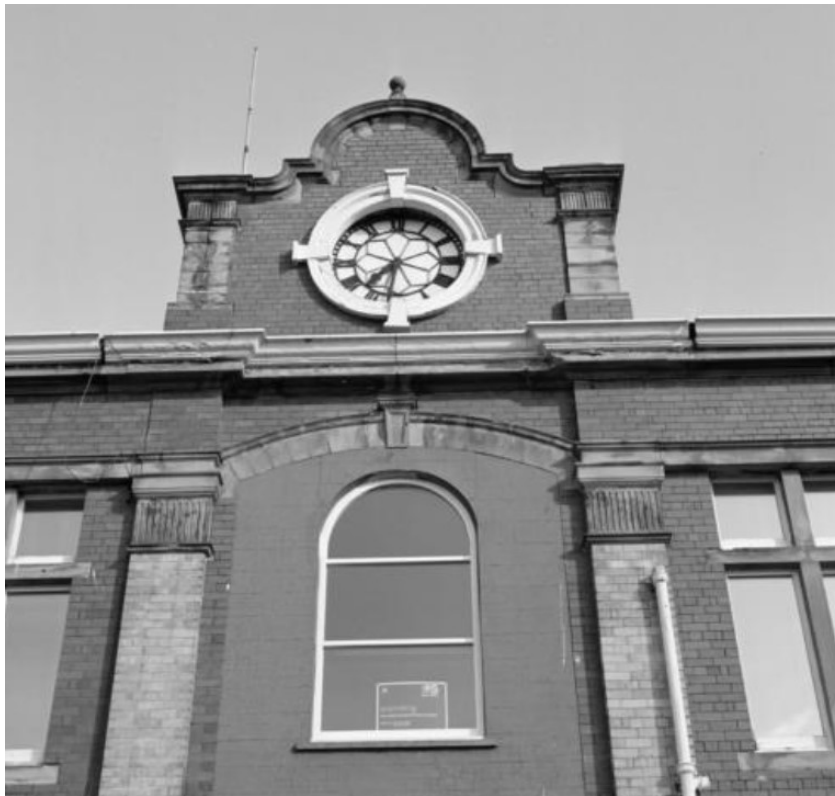
Figure 43: Clock to station building having suffered storm damage, 1998 (Canmore 2023)

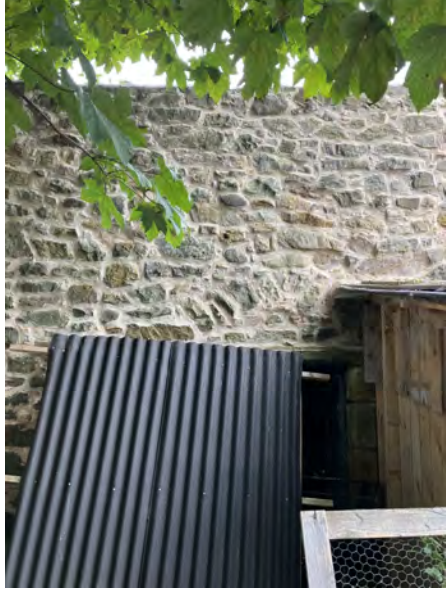
1.15

Recently repaired north wall to Granton Castle Walled Garden

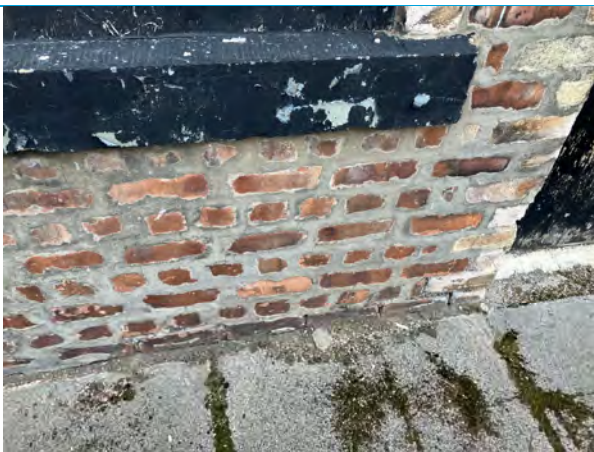
1.34

Cementitious pointing to outbuilding

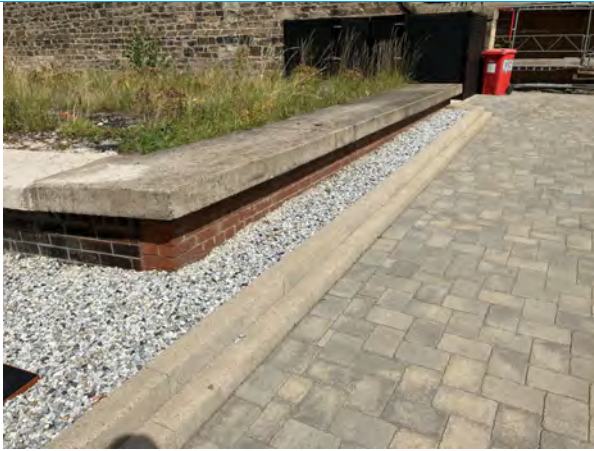
1.39

Granton Station
Platform

A regular maintenance plan should be implemented to maintain the platforms and remove vegetation growth as they are a significant part of the readability of the station building and its historic use.

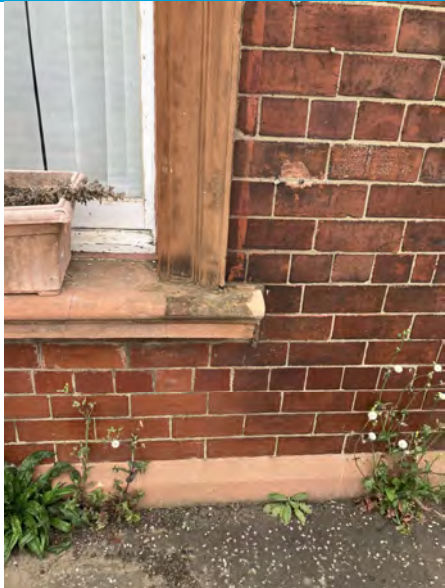
1.45

Replaced plinth to main façade

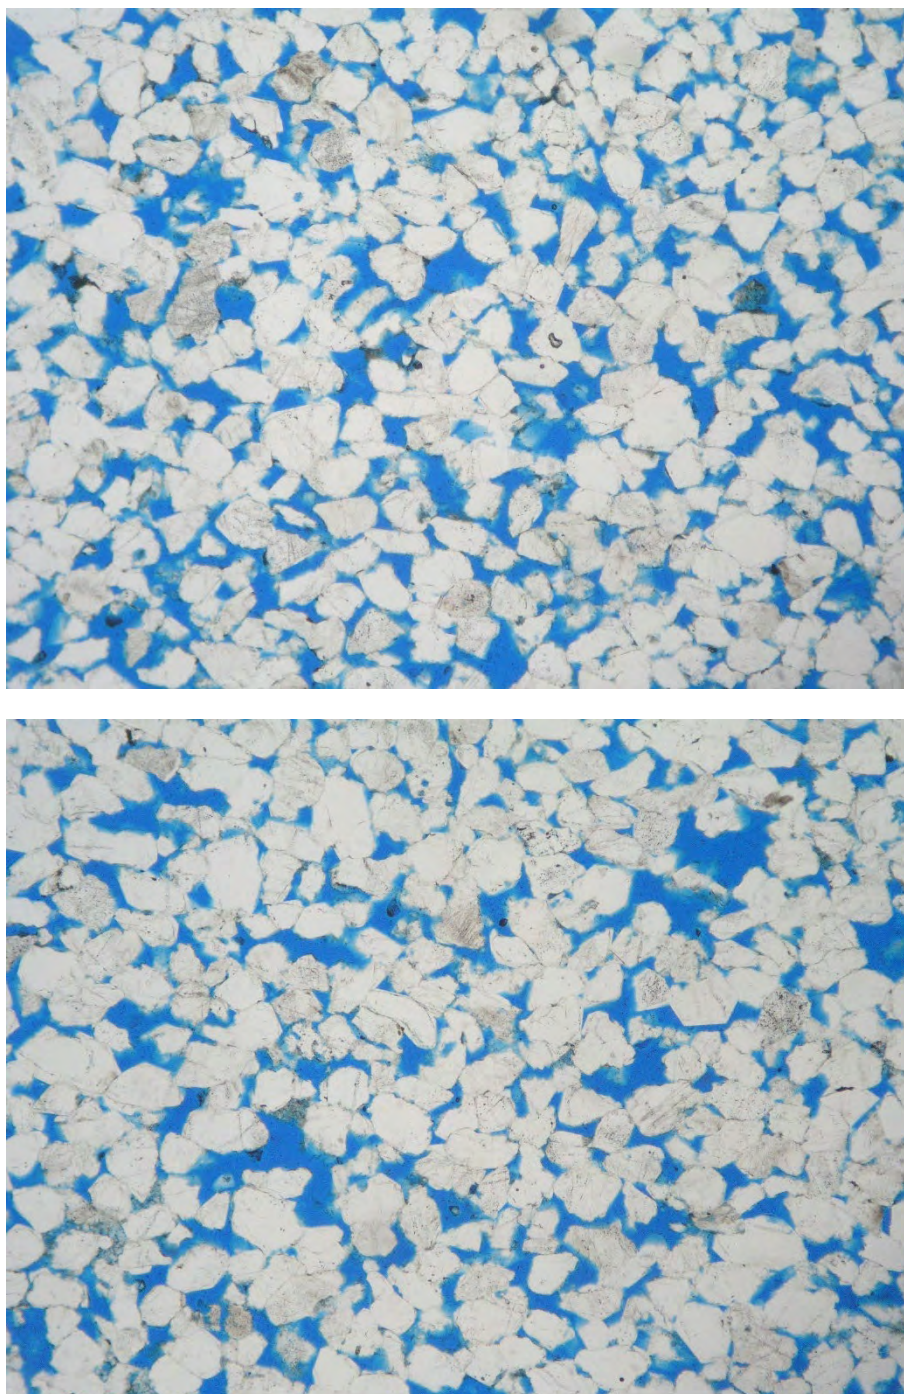
Figure 2. Thin section photographs of sample ED12408. Grains of quartz appear white. Iron oxide particles (tiny in this case) appear black, and pore space appears blue. The images were taken in plane-polarised light, and the field of view is c. 3.3 mm wide.
