Corstorphine Connections – Phase 1 Stage 3 Road Safety Audit

City of Edinburgh Council

October 2023

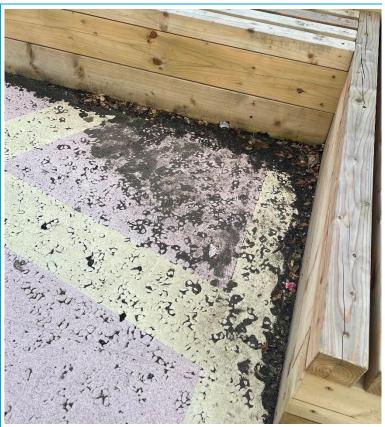
Problem:	3.1
Location(s):	Featherhall Crescent - at Meadow Place Road
Drawing(s):	60636731-SHT- C-P1-LTN-0701
Summary:	Evidence of surface water collection at pocket park.

Residual debris observed during the site visit indicates surface water collection at the pocket park on Featherhall Crescent. Surface water presents a slip and fall hazard to pedestrians and cyclists, particularly during periods of cold freezing weather when water can form ice.

3.1	Evidence of surface water collection at pocket park	positive (mended that drainage is vided.	accepted - remedy dra	noted and Contractor to sinage through p holes	Agree with designer		As per designer response

It is recommended that positive drainage is provided.

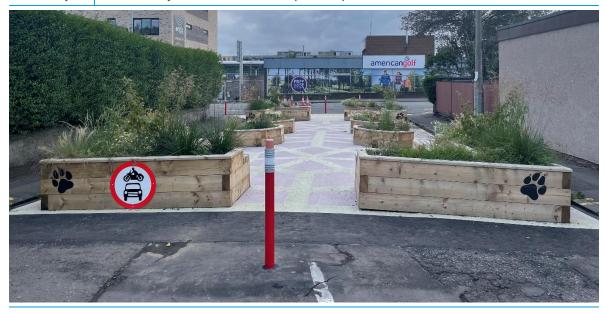
Summary: Accessibility constraints at the pocket park.

The pocket park installed at Featherhall Crescent is located within the former carriageway area, with footways retained on either side. As a result, full height kerbs separate the footways and pocket park which may impede access and egress for users with visual impairments and mobility assisting devices. Users who have been able to enter the pocket park, for example via the dropped kerbs at the junction of Featherhall Crescent at Meadow Place Road, may be unable to leave the former carriageway and re-join the footway, inadvertently entering the carriageway in conflict with other road users. Additionally, the full height kerbs increase the likelihood of users suffering injury from trips and falls.

3.2	Accessibility constraints at the pocket park	step free provided b pocket park	mended that e access is between the and adjacent tways.	scope or b	not within the udget for the project	Agree with designer this aspect wasn't within the in scope for this phase of works. There are also dropped kerbs at either end of the pocket park. However we will consider implementing dropped kerb access if the scheme becomes permanent.		As per overseeing organisation response

It is recommended that step free access is provided between the pocket park and adjacent footways.

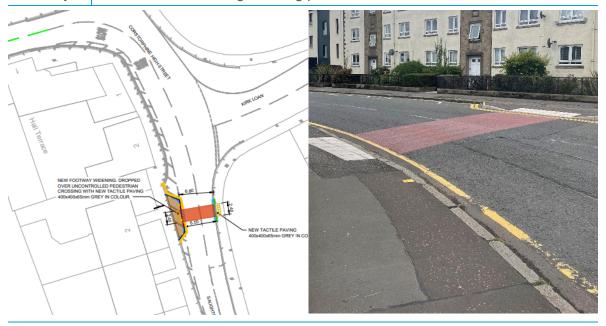
Summary: Risk of vehicles striking crossing pedestrians.

During the site visit it was observed that the wide junction layout at Kirk Loan and Saughton Road North enables vehicles to turn left onto Saughton Road North at high speeds. Furthermore, drivers were generally observed to be looking right for oncoming vehicles. As a result, there is a risk that drivers exiting Kirk Loan may not see pedestrians crossing at the new uncontrolled facility on Saughton Road North, south of Kirk Loan. This increases the risk of pedestrians being struck, and of rear end shunt collisions due to sudden braking.

3.5	Risk of vehicles striking crossing pedestrians.	measures are installed to	Problem noted and accepted - as part of the Phase 2 works, this junction is to be narrowed and carriageway radii tightened to slow vehicles	Agree with designer	As per designer response

It is recommended that measures are installed to slow vehicles exiting Kirk Loan.

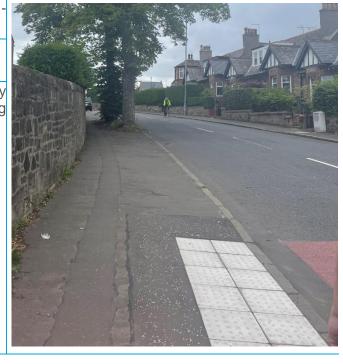
Problem:	3.7
	Location(s):	Saughton Road North north of Dovecot Road
	Drawing(s):	60636731-SHT-C-P1- LTN-0705
	Summary:	Insufficient visibility may result in pedestrians being struck whilst crossing.

Due to the geometry of Saughton Road North and the trees located on the western footway, visibility of southbound vehicles approaching the uncontrolled crossing facility from the western footway is limited. The RSA team noted during the site visit that pedestrians are unable to see vehicles exiting Corstorphine Park Gardens. Insufficient visibility to/from the crossing facility increases the risk of pedestrians being struck. The risk is exacerbated due to the downhill approach to the crossing which may lead to increased vehicle speeds.

3.7	Insufficient visibility may result in pedestrians being struck whilst crossing.	It is recommended that sufficient visibility is provided at the crossing facility.	The visibility splay of this crossing location is in accordance with the Stopping Sight Distance (SSD) for a 20mph road (Designing Streets) (minimum requirement is 23m - over 30m length)	Agree with designer	As per designer response

It is recommended that sufficient visibility is provided at the crossing facility.

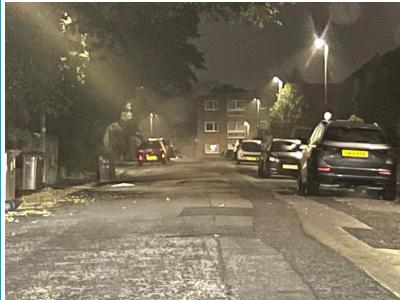
Summary: Inconspicuous speed cushions could result in road user injury.

Speed cushions have been installed along Dovecot Road with dragon teeth markings provided on each cushion in one direction. It is appreciated that the positioning of the markings is relative to the direction of travel, however it was observed that the absence of markings in both directions reduces visibility of the traffic calming features, particularly during the hours of darkness. This presents a risk to road users, especially those on two wheeled vehicles, who may inadvertently be unsteadied by the cushions and fall.

This risk is exacerbated for eastbound road users where only the nearside speed cushion has a dragon tooth marking as this could be obstructed by a parked vehicle and require road users to position themselves centrally.

3.8	Inconspicuous speed cushions could result in road user injury.	markings are installed to	Problem noted and accepted - speed cushions to have dragon teeth markings installed on both sides where applicable	Agree with designer	As per designer response

It is recommended that markings are installed to make road users aware of the speed cushions installed.

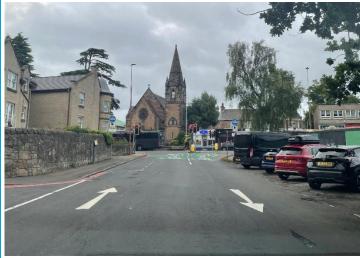
Problem:	3.9
Location(s):	Manse Road - at St John's Road
Drawing(s):	60636731-SHT-C- P1-LTN-0707
Summary:	Driver confusion over intended lane operation.

Whilst it is appreciated road markings have been installed to indicate two-way traffic flows south of the Manse Road and St John's Road junction, there is a lack of clarity as to the intended start/end of the two-way and one-way systems in place. During the site visit, northbound vehicles were observed using both the northbound and southbound lanes on approach to the junction of Manse Road and St John's Road. This could result in vehicle collisions, especially with vehicles exiting the echelon parking bays as visibility is likely to be restricted.

Furthermore, the uncertainty of the commencement and termination of the one-way and two-way systems may result in queuing vehicles at the junction obstructing the southbound lane. This presents a risk to vehicles exiting the car park north of Iceland, who may be forced to utilise the nearside lane, giving rise to collisions with oncoming road users.

3.9	Driver confusion over intended lane operation.	It is recommended that measures are installed to clarify the intended operation of the lanes between St John's Road and Featherhall Terrace in line with the one-way and two-way traffic systems in place.	Problem noted and accepted - further measures have since been introduced to highlighted intended start / end of two-way operation	Agree with designer	As per designer response

It is recommended that measures are installed to clarify the intended operation of the lanes between St John's Road and Featherhall Terrace in line with the one-way and two-way traffic systems in place.

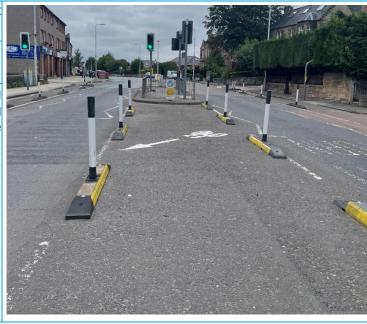
Problem:	3.11
Location(s):	St John's Road – at Featherhall Avenue
Drawing(s):	60636731-SHT-C- P1-LTN-0708
Summary:	Risk of cyclists being struck whilst moving across the carriageway.

It is anticipated that cyclists travelling eastbound on St John's Road will be positioned on the nearside of the carriageway. Cyclists in this position seeking to turn right would be required to cross general traffic. St John's Road is regularly busy as it forms part of the arterial route to / from Edinburgh City Centre. Therefore, the availability of acceptable gaps in traffic to cross into the central right turn area will be limited. There is a risk that cyclists may attempt to cross during shorter gaps in traffic, increasing the risk of collisions. In addition, cyclists may swerve across free-flowing traffic to reach the right turn facility, again potentially resulting in collision. The risks are exacerbated as cyclists would need to be looking immediately behind them to observe opposing traffic.

3.11	Risk of cyclists being struck whilst moving across the carriageway.	It is recommended that measures are installed to better enable cyclists to transition from the secondary position into the right turn facility.	In its current operation, cyclists are already required to move from secondary position on St John's Road given the positioning of the widened footway. Cyclists are also given advanced warning through the "no right turn except cycles" sign on approach to the traffic signals. This gives them prior warning they should be in primary position on approach.	Agree with designer	As per designer response

It is recommended that measures are installed to better enable cyclists to transition from the secondary position into the right turn facility.

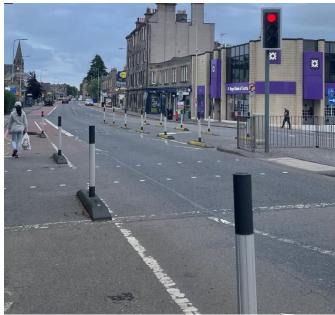
3.12
Location(s):	St John's Road – at Featherhall Avenue
Drawing(s):	60636731-SHT-C-P1- LTN-0708
Summary:	Risk of cyclists being struck from the rear by vehicles.

The scheme enables cycles to turn right from St John's Road into Featherhall Avenue via a right turn facility enclosed by temporary kerbs. To enter the right turn facility cyclists would need to manoeuvre through gaps in the temporary kerbs. To do so cyclists, particularly riding in the primary (central lane) position would need to slow markedly to safely transition from the carriageway into the right turn facility. This would create a differential in speed between right turning cyclists and traffic going ahead. There is a risk that a following driver, not anticipating the cyclist to slow, may not adjust their speed sufficiently, potentially resulting in rear shunt collision.

The risk is exacerbated by the lack of advanced signage for both user groups.

3.12	Risk of cyclists being struck from the rear by vehicles.	It is recommended that the measures are adjusted to reduce speed differential between cycles and vehicles. It is also recommended advanced signage is provided to inform both cyclist and drivers of the cycle right turn facility.	As highlighted aboved, cycles and motor vehicles are given advanced warning of right turn provision for cycles with the "no right turn except cycles" sign on approach to traffic signals. This layout has been tracked for cargo bikes and is anticipated to operate as per any right turn for cyclists into a side road, albeit with additional protection. Slow markings could also be considered as another mitigation.	Agree with designer, slow marking to be added	Slow marking to be added

It is recommended that the measures are adjusted to reduce speed differential between cycles and vehicles. It is also recommended advanced signage is provided to inform both cyclist and drivers of the cycle right turn facility.

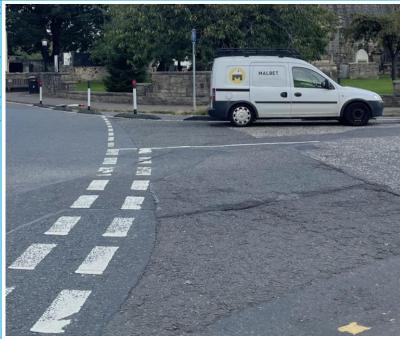
Summary: Temporary kerb layout may impede crossing users.

During the second site visit, the RSA team observed a pedestrian with a pram crossing from south to north, having difficulties negotiating the temporary kerbs due to their narrow spacing. The restricted gap between the kerbs increases the risk of pedestrians with prams and wheelchairs being unable to egress from the carriageway onto the footway. This may give rise to pedestrians travelling along the carriageway and being struck by vehicles entering Kirk Loan. This risk is exacerbated due to the absence of dropped kerbs as discussed in Problem 3.14.

Furthermore, the layout of the temporary kerbs in line with the pedestrian desire line increases the likelihood of pedestrians suffering injury from trips and falls.

It is recommended that the temporary kerb layout is amended to accommodate all pedestrian users.
