**Corstorphine Connections – Phase 2**  
Stage 1 and 2 Road Safety Audit  
City of Edinburgh Council

September 2023

Report Title	Corstorphine Connections – Phase 2 Stage 1 and 2 Road Safety Audit
Date:	September 2023
Document Reference and Revision:	8003-676
Prepared by:	Atkins
Overseeing Organisation:	City of Edinburgh Council

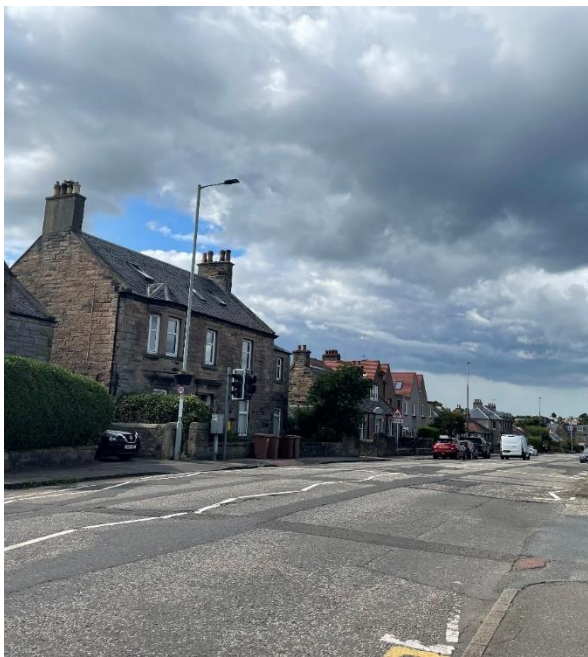
<b>Problem:</b>	3.1
<b>Location(s):</b>	Scheme extents
<b>Drawing(s):</b>	60636731-SHT-C-P2-LTN-0701 to 60636731-SHT-C-P2-LTN-0706
<b>Summary:</b>	Worn road markings may give rise to unplanned driver behaviours.

Example of worn markings at Saughton Road North

The worn markings increase the likelihood of drivers failing to give way, not moderating speed, obstructing junctions and other users by stopping/parking at adverse locations. These behaviours increase the likelihood of vehicle conflicts and collisions.

It is recommended that worn road markings are refreshed across the scheme extents.

3.1	Worn road markings may give rise to unplanned driver behaviours.	It is recommended that worn road markings are refreshed across the scheme extents.	Problem noted and accepted. Design proposals show locations where existing road markings are affected by our works and will be renewed. Any wider road markings not directly affected by the scheme are not within the scope / budget of the project.	As per design organisation's response	Noted for consideration under future schemes

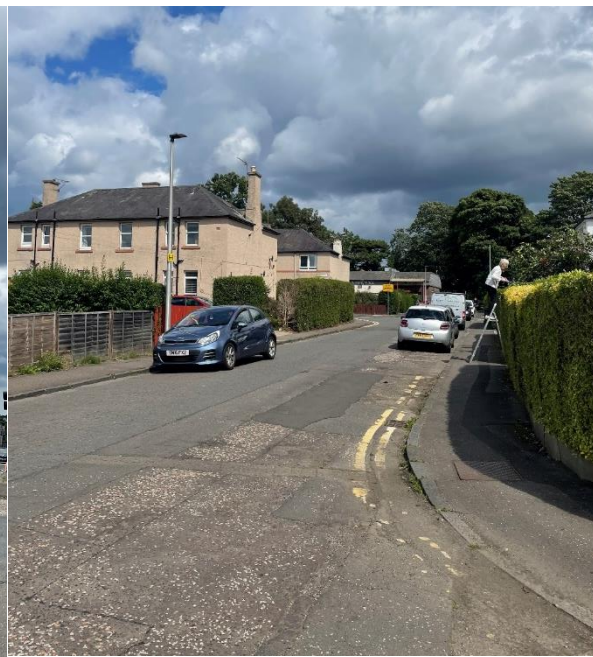
Example of worn markings at Featherhall Road and Featherhall Terrace

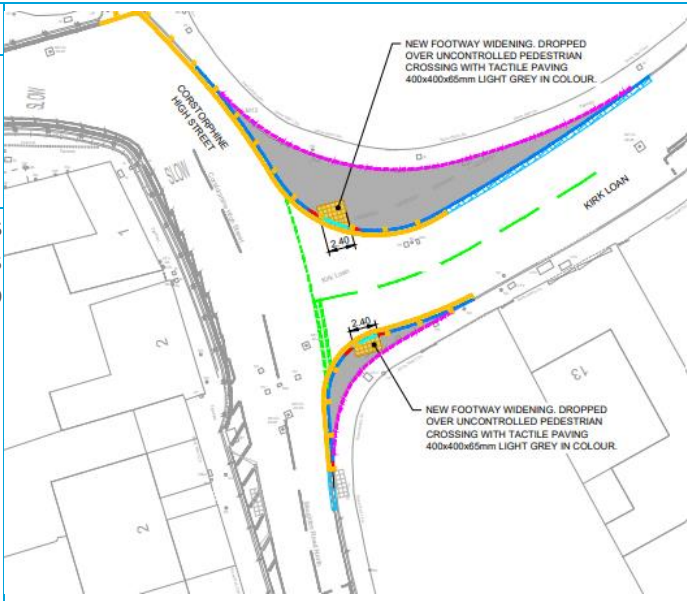
<b>Problem:</b>	<b>3.2</b>
<b>Location(s):</b>	Scheme extents
<b>Drawing(s):</b>	60636731-SHT-C-P2-LTN-0701 to 60636731-SHT-C-P2-LTN-0706
<b>Summary:</b>	Risk of collisions resulting from vehicles being unable to simultaneously manoeuvre.

The existing carriageway geometry is to be amended at several junctions where footway widening, and buildouts are proposed. The reduced junction and carriageway widths may be unable to accommodate all vehicle manoeuvres without encroaching adjacent running lanes and footways. This increases the likelihood of side impact or head-on collisions.

It is recommended that all anticipated vehicle manoeuvres can be safely accommodated.

3.2	Risk of collisions resulting from vehicles being unable to simultaneously manoeuvre.	It is recommended that all anticipated vehicle manoeuvres can be safely accommodated.	All junction modifications have had swept path analysis undertaken to determine radius / widths.	As per design organisation's response	No action

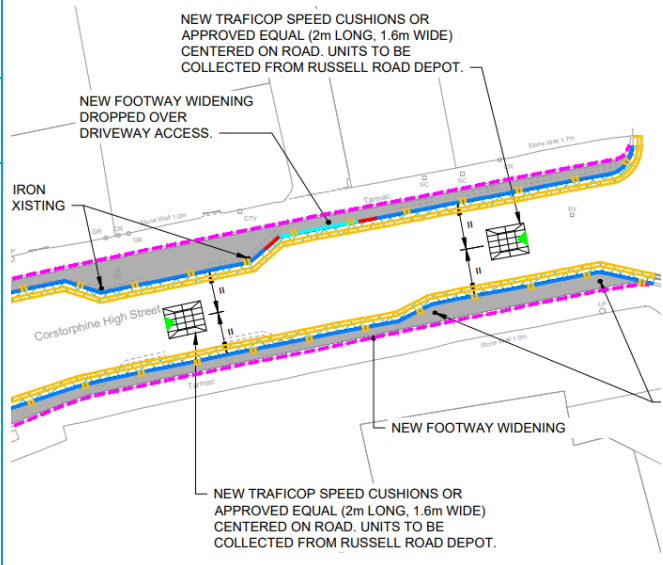
<b>Problem:</b>	<b>3.3</b>
<b>Location(s):</b>	Corstorphine High Street, priority one-way working
<b>Drawing(s):</b>	60636731-SHT-C-P2-LTN-0701
<b>Summary:</b>	Inconspicuous speed cushions could result in road user injury.

Two speed cushions are proposed on Corstorphine High Street at the priority one-way working between Ladywell Avenue and Corstorphine Primary School. The proposals indicate the provision of only one triangle marking on each speed cushion. The absence of triangle markings/dragon teeth in both directions could reduce driver visibility of the traffic calming features, particularly during the hours of darkness. This presents a risk to road users, especially those on two wheeled vehicles, who may be unsteadied and fall.

It is recommended that dragon teeth are installed on both approaches to the speed cushions.

3.3	Inconspicuous speed cushions could result in road user injury.	It is recommended that dragon teeth are installed on both approaches to the speed cushions.	Problem noted and accepted - dragon teeth to be added on all approaches to speed cushions	As per design organisation's response	Dragon teeth to be added on all approaches to speed cushions

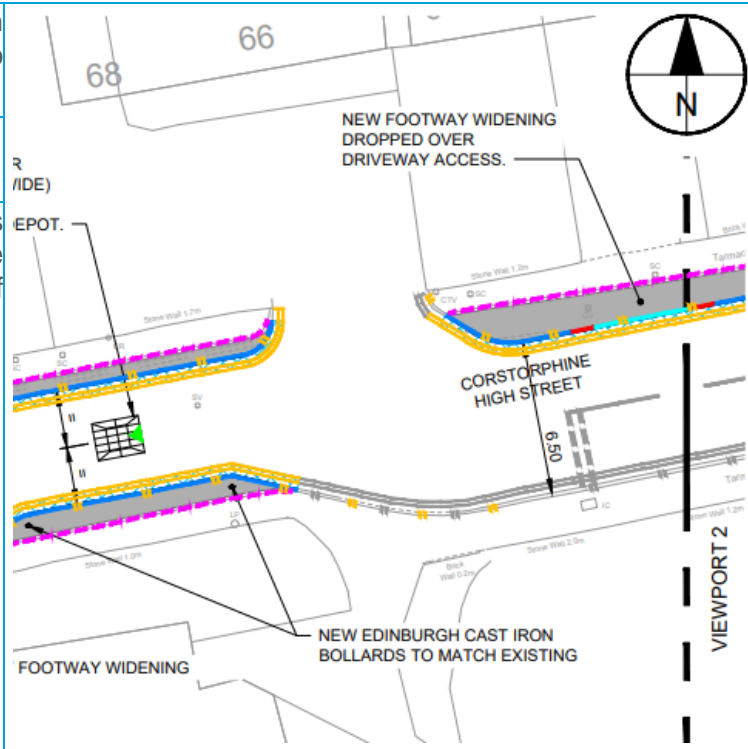
**Summary:** Risk of pedestrians suffering injury due to the absence of tactile paving.

The plans do not indicate the provision of tactile paving at the access to house number 66. The absence of tactile paving, which warns users they are transitioning from footway to carriageway and vice versa presents a risk to pedestrians, particularly those with visual impairments who may inadvertently enter the carriageway and be struck by passing vehicles.

It is recommended that tactile paving is provided.

3.4	Risk of pedestrians suffering injury due to the absence of tactile paving.	It is recommended that tactile paving is provided.	Agreed. This was not originally within the scope or budget of the project. Recommend this is considered at future phase.	As per design organisation's response	Noted for consideration under future schemes

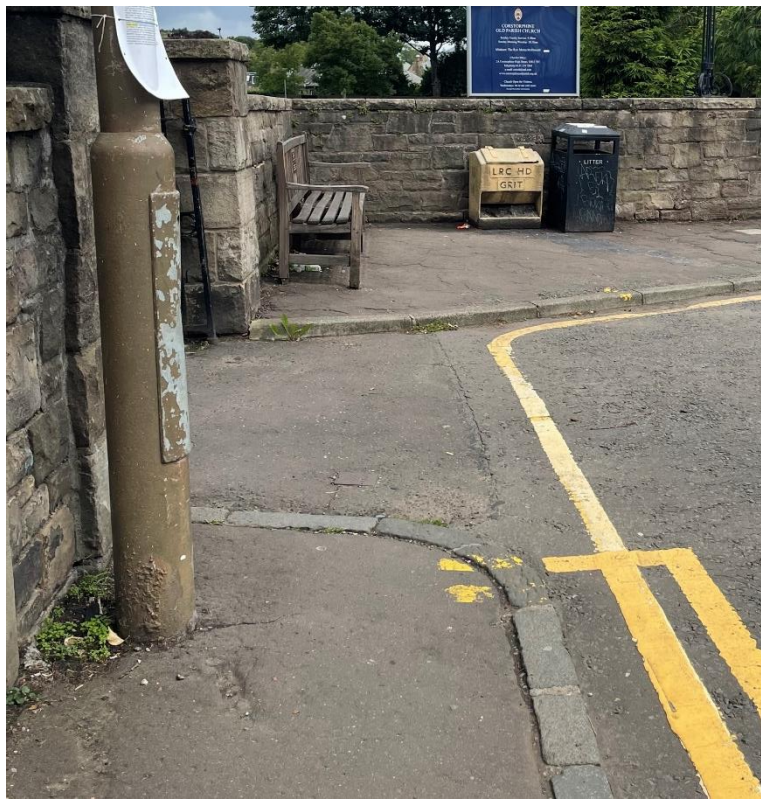
<b>Problem:</b>	<b>3.5</b>
<b>Location(s):</b>	Corstorphine High Street, access to the Church Hall
<b>Drawing(s):</b>	60636731-SHT-C-P2-LTN-0702
<b>Summary:</b>	Risk of pedestrians suffering injury due to the absence of dropped kerbs.

The proposals do not indicate the provision of dropped kerbs, or tactile paving, at the access to the Church Hall at Corstorphine High Street. The absence of dropped kerbs increases the likelihood of pedestrians tripping and falling over full height kerbs and impedes accessibility for pedestrians travelling with wheeled devices.

It is recommended that dropped kerbs and tactile paving are provided.

3.5	Risk of pedestrians suffering injury due to the absence of dropped kerbs.	It is recommended that dropped kerbs and tactile paving are provided.	Problem noted and accepted - consideration to be made to widen footway / accommodate dropped kerbs and tactile paving.	As per design organisation's response	Consideration to be given to widening footway

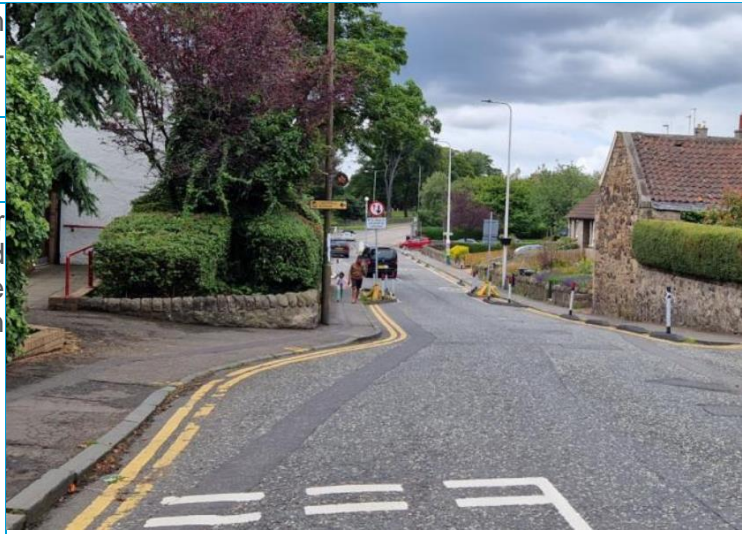
<b>Problem:</b>	<b>3.6</b>
<b>Location(s):</b>	Corstorphine High Street, priority one-way working
<b>Drawing(s):</b>	60636731-SHT-C-P2-LTN-0701
<b>Summary:</b>	Risk of driver confusion and drivers failing to give way resulting in collisions.

The existing give way sign associated with the priority one-way working between Ladywell Avenue and Corstorphine Primary School is located west of the give way road markings. During the site visit, a vehicle was observed giving way to eastbound traffic at the signage location and not at the road markings where the carriageway is wider to accommodate two-way traffic flows. The distance between the road markings and signage may confuse drivers as to the intended operation of the priority system and increases the risk of collisions should vehicles fail to give way at the location intended.

It is recommended that the give way signage is relocated closer to the give way markings.

3.6	Risk of driver confusion and drivers failing to give way resulting in collisions.	It is recommended that the give way signage is relocated closer to the give way markings.	Problem noted and accepted - give way signage to be installed closer to markings	As per design organisation's response	Give way signage to be installed closer to markings

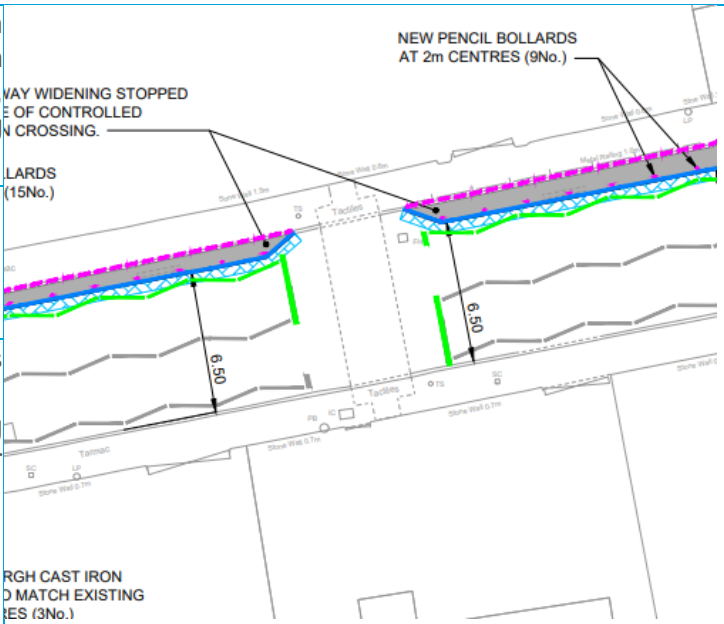
<b>Problem:</b>	<b>3.7</b>
<b>Location(s):</b>	Corstorphine High Street and Saughton Road North, signalised crossing facilities
<b>Drawing(s):</b>	60636731-SHT-C-P2-LTN-0701 and 60636731-SHT-C-P2-LTN-0703
<b>Summary:</b>	Risk of pedestrians accessing/egressing from the crossing facilities tripping over kerbs.

Footway widening is proposed on the north footway at Corstorphine High Street and east footway at Saughton Road North. The proposals indicate that the widened footways will taper into the existing kerb lines at the signalised crossing facilities. The tapered kerbs pose a trip hazard to pedestrians transitioning to/from the crossing facilities and to those travelling along the widened areas of footway.

It is recommended that a consistent kerb alignment is provided.

3.7	Risk of pedestrians accessing/egressing from the crossing facilities tripping over kerbs.	It is recommended that a consistent kerb alignment is provided.	Bollards are proposed on the west side and guardrail has been proposed on the east side which will both help to delineate the path edge. A new signalised crossing was not within the scope or budget of the project.	As per design organisation's response	Bollards to be added

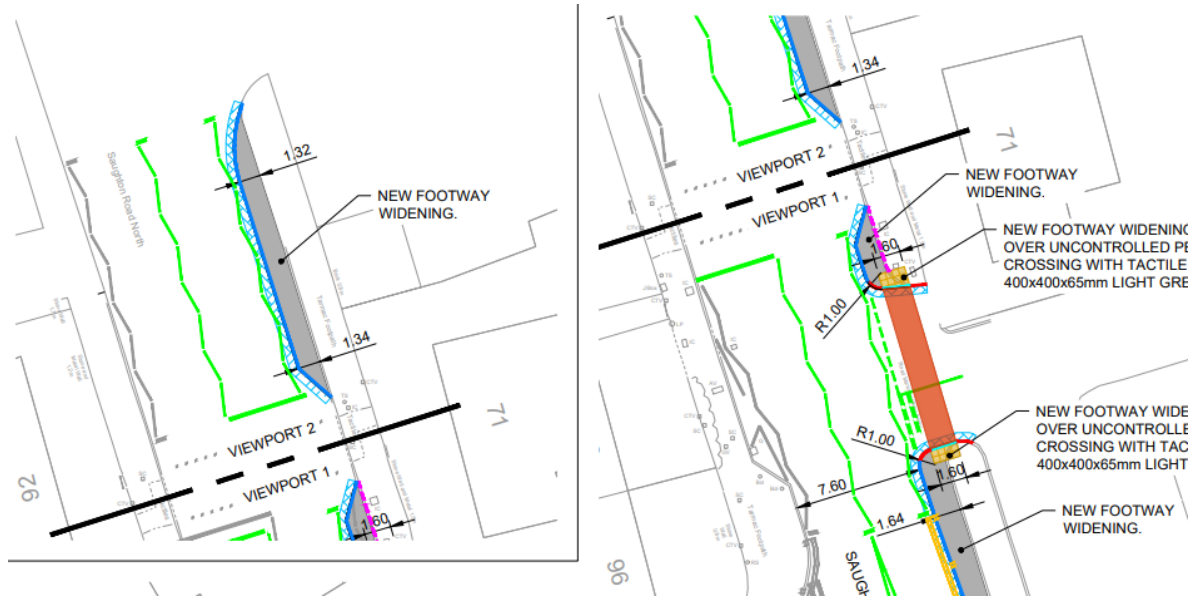
<b>Problem:</b>	<b>3.8</b>
<b>Location(s):</b>	Corstorphine High Street and Saughton Road North, signalised crossing facilities
<b>Drawing(s):</b>	60636731-SHT-C-P2-LTN-0701 and 60636731-SHT-C-P2-LTN-0703
<b>Summary:</b>	Risk of pedestrians being struck by passing vehicles at the crossing facilities.

It is anticipated that the varying kerb lines between the approaches to the crossing facilities and the existing kerb lines to be retained at the crossing frontiers will give rise to pedestrians waiting on the carriageway for the crossing to activate. This increases the likelihood of pedestrians being struck by vehicles.

It is recommended that sufficient space is provided for pedestrians to congregate and pass one another on the footway, without needing to step on the carriageway.

3.8	Risk of pedestrians being struck by passing vehicles at the crossing facilities.	It is recommended that sufficient space is provided for pedestrians to congregate and pass one another on the footway, without needing to step on the carriageway.	A new signalised crossing was not within the scope or budget of the project. Site observations to be undertaken during school times to understand how the crossings are used.	As per design organisation's response	Site observations to be undertaken

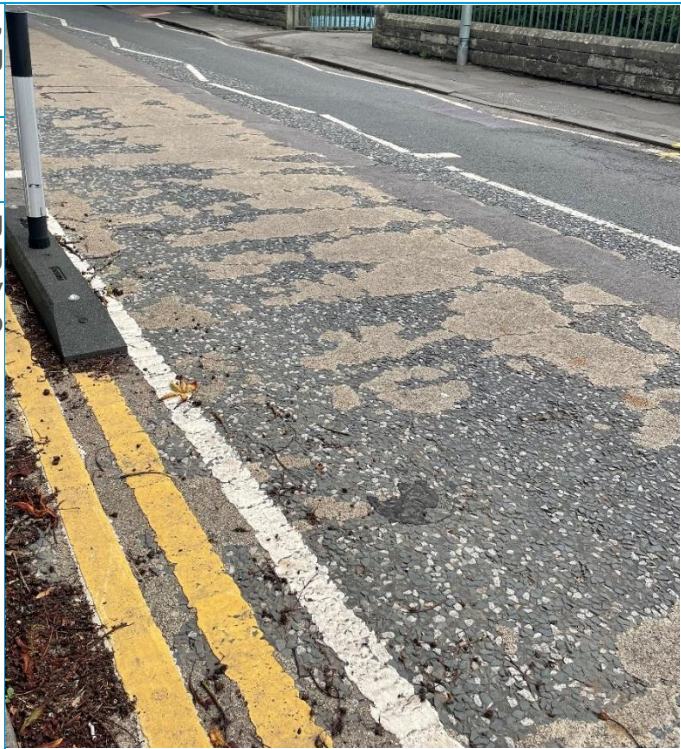
<b>Problem:</b>	<b>3.9</b>
<b>Location(s):</b>	Corstorphine High Street, signalised crossing facility
<b>Drawing(s):</b>	60636731-SHT-C-P2-LTN-0701
<b>Summary:</b>	Risk of pedestrians being stuck at the crossing facility or secondary collision resulting due to vehicles failing to stop.

It was observed during the site visit that the existing high friction surfacing at the signalised crossing facility on Corstorphine High Street is very worn. The worn surfacing could be an indication of frequent heavy braking as vehicles act upon a red traffic signal at this location. It is unlikely that the high friction surfacing is currently operating as intended due to its worn condition. This increases the likelihood of vehicles being unable to stop or act upon a red signal in time. This increases the likelihood of:

It is recommended that the high friction surfacing is replaced.

3.9	Risk of pedestrians being stuck at the crossing facility or secondary collision resulting due to vehicles failing to stop.	It is recommended that the high friction surfacing is replaced.	No changes have been made to the crossing or associated carriageway as part of the scope of the project. It is understood the existing HFS is >15 years old and historic. The road is currently a 20mph speed limit and Edinburgh Council Street Design guidance does not require stand along crossings to be HFS on approach.	As per design organisation's response	Noted for consideration under future schemes

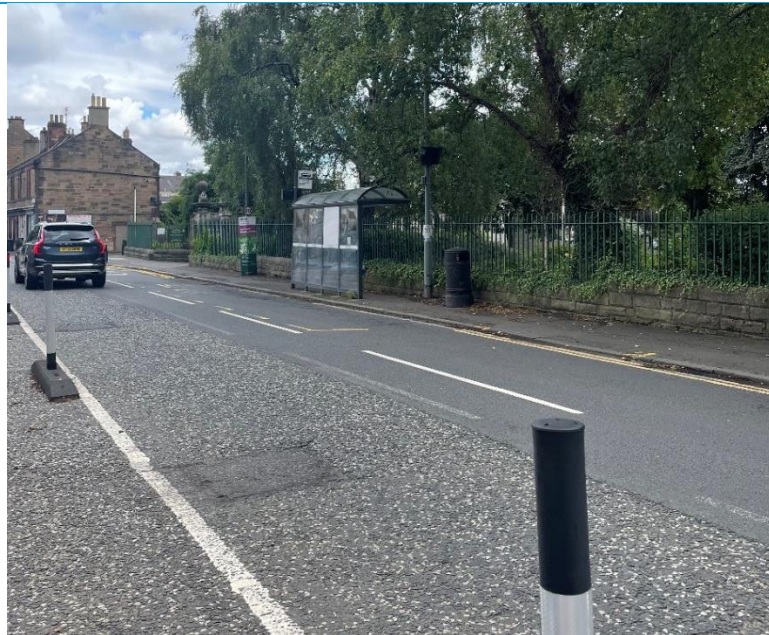
**Summary:** Constrained footway may give rise to pedestrian travelling along the carriageway.

The footway on the south side of Corstorphine High Street appears narrow for the pedestrian levels observed. It is further constrained by a bus shelter and bin located adjacent to St Margaret’s Park, where a pedestrian was observed struggling to pass with a walking frame. Insufficient footway width increases the risk of pedestrians stepping into the carriageway to pass other users and/or avoid street furniture. This could lead to pedestrians being stuck by oncoming vehicles.

It is recommended that the footway is sufficiently wide to accommodate all user types and volumes anticipated to use the footway.

3.10	Constrained footway may give rise to pedestrian travelling along the carriageway.	It is recommended that the footway is sufficiently wide to accommodate all user types and volumes anticipated to use the footway.	The footway on the south side of the High Street was not part of the project scope.	As per design organisation's response, it can be considered as part of future schemes	Noted for consideration under future schemes

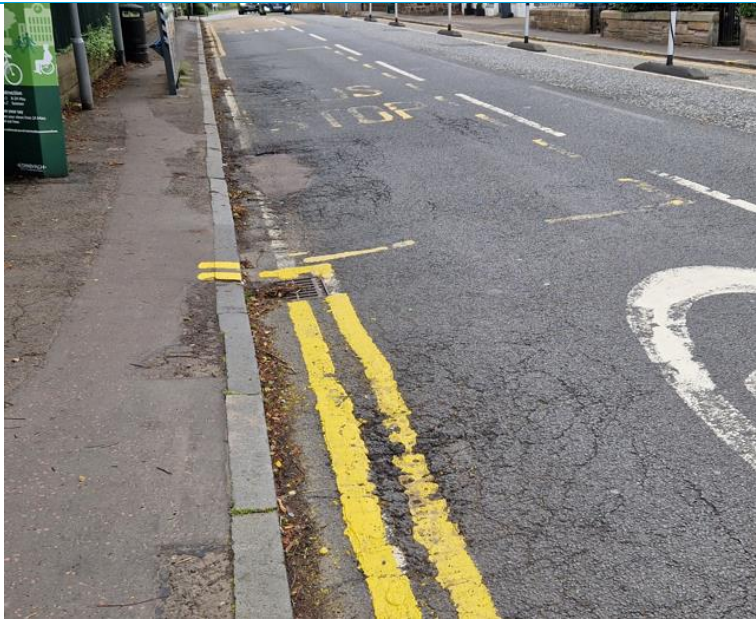
<b>Problem:</b>	<b>3.11</b>
<b>Location(s):</b>	Corstorphine High Street, westbound carriageway
<b>Drawing(s):</b>	60636731-SHT-C-P2-LTN-0701
<b>Summary:</b>	Defective carriageway surface could be unsteady for two-wheeled vehicles

The westbound carriageway surface at Corstorphine High Street looks comparatively newer than the eastbound carriageway, however several defects and cracks are present. The uneven surface presents a risk to cycles and motorcycles who may become unbalanced and suffer injury from falls. Additionally, broken and loose surface material increases the risk of vehicles skidding and secondary collisions occurring due to reduced tyre grip.

It is recommended that the carriageway is resurfaced.

3.11	Defective carriageway surface could unsteady two-wheeled vehicles	It is recommended that the carriageway is resurfaced.	Problem noted, however this is outwith the scope of the project and funding. Active Travel team to raise with relevant internal department for consideration.	As per design organisation's response	Active Travel team to raise with relevant internal department for consideration.

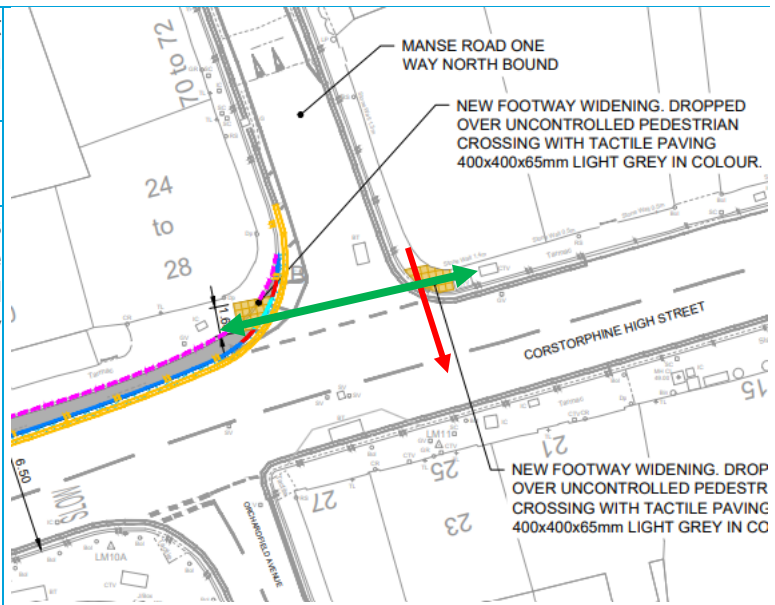
**Summary:** Risk of pedestrians entering the carriageway and being stuck by oncoming vehicles.

The tactile paving positioning relative to the radii of the junction could be interpreted in two ways. Pedestrians walking along Corstorphine High Street would be directed by the orientation of tactile paving across the side road correctly (indicated by the green arrow in the picture). However, those pedestrians walking along the Manse Road would also detect the tactile paving and crossing. In this case the tactiles would direct pedestrians across Corstorphine High Street, as indicated by the red arrow, where no connecting provision is provided. This increases the likelihood of pedestrian and vehicle collisions.

It is recommended that the tactile paving is realigned to better direct visually impaired pedestrians to the intended crossing facility.

3.12	Risk of pedestrians entering the carriageway and being stuck by oncoming vehicles.	It is recommended that the tactile paving is realigned to better direct visually impaired pedestrians to the intended crossing facility.	The footway on the north/east of the High Street is particularly narrow and the tactile layout provides the best balance of what is achievable at this constrained location. The tactile paving on the east side is set from the High Street kerbline and as such, it is intended that those with visual impairments will recognise the orientation of the tactile paving and cross in the intended direction.	As per design organisation's response	No action

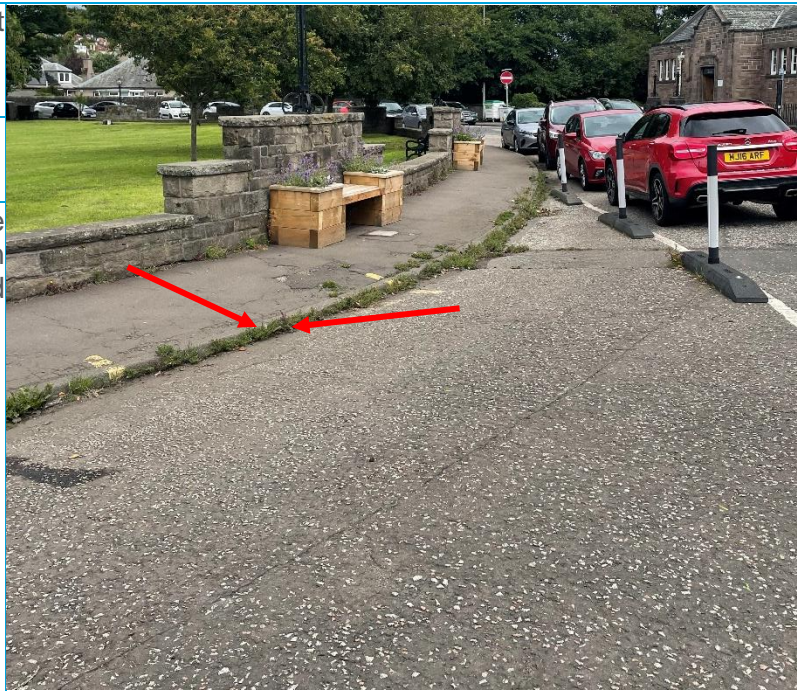
**Summary:** Risk of surface water collection at the proposed footway.

Footway buildouts are proposed at Kirk Loan at its junction with Corstorphine High Street. The current profile of the existing footways and carriageway where the buildouts are proposed look to form a channel, as illustrated above. There is therefore a risk that surface water may collect in these channels on the widened footways. This could form trip and slip hazards for pedestrians, particularly during periods of cold freezing weather.

It is recommended that sufficient drainage is provided.

3.13	Risk of surface water collection at the proposed footway	It is recommended that sufficient drainage is provided.	Drainage has been provided as part of the scheme. This has been monitored on site, during high rainfall periods and it has been noted that ponding does not occur on these channels.	As per design organisation's response	Drainage under assessment

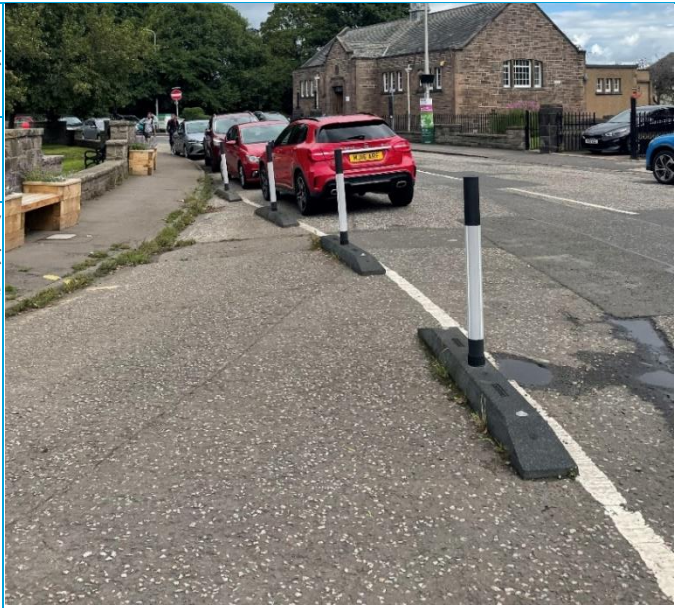
<b>Problem:</b>	<b>3.14</b>
<b>Location(s):</b>	Northside of pedestrian crossing on Kirk Loan, at Corstorphine High Street
<b>Drawing(s):</b>	60636731-SHT-C-P2-LTN-0702
<b>Summary:</b>	Insufficient intervisibility at the crossing may result in pedestrian and vehicle collisions.

It was noted during the site visit that intervisibility between pedestrians and approaching vehicles at Kirk Loan is obstructed by parked vehicles. There is a risk of crossing pedestrians entering the carriageway into the path of an oncoming vehicle and being struck. This risk is exacerbated for smaller pedestrians who may be completely obstructed by a parked vehicle.

It is recommended that sufficient visibility is provided at the crossing facility.

3.14	Insufficient intervisibility at the crossing may result in pedestrian and vehicle collisions.	It is recommended that sufficient visibility is provided at the crossing facility.	Visibility checked against 20mph SSD @ 25m. Confirm that southern crossing point is suitable, however, that the northern crossing point is sub-standard and a section of parking removal is recommended	Removal of this parking will be considered as part of a future permanent scheme. It is not within the powers of current ETRO trial to reduce waiting/loading provision at this location.	Noted for consideration under future schemes

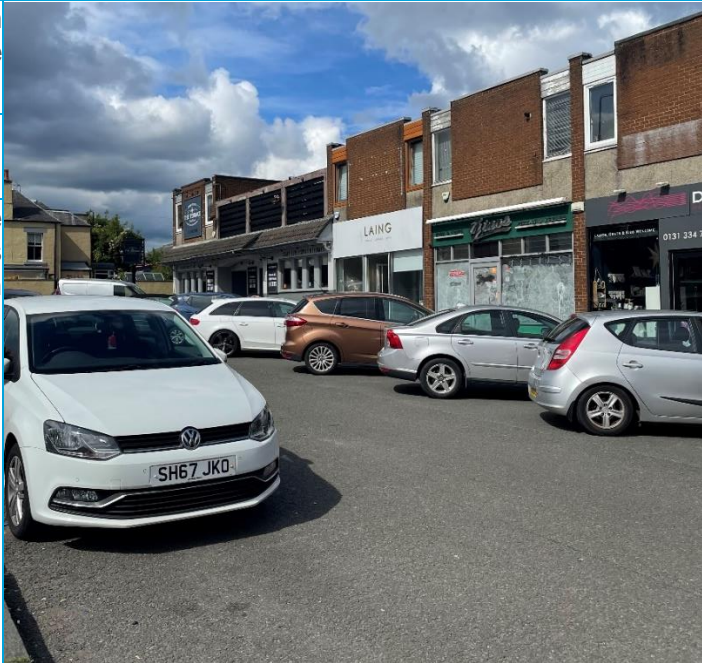
<b>Problem:</b>	<b>3.15</b>
<b>Location(s):</b>	Saughton Road North (east side), entrance and exit to the shops
<b>Drawing(s):</b>	60636731-SHT-C-P2-LTN-0703
<b>Summary:</b>	Risk of vehicle conflicts and collisions due to the introduction of two-way traffic.

It was observed during the site visit that the accesses to the minor road serving the shops located on the east side of Saughton Road North operates as a one-way, with vehicles entering to the north and exiting from the south. The plans indicate the installation of two-way give way markings at both accesses. It is anticipated that two-way vehicular traffic at these accesses and across the minor road will result in vehicle conflicts as drivers may not expect opposing movements. Additionally, the southern access is narrow, and vehicles were observed encroaching what would be the opposing running lane in order to manoeuvre out of the minor road. This could result in collisions.

It is recommended that the one-way system is formalised.

3.15	Risk of vehicle conflicts and collisions due to the introduction of two-way traffic.	It is recommended that the one-way system is formalised.	The operation of the car park has been maintained, with no changes as part of our proposals. Additionally, the car park is privately owned and no formal control of enforcement would be possible.	As per design organisation's response	No action

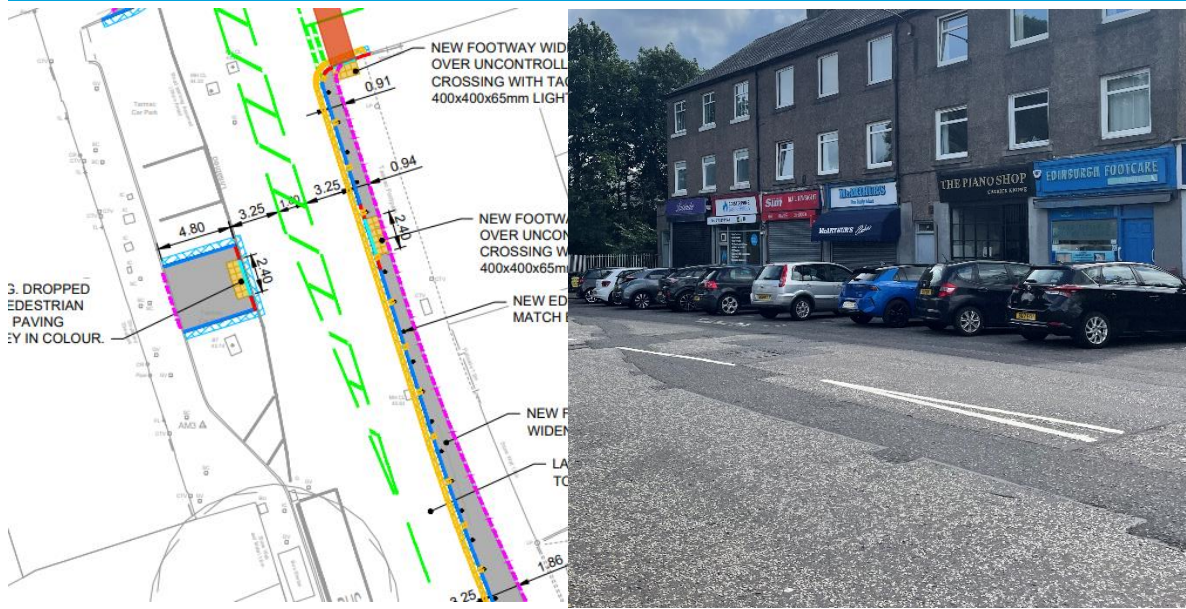
<b>Problem:</b>	<b>3.16</b>
<b>Location(s):</b>	Saughton Road North (west side), adjacent to shops
<b>Drawing(s):</b>	60636731-SHT-C-P2-LTN-0703
<b>Summary:</b>	Restricted visibility may result in crossing pedestrians being struck.

A buildout and uncontrolled crossing facility is proposed between the existing parking spaces located outside the shops on the west side of Saughton Road North. There is a risk that parked vehicles either side of the buildout will restrict intervisibility to/from the crossing for pedestrians and approaching vehicles. This increases the risk of pedestrians entering the carriageway into the path of an oncoming vehicle and being struck.

It is recommended that sufficient visibility is provided at the crossing facility.

3.16	Restricted visibility may result in crossing pedestrians being struck.	It is recommended that sufficient visibility is provided at the crossing facility	Visibility checked against 20mph SSD @ 25m. We confirm that both crossing points are suitable.	As per design organisation's response	No action

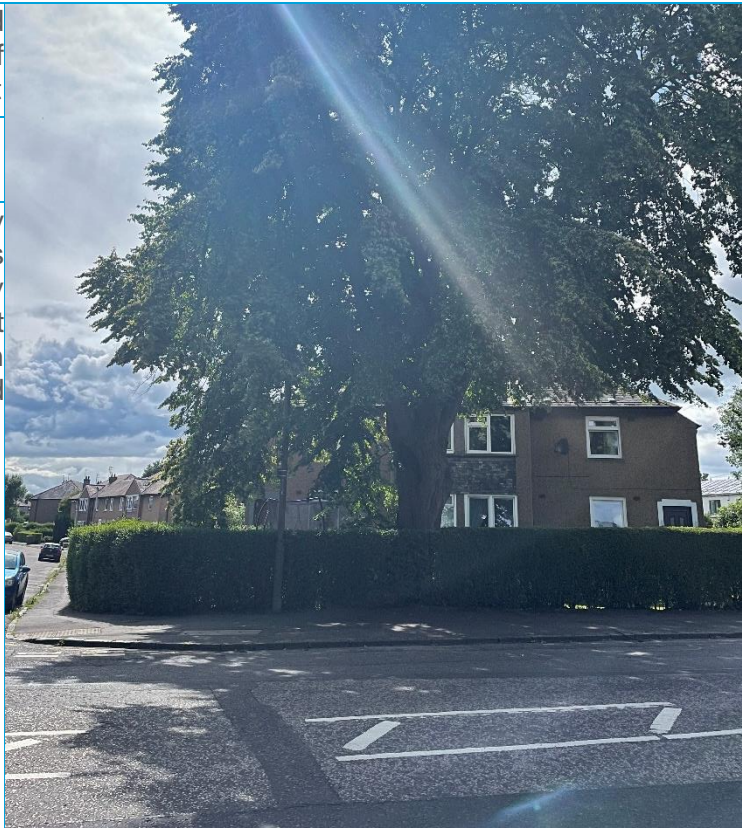
<b>Problem:</b>	<b>3.17</b>
<b>Location(s):</b>	Saughton Road North, north of Broomfield Crescent
<b>Drawing(s):</b>	60636731-SHT-C-P2-LTN-0703
<b>Summary:</b>	Tree canopy creating dark spots and potentially reducing street lighting illumination at the footway and crossing facility.

During the site visit it was observed that tree canopies on the west side of Saughton Road North were creating dark spots over the western footway and at the pedestrian refuge island north of Broomfield Crescent. As a result, pedestrians were difficult to see, and the reduced visibility increases the risk of pedestrians crossing at the refuge island being struck.

It is recommended that the tree canopies are cut back to ensure sufficient illumination is provided and to remove the dark spot observed.

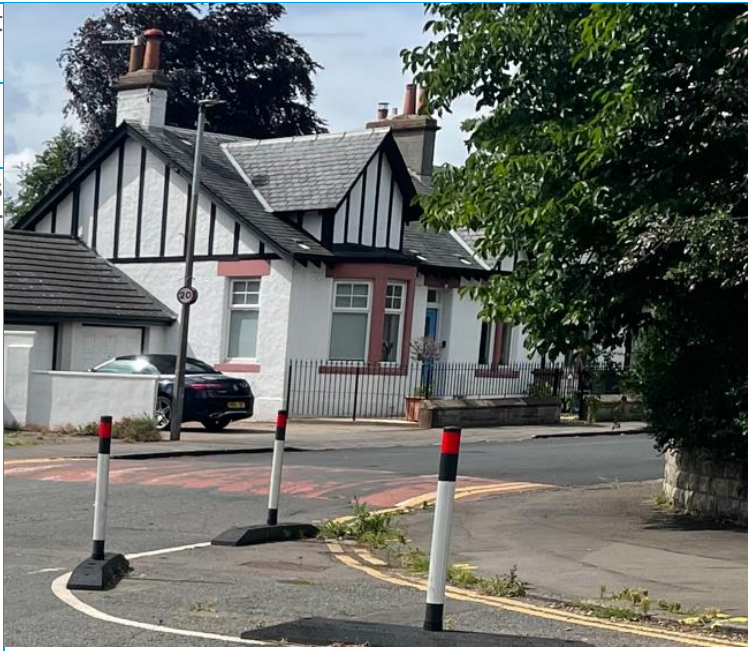
<b>Problem:</b>	<b>3.18</b>
<b>Location(s):</b>	Dovecot Road, at Ladywell Avenue
<b>Drawing(s):</b>	60636731-SHT-C-P2-LTN-0704
<b>Summary:</b>	Vegetation reduces visibility of and for crossing users.

Pedestrians crossing southwards at Dovecot Road have restricted visibility of vehicles travelling south on Ladywell Avenue due to vegetation around the junction. This increases the risk of pedestrians attempting to cross and vehicles entering Dovecot Road colliding due to poor intervisibility of one another.

It is recommended that the overgrown vegetation is removed.

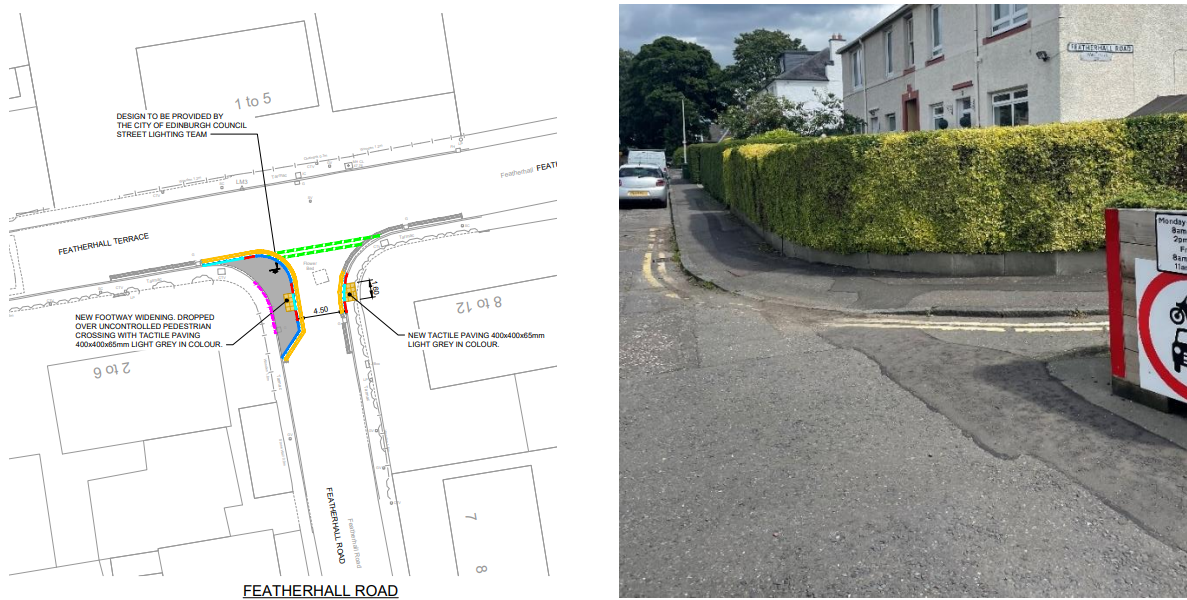
<b>Problem:</b>	<b>3.19</b>
<b>Location(s):</b>	Featherhall Road, at Featherhall Terrace
<b>Drawing(s):</b>	60636731-SHT-C-P2-LTN-0705
<b>Summary:</b>	Risk of vehicles colliding due to restricted visibility from the junction.

The buildout proposed at Featherhall Road, at its junction with Featherhall Terrace will locate northbound vehicles on the right side of the junction. As a result, driver intervisibility of vehicles approaching on Featherhall Terrace and of those exiting Featherhall Road is restricted by property lines and vegetation around the east side of the junction. This increases the risk of vehicles colliding whilst manoeuvring to and from the junction.

It is recommended that the proposed buildout is relocated to the east side of the junction to improve driver intervisibility.

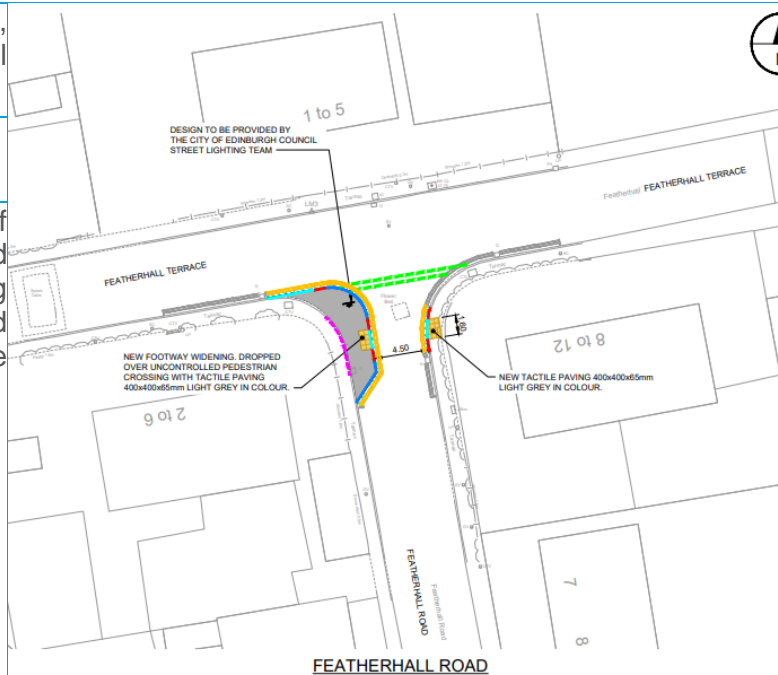
**Summary:** Risk of pedestrians and vehicles colliding due to restricted visibility from the junction.

The uncontrolled pedestrian crossing facility at Featherhall Road is proposed inset of the junction with Featherhall Terrace. In cognisance of Problem 3.22, the property boundaries and vegetation around the east side of the Featherhall Road and Featherhall Terrace junction obstruct intervisibility of pedestrians crossing from east to west and of vehicles approaching from Featherhall Terrace. This increases the risk of vehicles entering Featherhall Road striking pedestrian crossing the carriageway.

It is recommended that the proposed buildout is relocated to the east side of the junction to improve driver and pedestrian intervisibility.

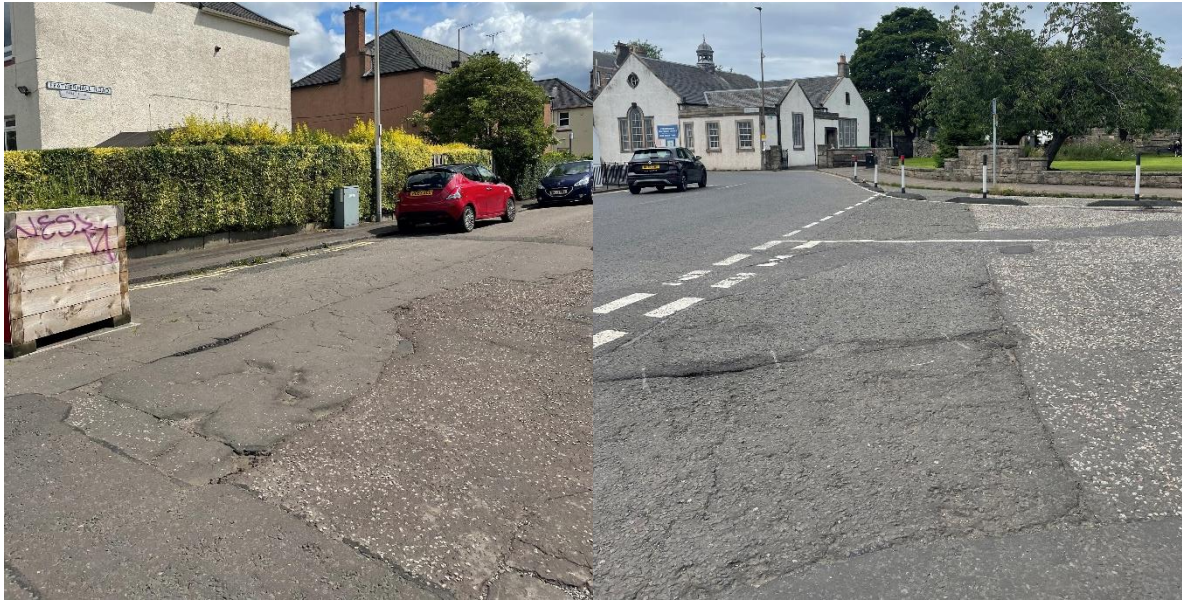
<b>Problem:</b>	3.21
<b>Location(s):</b>	Featherhall Road and Kirk Loan
<b>Drawing(s):</b>	60636731-SHT-C-P2-LTN-0703 and 60636731-SHT-C-P2-LTN-0705
<b>Summary:</b>	Risk of pedestrians tripping and falling in the carriageway.

Featherhall Road at Featherhall Terrace

Kirk Loan at Corstorphine High Street

The carriageway surfaces at the proposed uncontrolled pedestrian crossing facilities at Featherhall Road at Featherhall Terrace and Kirk Loan at Corstorphine High Street are uneven with several voids evident. These carriageway defects increase the likelihood of a crossing pedestrian tripping and suffering injury from falls.

It is recommended that the carriageway at the crossing locations are resurfaced.

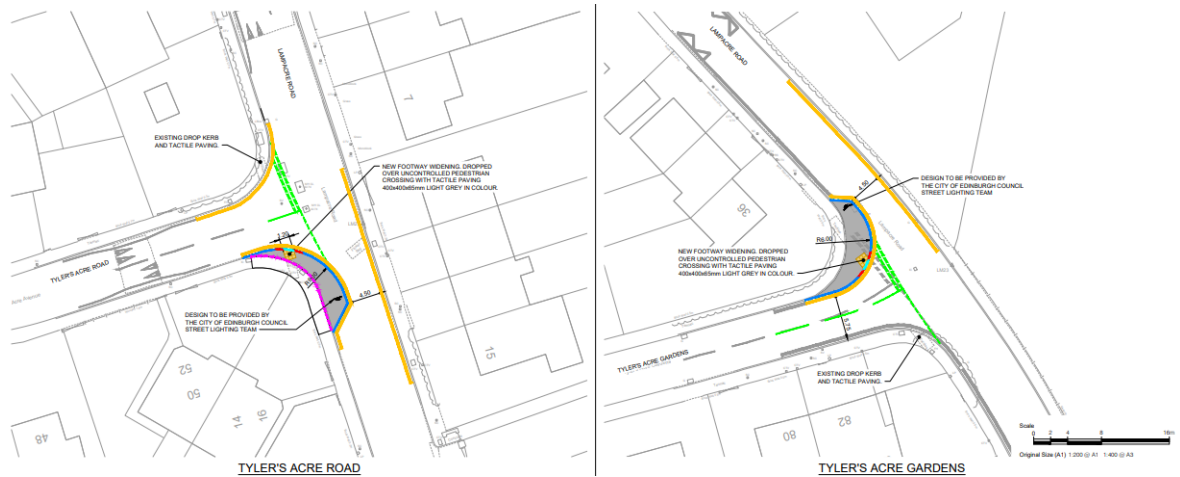
<b>Problem:</b>	<b>3.22</b>
<b>Location(s):</b>	Lampacre Road, at Tyler's Acre Road and Tyler's Acre Gardens
<b>Drawing(s):</b>	60636731-SHT-C-P2-LTN-0706
<b>Summary:</b>	Risk of side swipe collisions occurring as vehicles try to manoeuvre simultaneously.

Buildouts are proposed on Lampacre Road at its junctions with Tyler's Acre Road and Tyler's Acre Gardens, either side of Carrick Knowe Primary School. Opposing vehicles may attempt to pass one another at these locations as measures are not proposed to instruct one direction to give way to another. This increases the risk of side swipe collisions and of vehicles mounting the footway, potentially colliding with pedestrians, whilst taking evasive action.

It is recommended that a priority one-way working is installed on the approaches to the proposed buildouts.

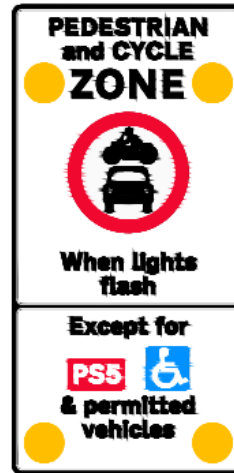
<b>Problem:</b>	<b>3.23</b>
<b>Location(s):</b>	Lampacre Road, at Carrick Knowe Primary School
<b>Drawing(s):</b>	60636731-SHT-C-P2-LTN-0706
<b>Summary:</b>	Risk of unpermitted vehicle movements occurring due to absent School Street signage.

It is recommended that an additional School Street sign is installed.
