**EDINBURGH TRAM YORK PLACE TO NEWHAVEN  
STAGE 3 ROAD SAFETY AUDIT RESPONSE REPORT**

PROJECT			ORIGIN			VOLUME			LEVEL		TYPE		ROLE		NUMBER				REV		
E	T	Y	N	S	E	F	X	X	X	0	3	R	P	D	0	0	9	2	P	0	1

November 2023

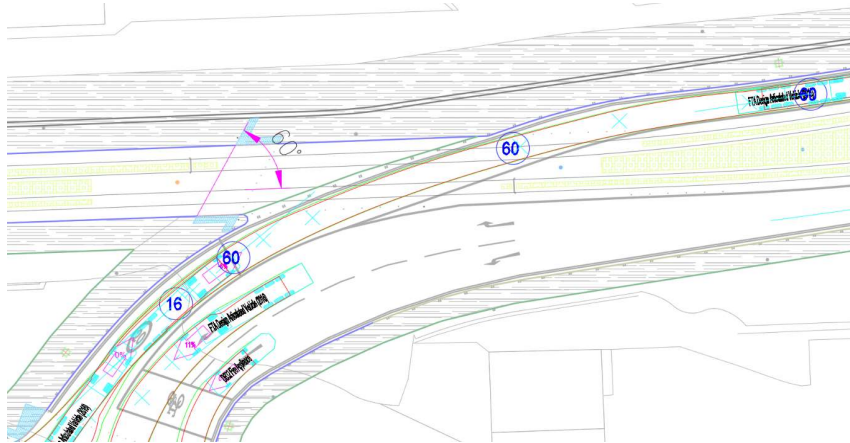
Figure 1 - Cycle Crossing at Newhaven

Throughout the scheme extents the design team have assessed the cycle crossings and confirm at no point do the cycle ways or cycle lanes, where provided, cross at an angle below 60 deg as per Figure 1.

The Audit Team note the Designer’s response comments, however there are still locations where cyclists can choose to travel and where there is a risk that they could cross the tram tracks at a very shallow angle and lose control as a result of a wheel entering the tram track. The above photo shows an example of this on Melrose Drive. The Audit Team retains the above recommendations.

It is recommended that appropriate measures are provided for turning cyclists, so that:

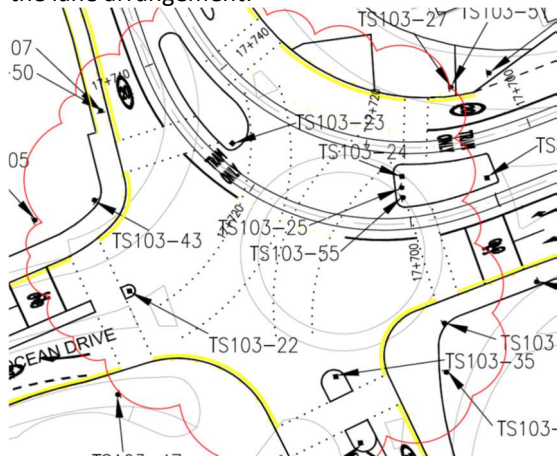
Figure 2 - Ocean Drive Road Markings

The provision of road markings through the junction will assist to guide vehicles from Victoria Quay into the correct lane. 'Tram Only' road markings have also been provided to make drivers aware of the lane arrangement.

The Audit Team retain their belief that this is an issue. The drivers / riders of vehicles turning onto Ocean Drive, particularly those from Victoria Quay, could inadvertently enter the tram lane and make a lane change upon realising that they are in the wrong lane, leading to side-swipe collisions occurring with vehicles in the nearside lane. It should be noted that during the site investigation the road markings through the junction had not been provided.

The Audit Team retain their belief that this is an issue. It is recommended that measures are implemented to guide drivers safely through this junction. During the site investigation associated it with the Final Stage 3 Road Safety Audit it was observed that the road markings had not been laid.

It is recommended that the design is appropriately amended so that is clear to the drivers / riders of approaching vehicles which lanes they can travel in and which they cannot.
