The Council has undertaken a number of structural surveys of the main building in Currie High School in 2017, in response to a leak in the home economics department. The results of those surveys are included in this document. To summarise, this document includes:

Currie High School Structural Appraisal – Reinforced Concrete Floors

**REPORT ON INSPECTION AND TESTING OF
REINFORCED CONCRETE FLOOR SLABS AT
CURRIE HIGH SCHOOL, EDINBURGH.**

**Report on Inspection and Testing of Reinforced Concrete Floor Slabs at
Currie High School, Edinburgh.**

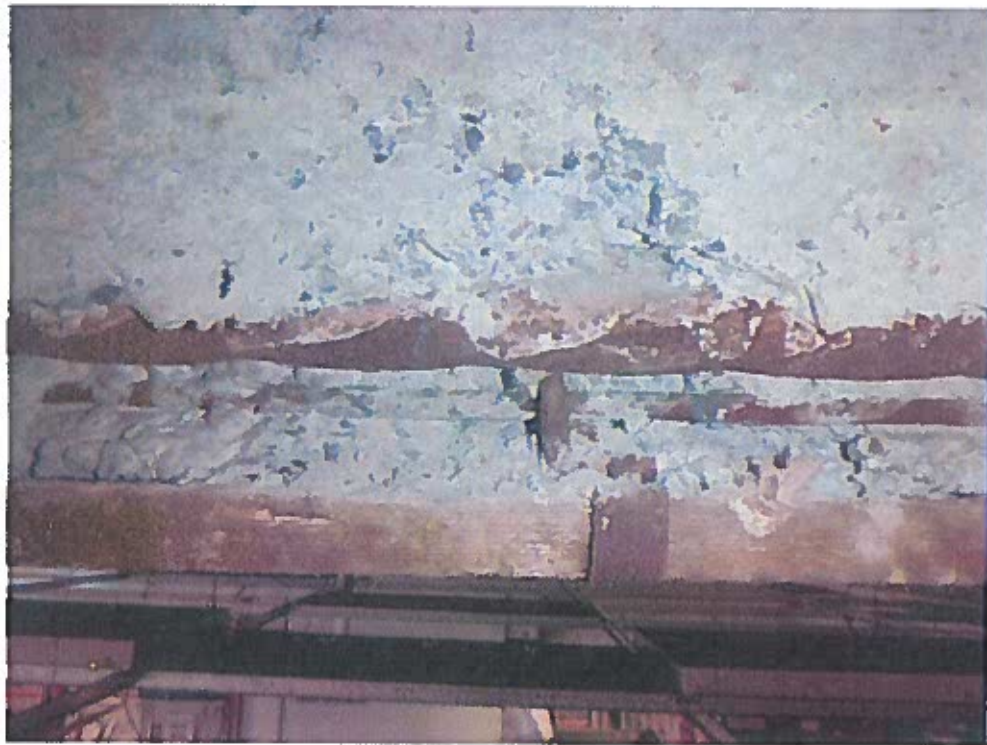
Plate 16. **Area 1, Rib**
Concrete Cover Removed to Expose Reinforcement

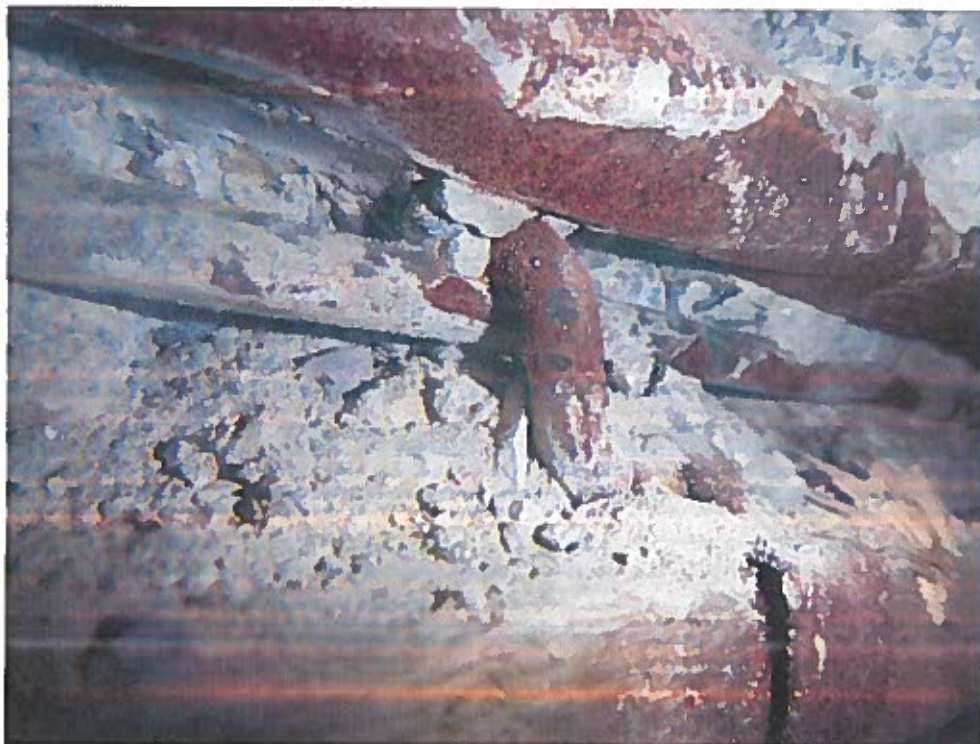
Plate 17. **Area 1, Rib**
Concrete Cover Removed to Expose Reinforcement

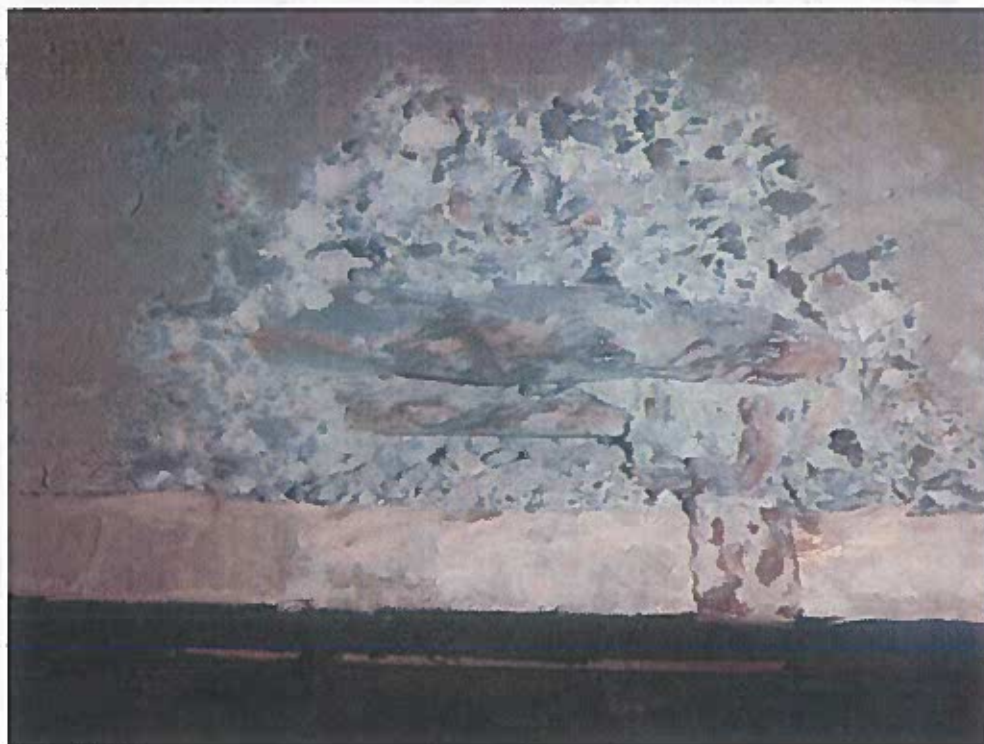
Plate 34. Area 2, Rib
Concrete Cover Removed to Expose Reinforcement

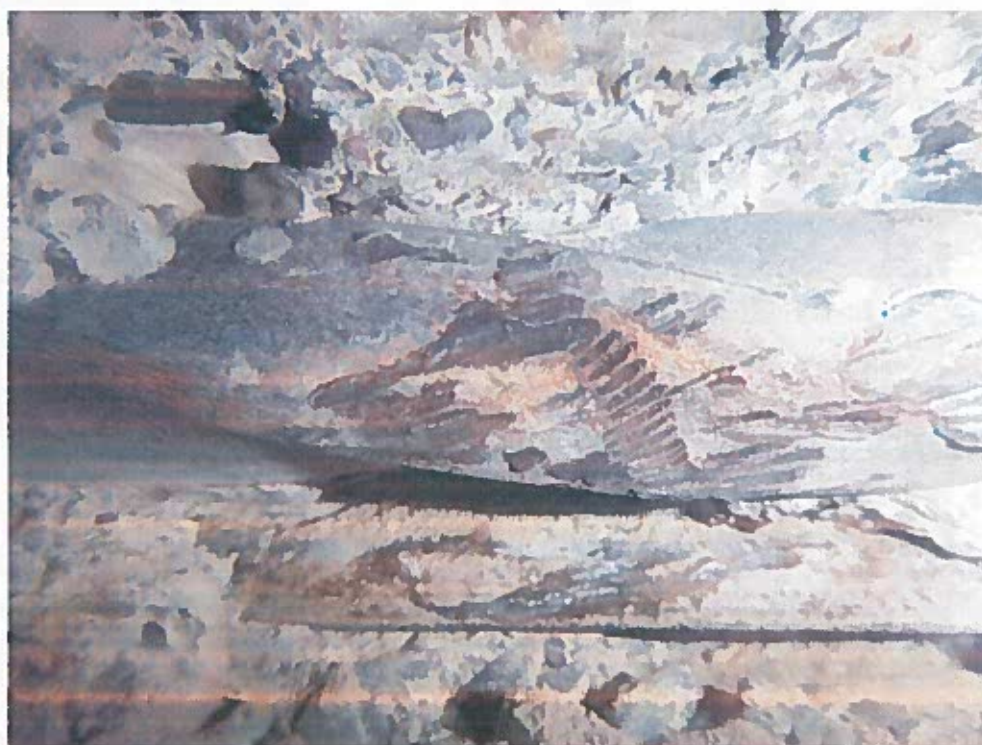
Plate 35. Area 2, Rib
Concrete Cover Removed to Expose Reinforcement

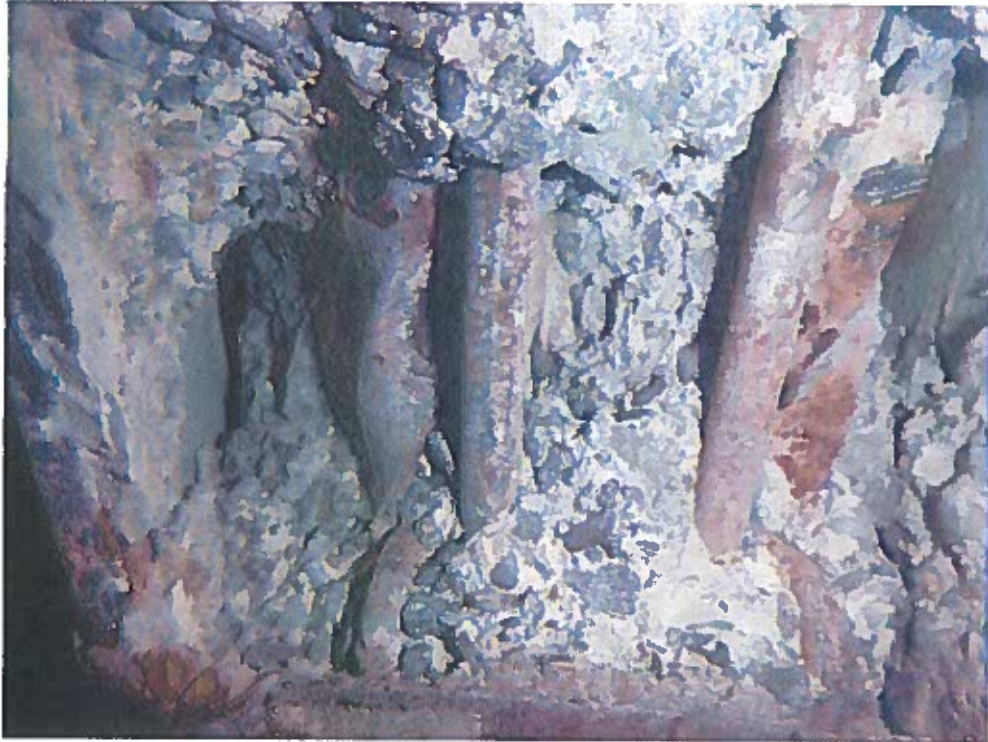
Plate 44. **Area 4, Rib**
Concrete Cover Removed to Expose Reinforcement

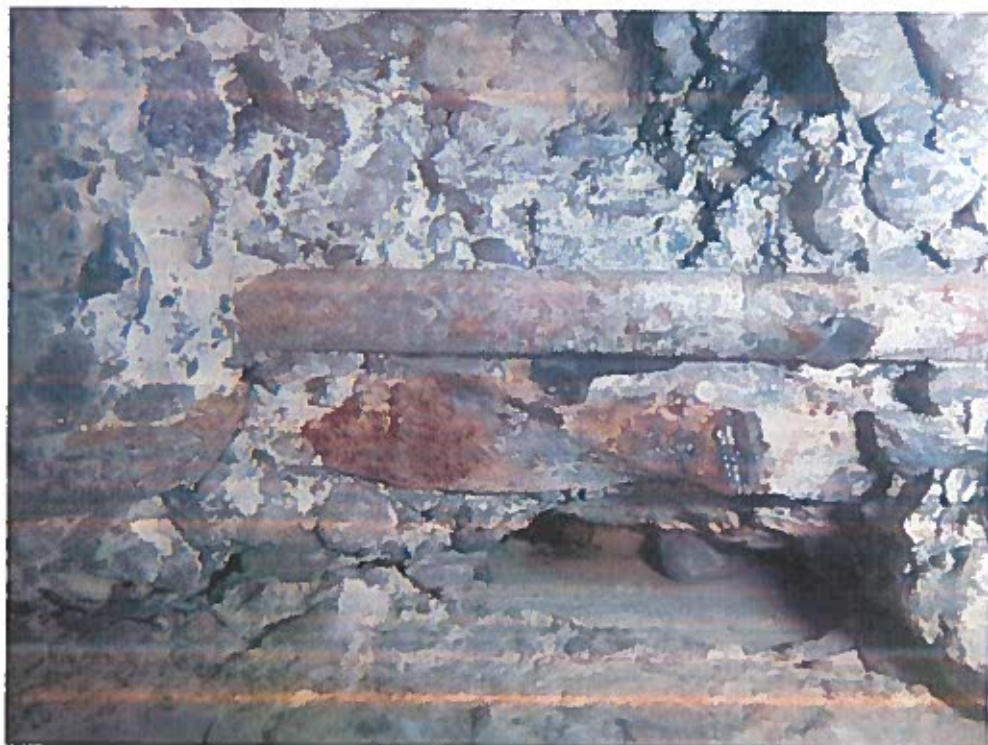
Plate 45. **Area 4, Rib**
Concrete Cover Removed to Expose Reinforcement
