CS000866

Survey Description	Survey Date	Survey Status	Surveyor	Organisation
<p>BLOCK A: 1970S CONCRETE FRAME TWO STOREY BUILDING. RENDERED BRICK INFILL PANELS WITH INVERTED FLAT ROOF. TIMBER INFILL PANELS WITH SINGLE GLAZED WINDOW UNITS</p> <p>BLOCK B&amp;C: 1970S CONSTRUCTION CONCRETE FRAME BUILDING WITH 4 STOREY TOWER SECTION AND SINGLE STOREY BLOCK C. CONCRETE CLADDING AND RENDERED BRICK INFILL. FLAT ROOF WITH MINERAL FELT AND GRP LIQUID APPLIED SYSTEMS. ALUMINIUM POWDER COATED DOUBLE GLAZED WINDOWS AND DOORS.</p> <p>BLOCK D: SINGLE AND TWO STOREY SECTIONS. CONCRETE FRAMED WITH RENDERED BRICK INFILLS, VERTICAL CLADDING. MINERAL FELT FLAT ROOF. POWDERCOATED ALUMINIUM WINDOWS AND TIMBER DOORS.</p> <p>BLOCK E: SINGLE STOREY SECTIONS. CONCRETE FRAMED WITH RENDERED BRICK INFILLS. MINERAL FELT FLAT ROOF. POWDERCOATED ALUMINIUM WINDOWS AND DOORS. BLOCK F: TU MINERAL FELT FLAT ROOF COMPOSITE BOARDING CLADDING THE EXTERIOR. SINGLE GLAZED METAL WINDOWS AND TIMBER DOOR SETS</p>	<p>07/08/2017</p>	<p>COMPLETE</p>	<p>F&amp;G</p>	<p>F&amp;G</p>

## Edinburgh - City Of Edinburgh Council

<b>Site</b>	SIT1186 WESTER HAILES EDUCATION CENTRE - WHEC
<b>Address</b>	5  EDINBURGH LOTHIAN EH14 2SU
<b>N

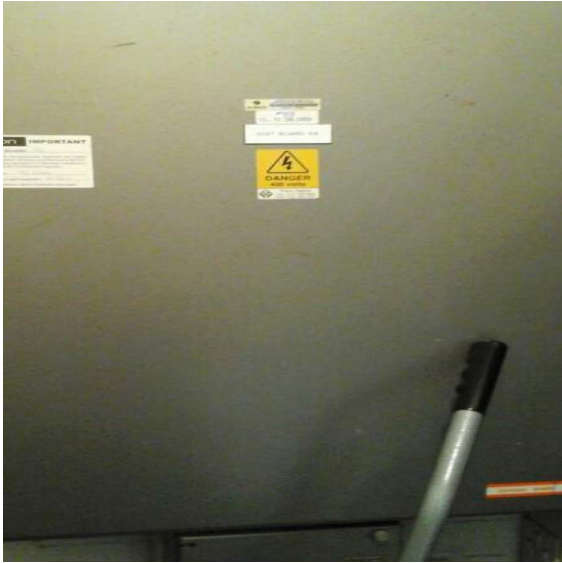
<b>Code:</b>	IW00015013	<b>Site:</b>	SIT1186 WESTER HAILES EDUCATION CENTRE - WHEC
<b>Element:</b>	08 Electrical services	<b>Building:</b>	BLD00251
<b>Subelement:</b>	08.03 Electrical Power	<b>Room:</b>	
<b>Item:</b>	08.03.04	<b>Cost:</b>	£48358.06
<b>Condition:</b>	C Poor	<b>Remedy:</b>	
<b>Priority:</b>	02 Essential - Within 2 years	<b>Defect:</b>	The distribution board/boards require to be replaced
<b>Comments:</b>	Dorman Smith, DB/A8, 20Way, TP&N, Fuse board. Recommend replacing the DB with a new MCB DB		
<b>Photo:</b>

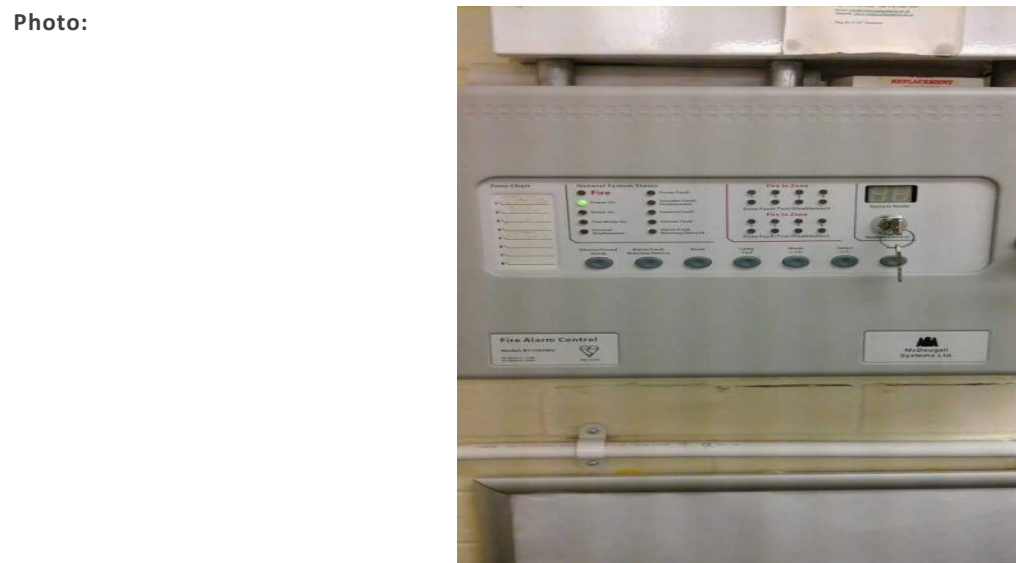
<b>Code:</b>	IW00015016	<b>Site:</b>	SIT1186 WESTER HAILES EDUCATION CENTRE - WHEC
<b>Element:</b>	08 Electrical services	<b>Building:</b>	BLD00251
<b>Subelement:</b>	08.04 Fire Alarm Systems	<b>Room:</b>	
<b>Item:</b>	08.04.01	<b>Cost:</b>	£230306.32
<b>Condition:</b>	C Poor	<b>Remedy:</b>	
<b>Priority:</b>	02 Essential - Within 2 years	<b>Defect:</b>	Defective fire alarm system or installation of system required/recommended

**Comments:** Fire alarm system appears to be a manual type system with break glass units located at final exits. There is no automatic detection provided within the building. Recommend adding automatic detection to the fire alarm system.

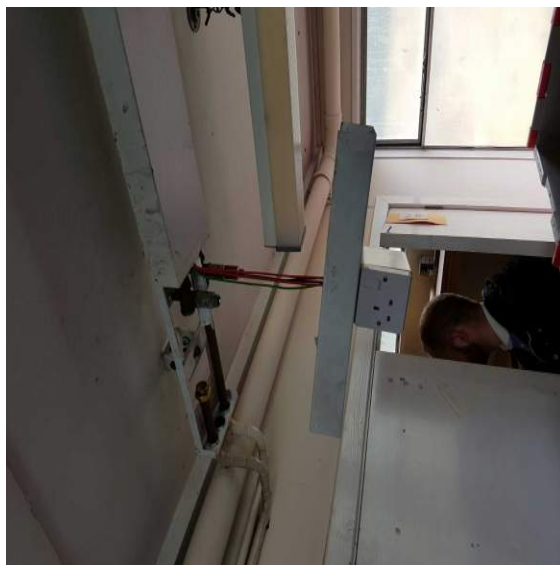
**Comments:** FMS noted building is due for demolition summer 2018

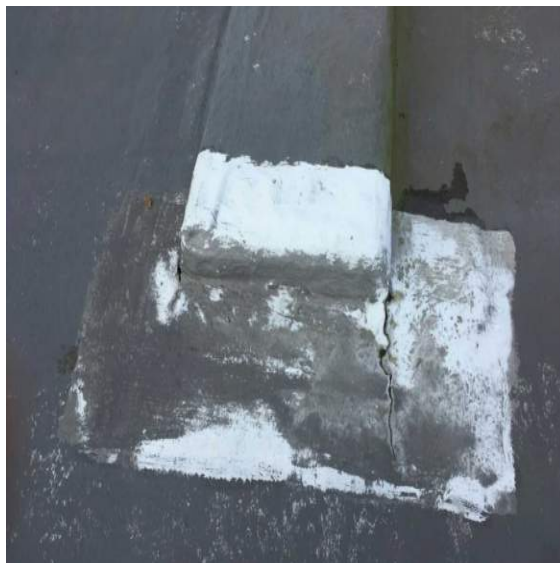
**Code:** IW00015106  
**Element:** 01 Roofs  
**Subelement:** 01.05 Roof Coverings  
**Item:** 01.05.07  
**Condition:** C Poor  
**Priority:** 02 Essential - Within 2 years

**Comments:** Desirable to install new single ply system to roof in year 5, current system appears to be performing satisfactorily with minor maintenance.

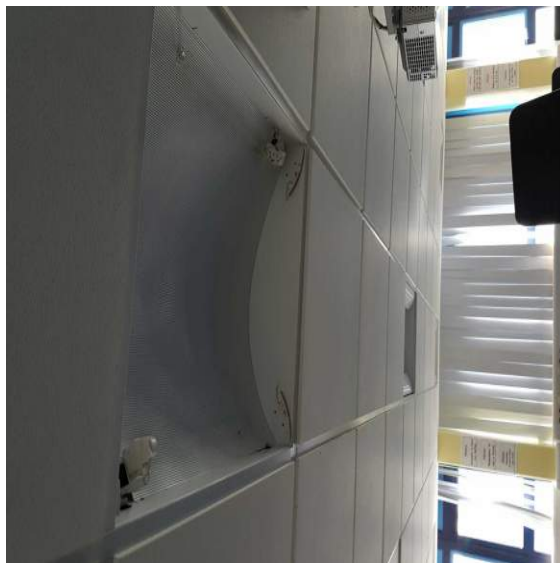
**Code:** IW00014704  
**Element:** 08 Electrical services  
**Subelement:** 08.05 Lighting  
**Item:** 08.05.03  
**Condition:** C Poor  
**Priority:** 02 Essential - Within 2 years

**Site:** SIT1186 WESTER HAILES EDUCATION CENTRE - WHEC  
**Building:** BLD02332  
**Room:**  
**Cost:** £197.56  
**Remedy:** Repair/replace fitting  
**Defect:** Faulty light fitting in IT room  
**Defect Location:** Room 081 first floor of drawing
