Materials Audit

City of Edinburgh Council

November 2023

GRANTON WATERFRONT MATERIALS AUDIT

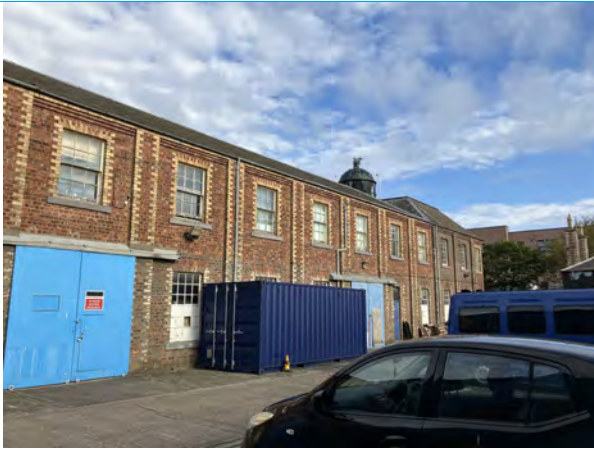
1.28

East Elevation
of Lighthouse

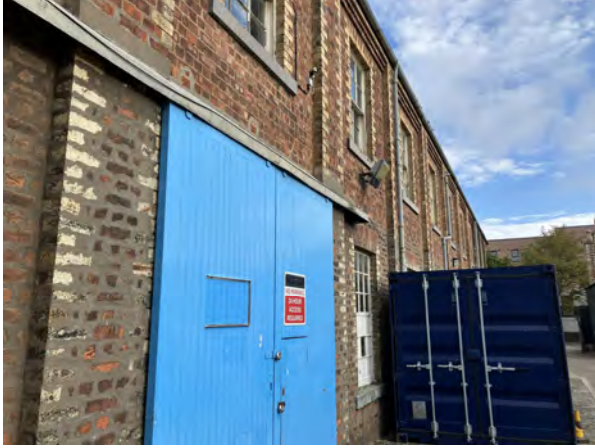
1.29

East Elevation
of Lighthouse

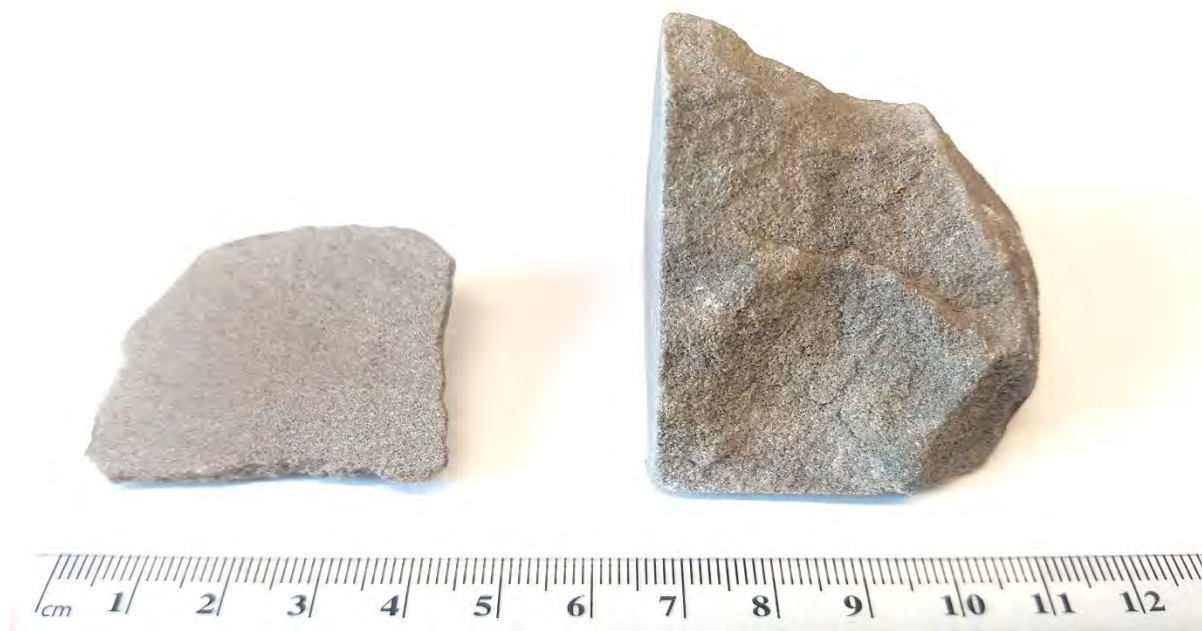
The client has provided a sample of the existing masonry for analysis, which is assumed to be representative of the 'original' stone requiring replacement. The sample comprises a single piece of brownish grey sandstone measuring approximately 55 x 45 x 40 mm; this was assigned the BGS sample number ED12408 (see Figure 1).

Figure 1. Image of sample ED12408. The supplied sample piece was sawn in two as part of the thin sectioning process. Ruler (with main divisions in cm) for scale.
