The Council has undertaken a number of structural surveys of the main building in Currie High School in 2017, in response to a leak in the home economics department. The results of those surveys are included in this document. To summarise, this document includes:

Currie High School Structural Appraisal – Reinforced Concrete Floors

**REPORT ON INSPECTION AND TESTING OF
REINFORCED CONCRETE FLOOR SLABS AT
CURRIE HIGH SCHOOL, EDINBURGH.**

**Report on Inspection and Testing of Reinforced Concrete Floor Slabs at
Currie High School, Edinburgh.**

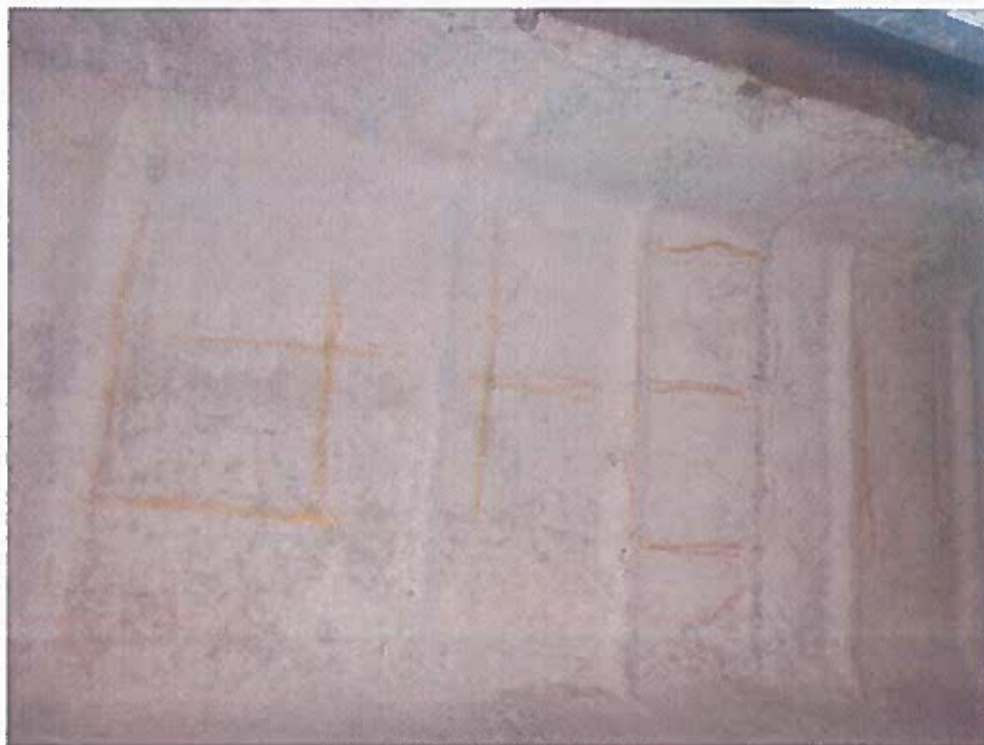
Plate 10.

**Area 1, Soffit of Slab
Layout of Embedded Reinforcement**

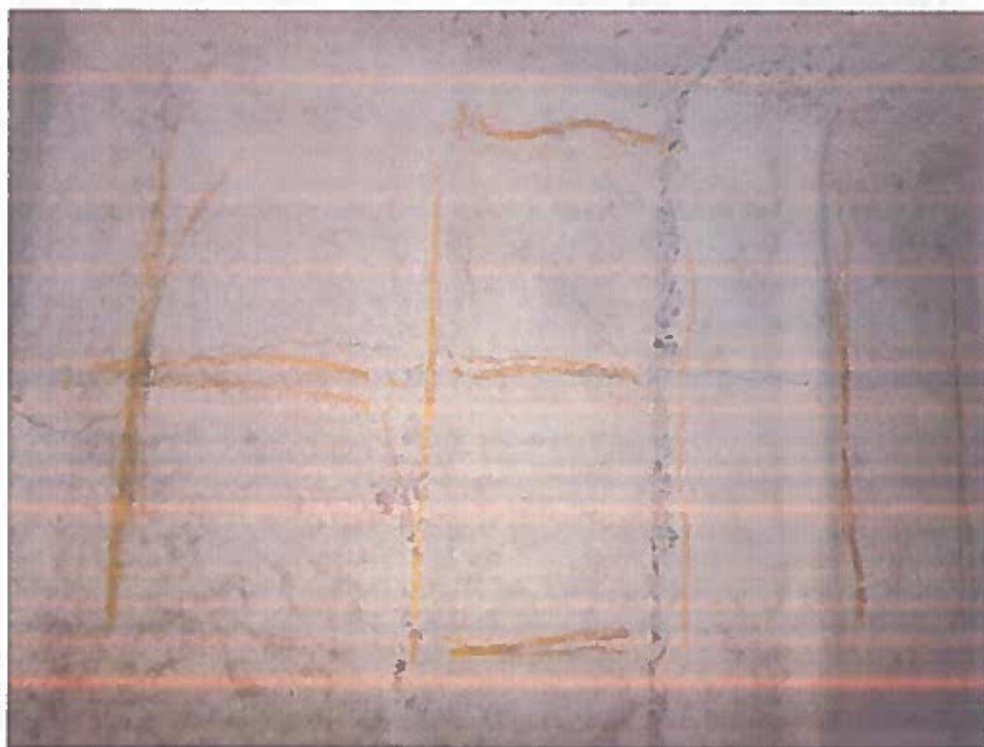
Plate 11.

**Area 1, Soffit of Slab
Layout of Embedded Reinforcement**

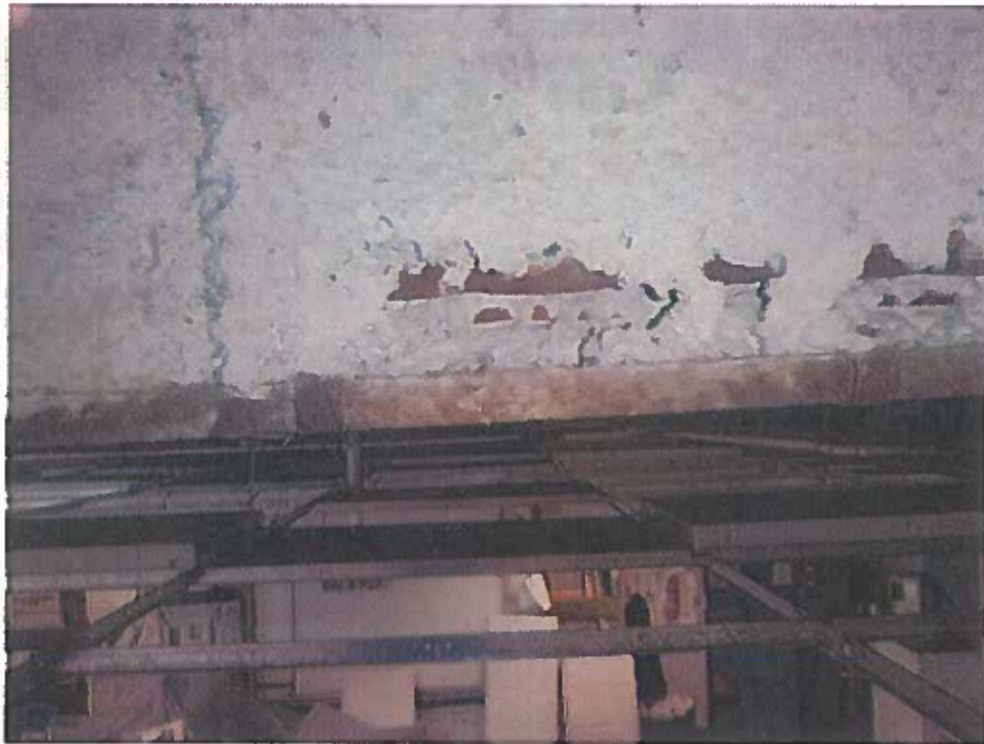
Plate 14.

**Area 1, Rib
Details of Reinforcement**

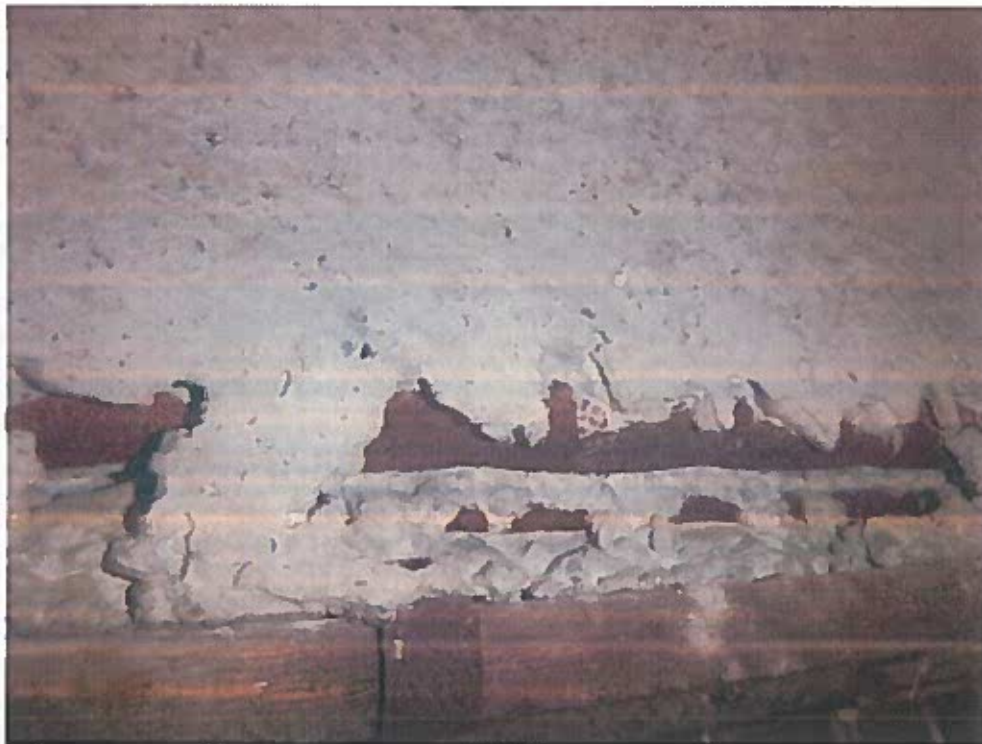
Plate 15.

**Area 1, Rib
Details of Reinforcement**

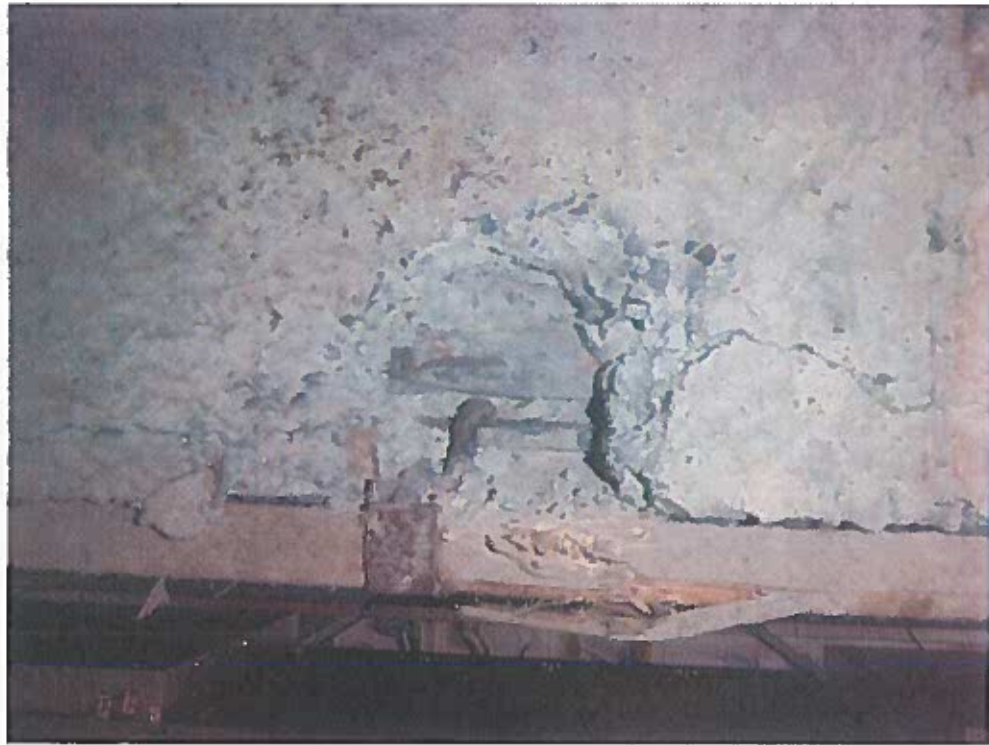
Plate 18.

**Area 1, Rib
Concrete Cover Removed to Expose Reinforcement**

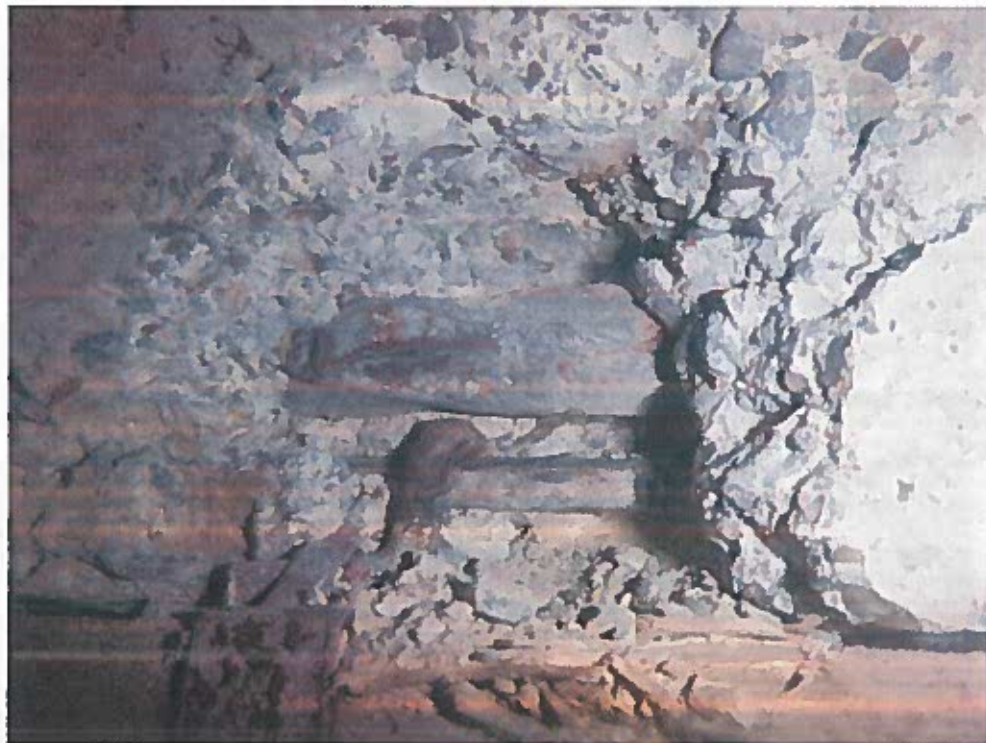
Plate 19.

**Area 1, Rib
Concrete Cover Removed to Expose Reinforcement**

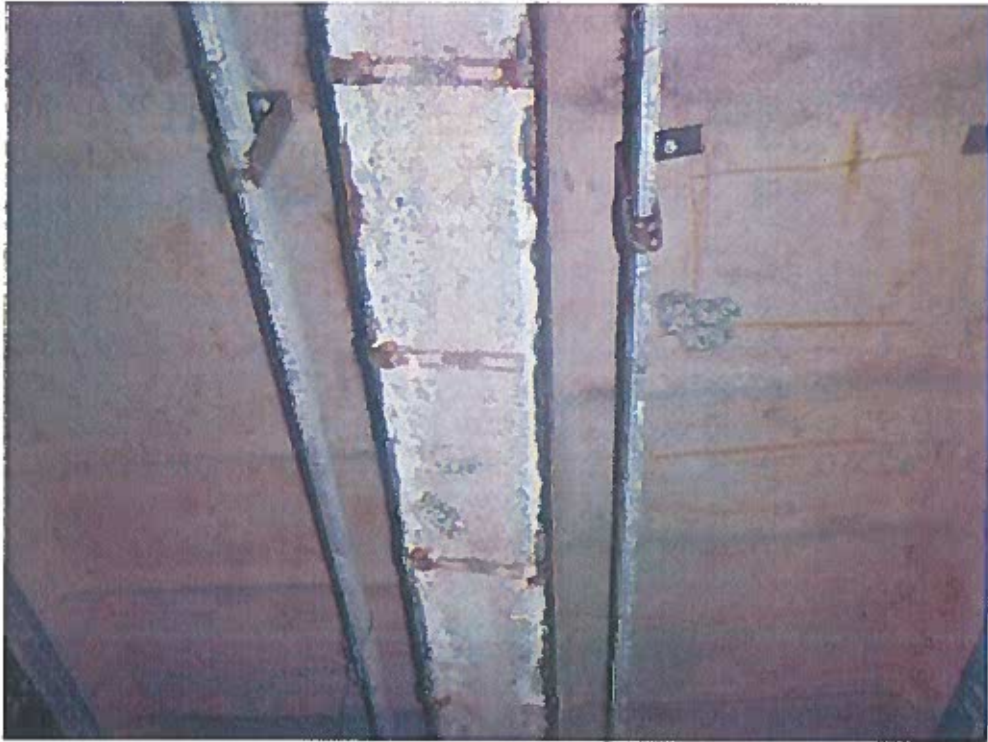
Plate 40.

**Area 4, Soffit of Slab
General View**

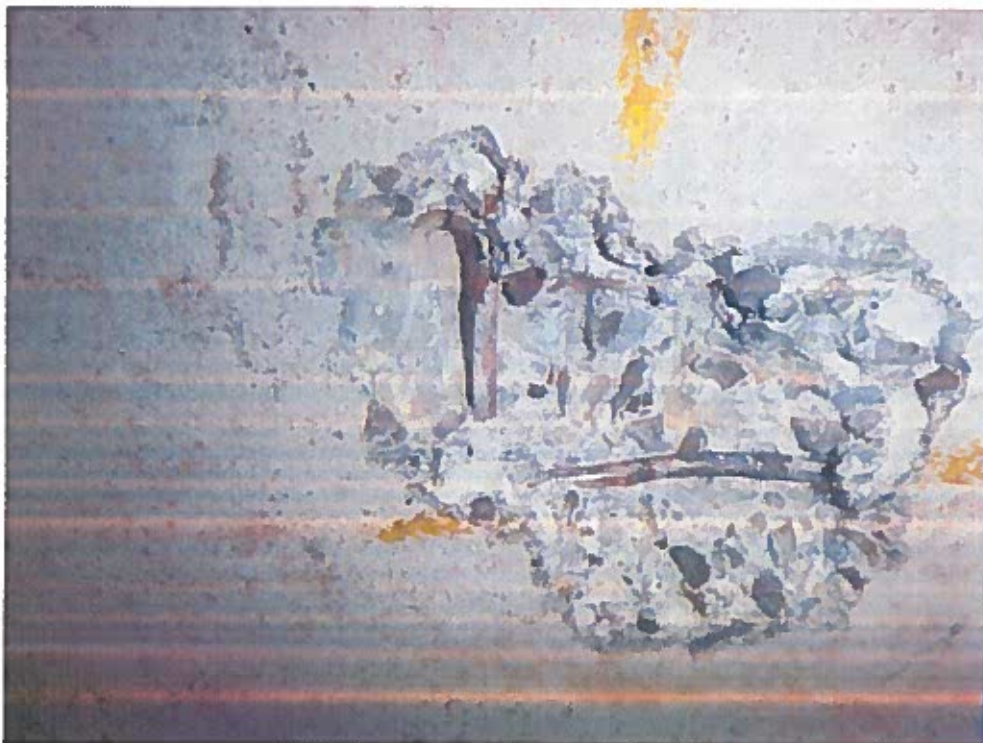
Plate 41.

**Area 4, Soffit of Slab
Concrete Cover Removed to Expose Reinforcement**

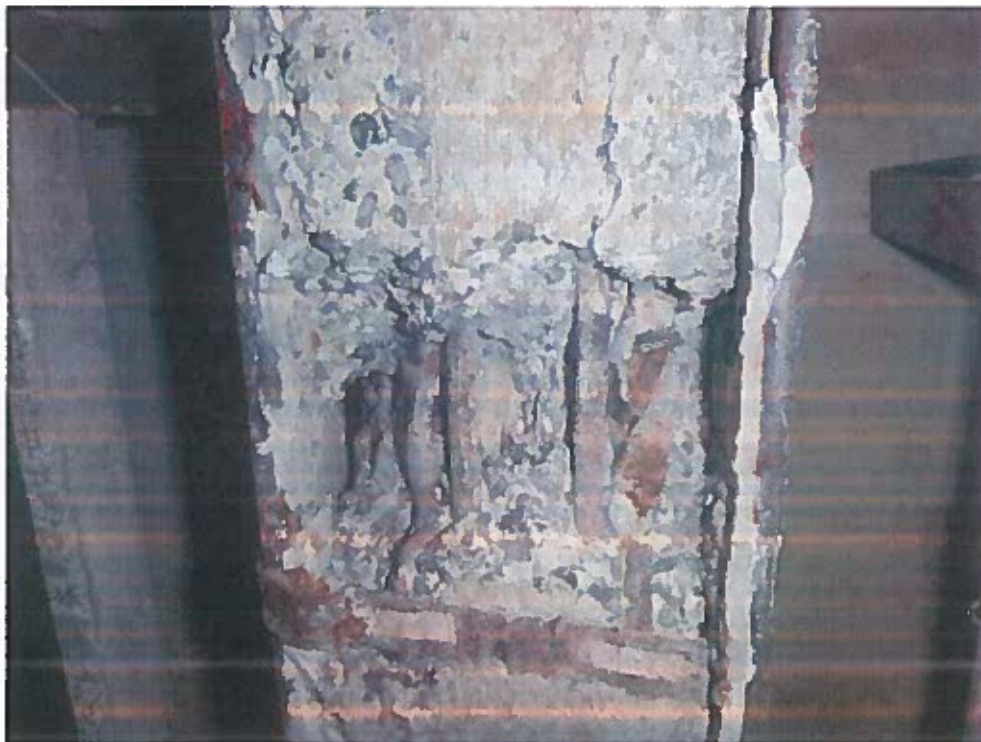
Plate 43.

**Area 4, Rib
Details of Reinforcement**
