Materials Audit

City of Edinburgh Council

November 2023

GRANTON WATERFRONT MATERIALS AUDIT

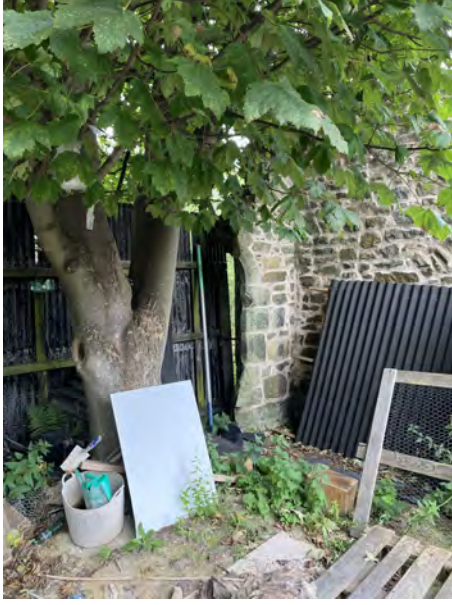
1.14

Granton Castle
Walled Garden

Remnants of arched
opening where walled
garden adjoined the
castle.

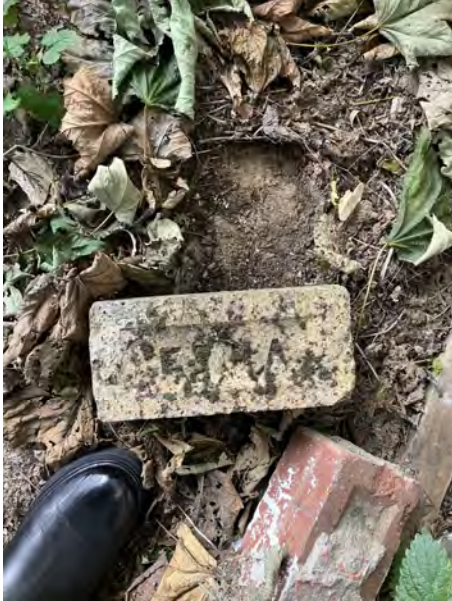
1.15

Etna brick found
in Granton
Castle Walled
Garden

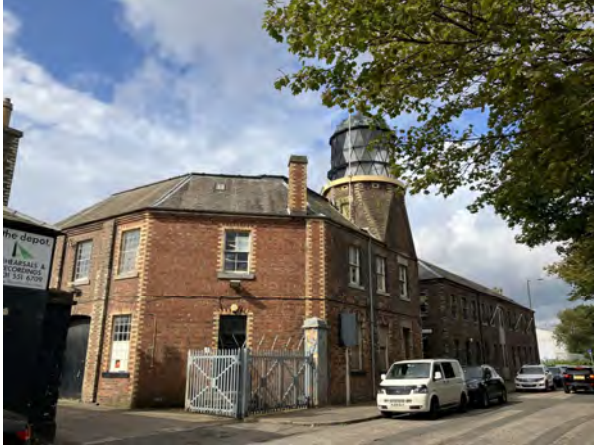
1.27

From our inspection, it is evident that there has not been any significant building repairs or maintenance carried out recently as the lighthouse building is in relatively poor condition. From ground level the roof looked to be in fair condition with some slipped slates visible. The coating to the copper domed roof to the cupola is significantly worn and, although close visual inspection was not possible, it is expected that the copper sheet has deteriorated, possibly accelerated by the marine environment. The cast iron rainwater goods are in varying states of repair with corrosion and cracking to joints visible. The brick walls are in fair condition, however, there is evidence of cement repointing which is causing sacrificial damage to the bricks. The windows are in a poor state of repair, with some boarded, other panes cracked or missing and timber decay evident due to a lack of regular maintenance. The timber doors are in a similar state of repair due to a lack of regular repairs and redecoration.

Granton
Lighthouse from
West Harbour
Road

The Lighthouse and Outbuilding require repairs to the roof, rainwater goods, masonry and joinery in the near future to put them back into good condition.

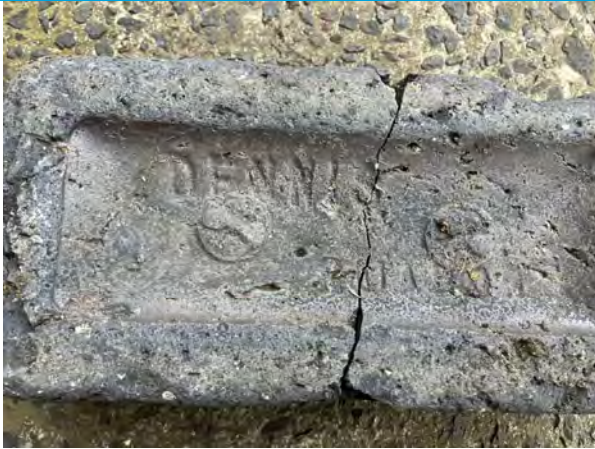
1.30

Dennis Ruabon

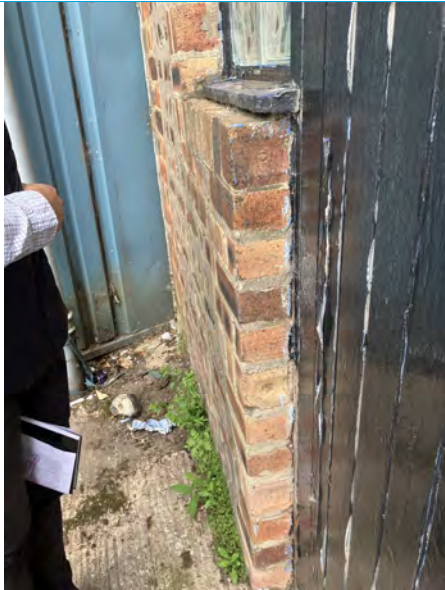
1.31

Brickwork to
West Elevation
– note the
circular marks to
the bricks

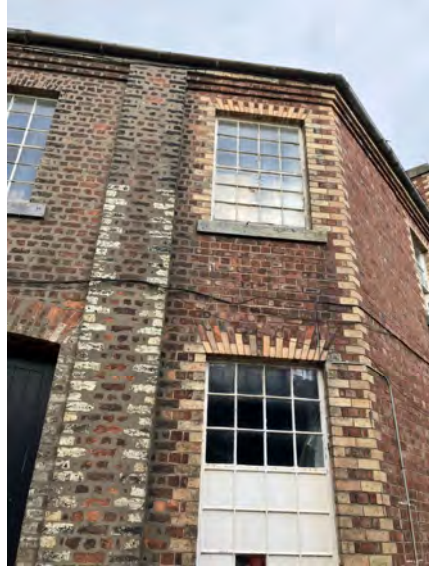
1.32

Note the change in bricks to the

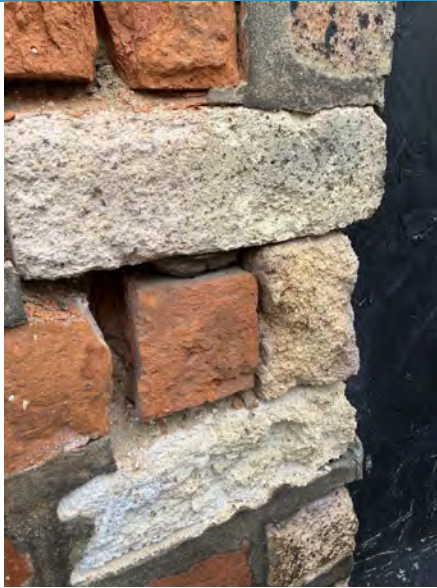
1.33

Whitehill Bricks to outbuilding

Note deterioration of bricks due to cementitious mortar.

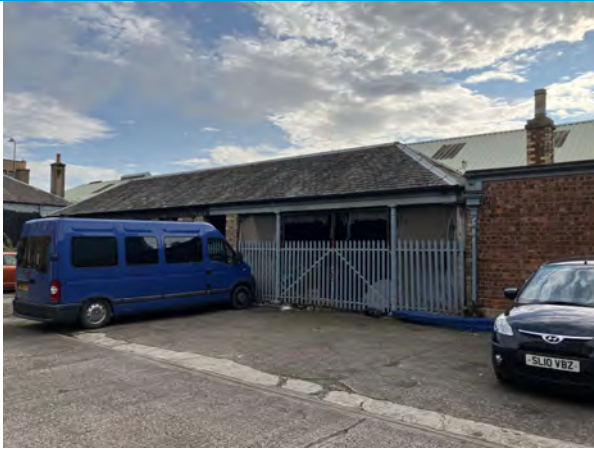
1.36

West elevation of outbuilding

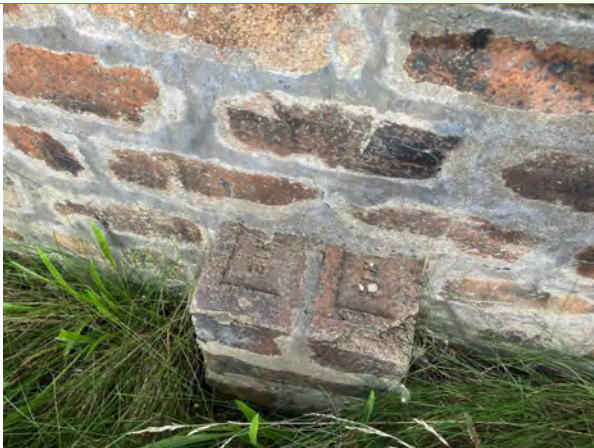
1.37

Garden wall – Niddrie Bricks visible.

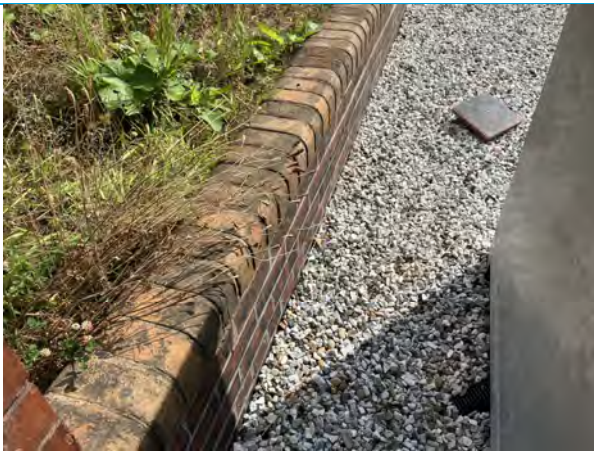
1.40

Low boundary
wall

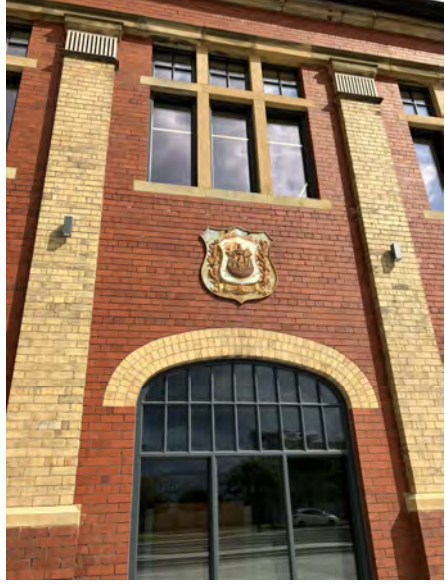
1.41

Main Façade to Granton Station

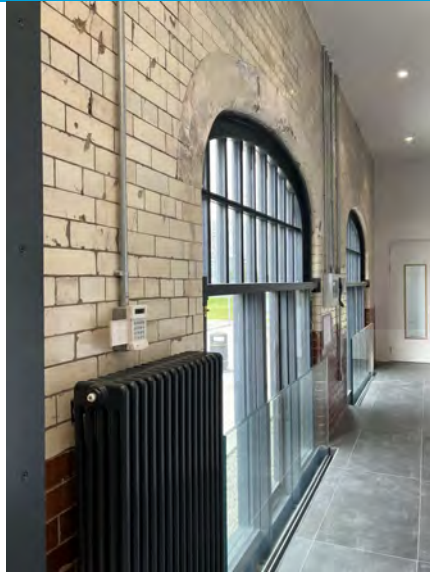
1.42

Interior of Station

Note glazed bricks

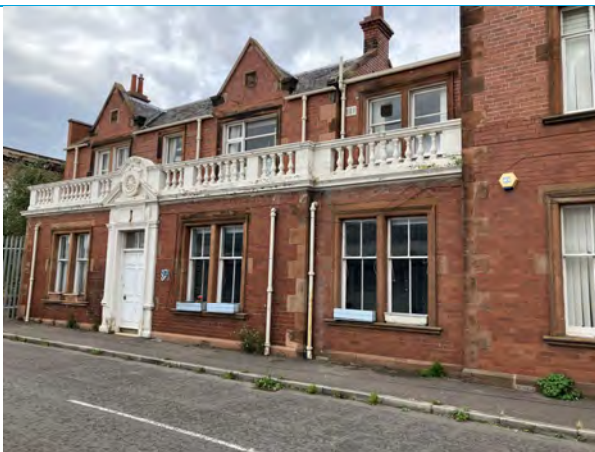
1.43

Madelvic House Main Facade

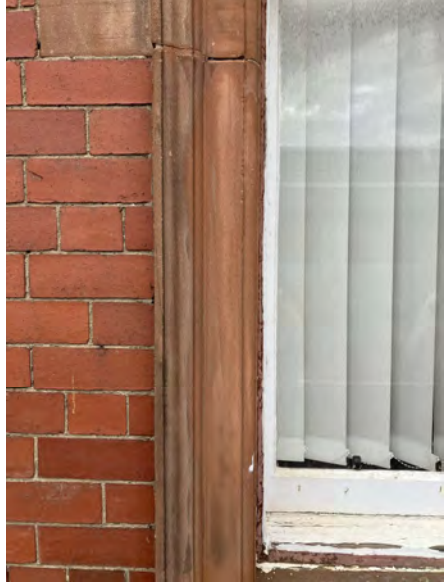
1.44

Red sandstone architrave and red bricks to main façade

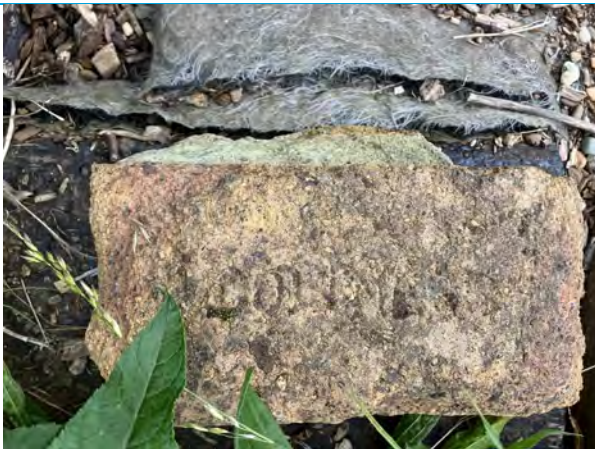
1.46

Coltness Brick found in garden of Madelvic House
